Preliminary Results of Post-Disaster Archaeological Investigations at the Kasthamandap and within Hanuman Dhoka, Kathmandu Valley UNESCO World Heritage Property (Nepal)

Coningham, R.A.E.¹, Acharya, K.P.², Davis, C.E.¹, Kunwar, R.B.³, Simpson, I.A.⁴, Schmidt, A.¹ and Tremblay, J.C.¹,

¹Department of Archaeology, Durham University, DH1 3LE, UK

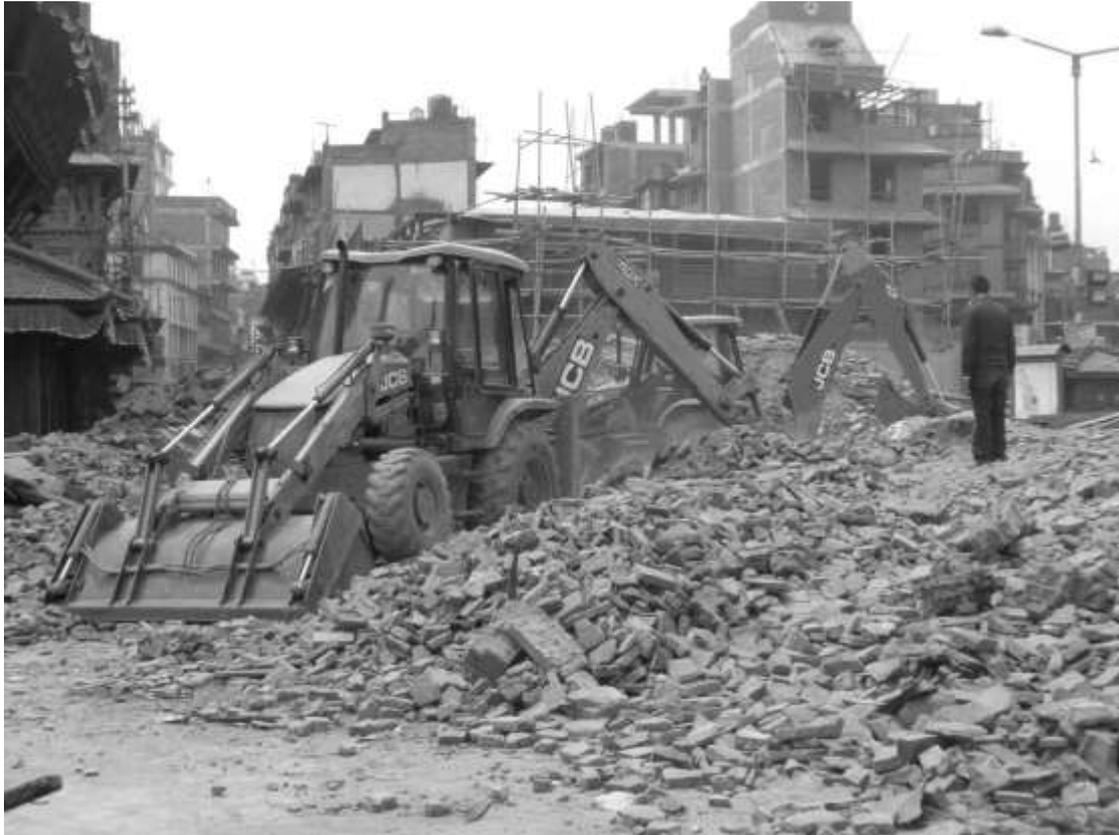
During the 7.8 Magnitude Gorkha Earthquake on the 25th April 2015, one of Kathmandu's oldest monuments, the Kasthamandap, collapsed killing over seventy individuals. In the immediate aftermath of the disaster, the army mobilised bulldozers to recover the dead and the injured and the next day two JCBs were deployed on the ruins (Figure 1). Whilst the earthquake caused a catastrophic loss of life and livelihoods across Nepal and surrounding areas, the damage within the UNESCO World Heritage Property of the Kathmandu Valley was particularly bad. Indeed, a number of key monuments within the medieval Durbar Square at Hanuman Dhoka were damaged and many collapsed. In response, a collaborative team of international and national experts from the Department of Archaeology, Government of Nepal, Durham University and the University of Stirling, was invited to participate in a UNESCO-sponsored mission of post-disaster surveys and rescue excavations across earthquake-damaged monuments and areas within the UNESCO Kathmandu Valley World Heritage Property, including Hanuman Dhoka.

Figure 1: JCBs clearing the debris at Kathmandap on the 26th April 2015 (Image courtesy of Kai Weise).

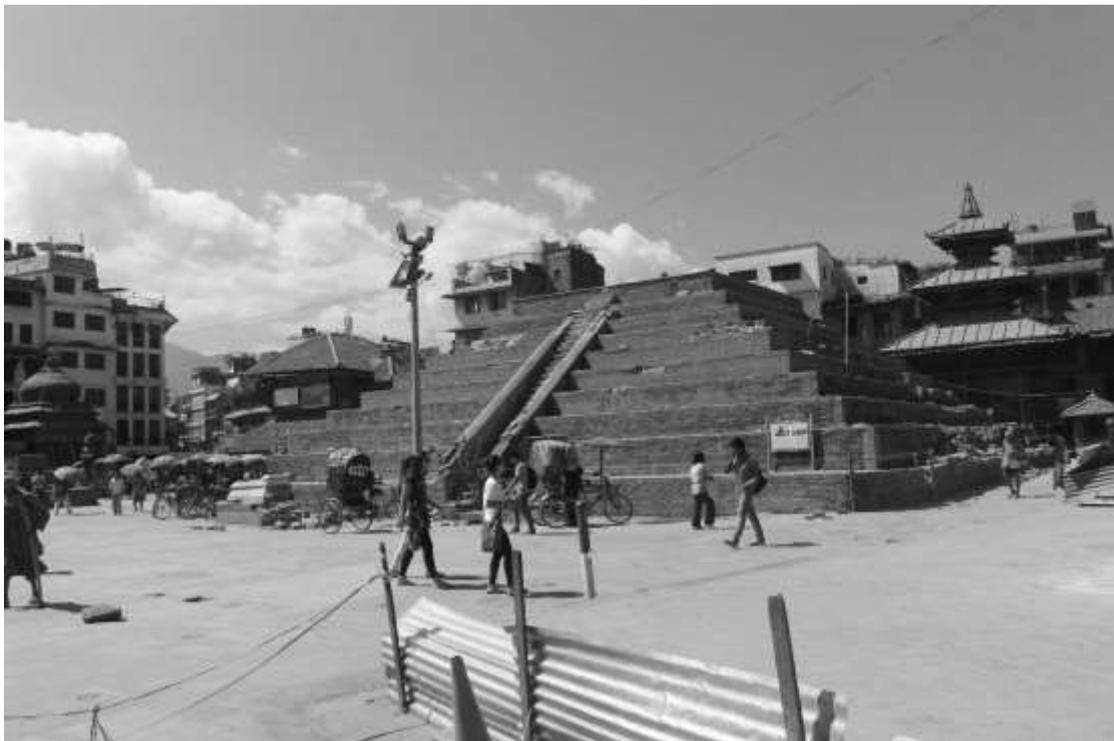
Figure 2: The foundation plinth of the collapsed Maju Degu Temple in Hanuman Dhoka's Durbar Square

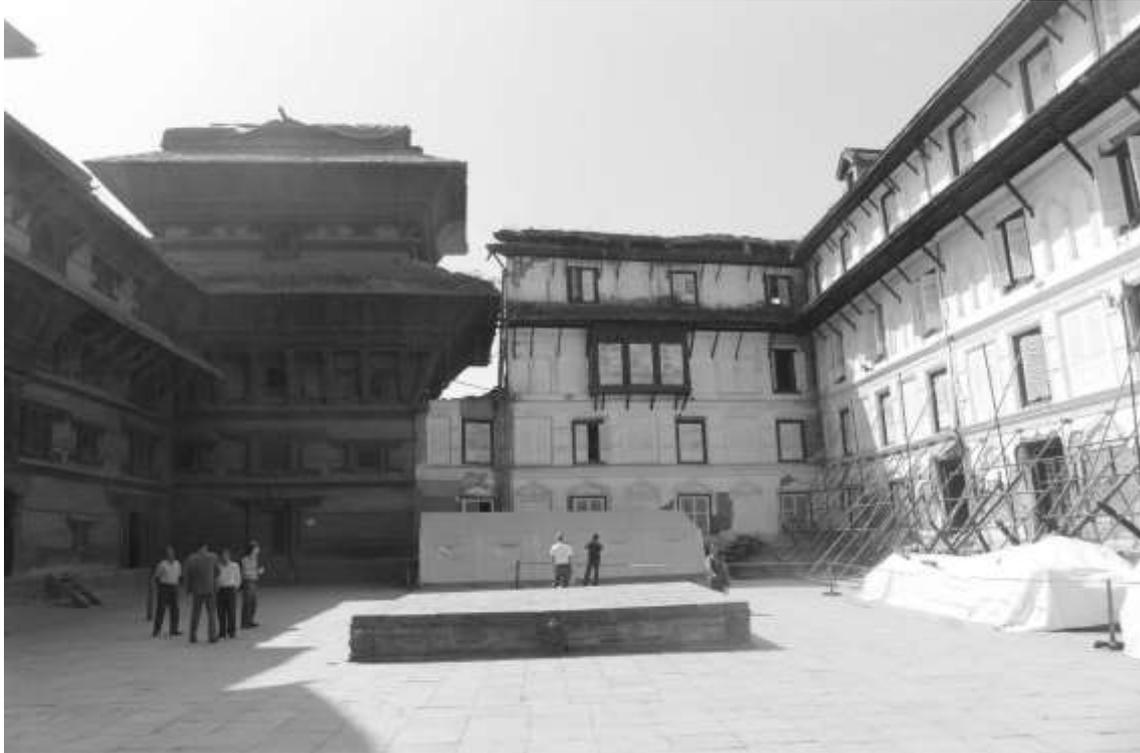
Figure 3: The collapsed Basantapur tower and damage to the interior courtyard at the Palace, Hanuman Dhoka.

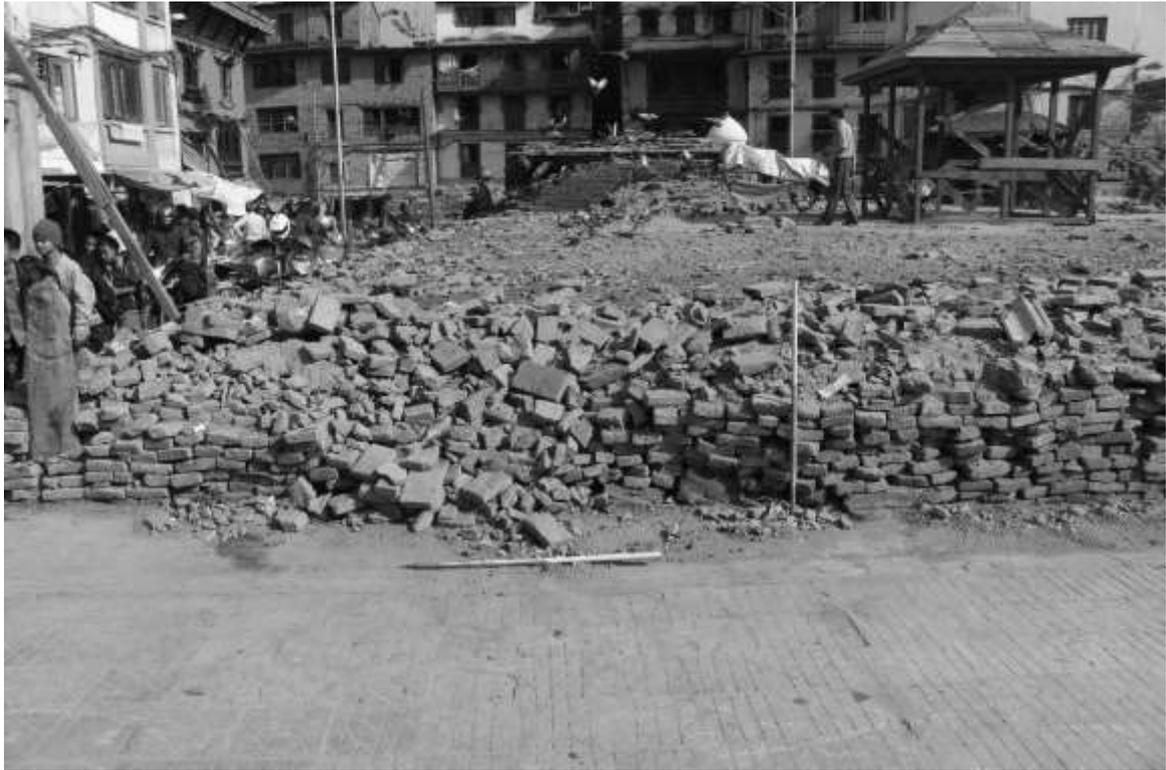
Following the collapse of the Kasthamandap and the subsequent clearance and recovery efforts, the footprint of the monument was reconfigured by volunteers utilising rubble to form a wall where the outer plinth had been bulldozed away. This temporary wall designated a slightly larger area than the original footprint and acted to retain a mixture of brick, tile, stone and concrete behind as well as clay from the roof construction (Figures 6 and 7). Once we had removed the rubble wall from the trench's location, we found evidence of the post-disaster deployment of the JCBs and bulldozers in the form of a very large cut which had removed the southern plinth of the monument as well as in situ subsurface archaeological material originally sealed below its tiled floor. We cleared portions of the remaining tiled surface of the monument, which was covered with debris from the collapse and subsequent clearing by the bulldozer and JCBs. Dating to the 1966 renovation campaign, we found that in places the tile flooring had been damaged by the buckets of the machinery with marks evident in places (Figure 8). We sieved the mixed material from collapse and reconfiguration carefully and recovered tile, brick and carved wood elements as well as modern materials, including surgical gloves, masks, needles and IV lines associated with the blood donation session held at the monument on the 25th April

Figure 7: Reconfigured footprint of the Kasthamandap on its southern edge, where the Trench was located.

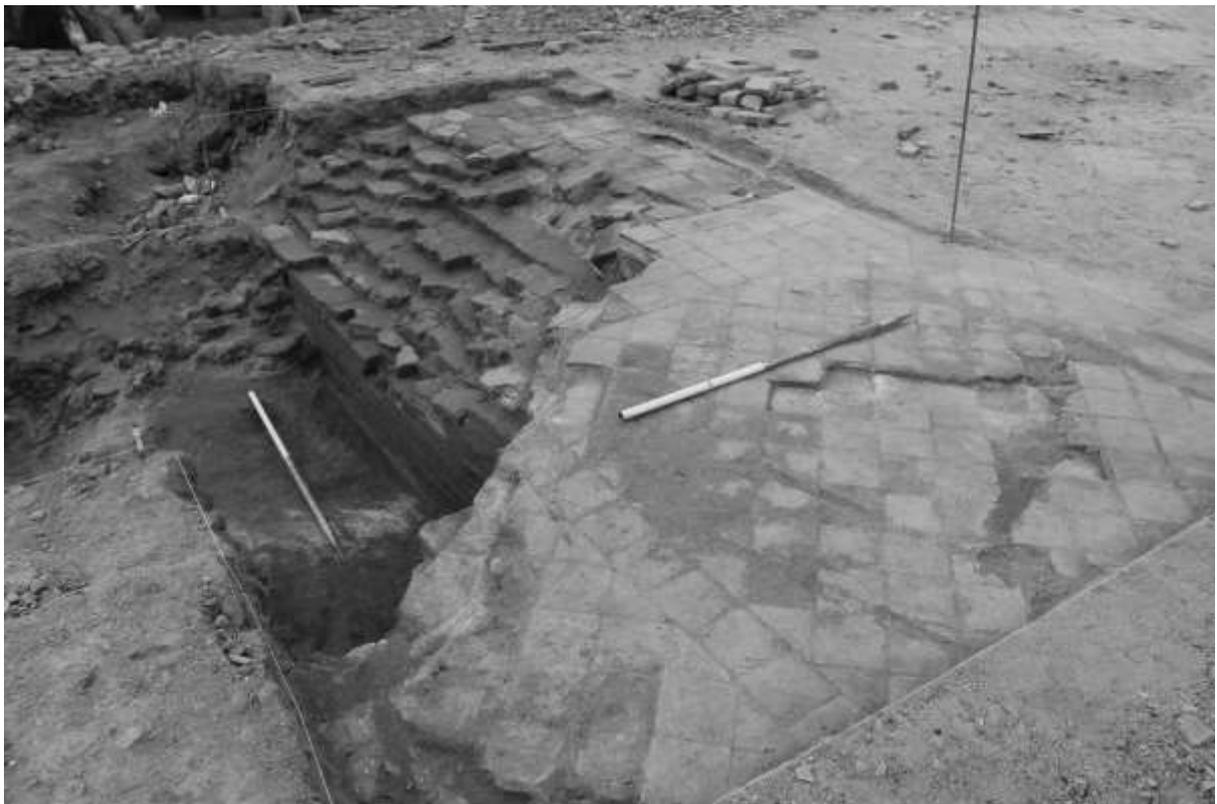
Figure 8: Clear marks from the bucket of machinery on the tiled surface, and cut through this tiled surface and foundation wall below, looking west.

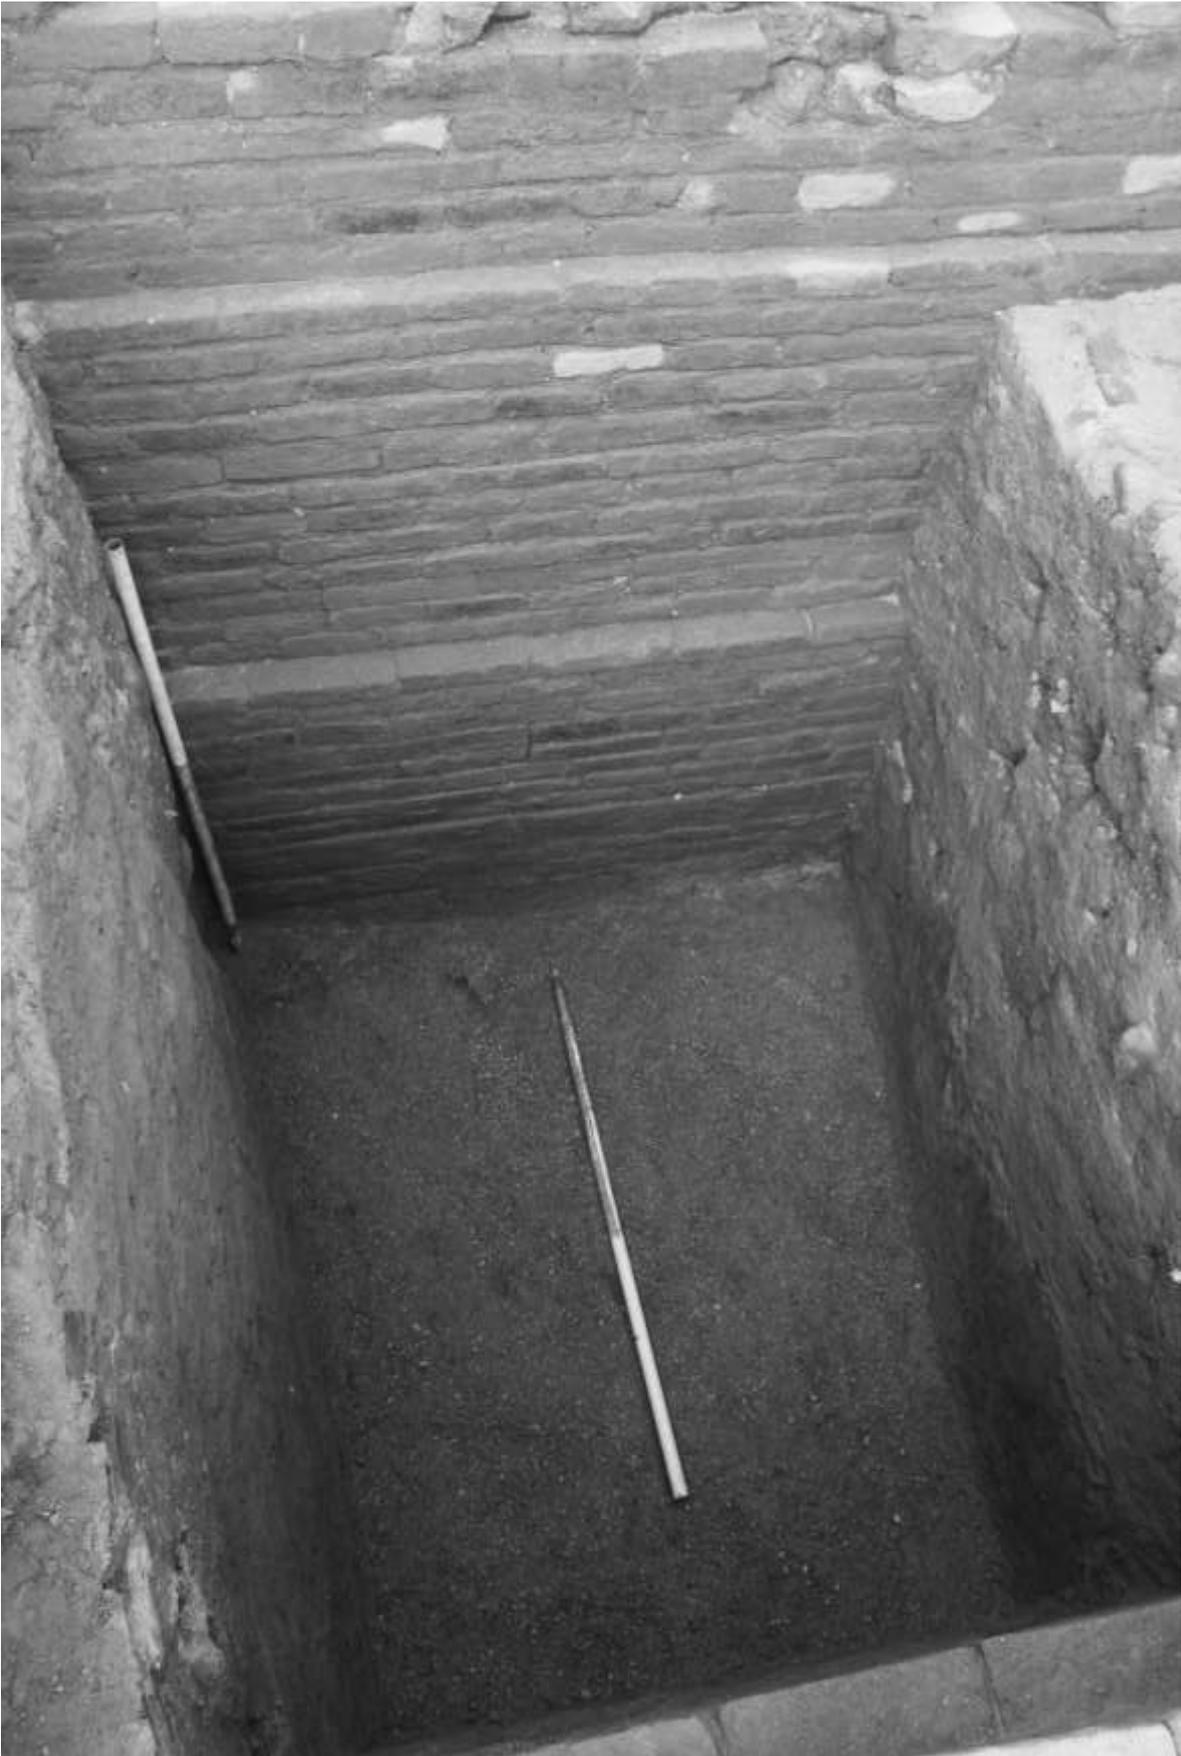
The most evident of these was the massive one metre thick and two metre deep wall which formed the core foundation for the monument. Indeed, it actually underpinned the apparently independent four L-shaped corner brick quoins and rows of paired saddlestones between them (Figure 11). Measuring an estimated 12 by 12 metres, this exceptionally well-built foundation was constructed of bricks laid in clay mortar. The bonding design of the wall involved placing two stretchers on the prepared ground surface and then following them with two headers, two stretchers and so on. After 12 courses, the wall was stepped and the pattern resumed, comprising three sets of 12 courses. We were unable to identify any signs of damage to this massive foundation relating to the recent or previous earthquakes and the only recorded damage was a direct result of the bulldozers and JCBs during the immediate post-earthquake emergency recovery stage. During the excavation of the lower levels of the wall, it became clear that the foundation wall had been constructed within a cut into underlying clay layers, both cultural and natural, but was only visible to the exterior of the monument.

Figure 11: Large foundation wall, looking north.

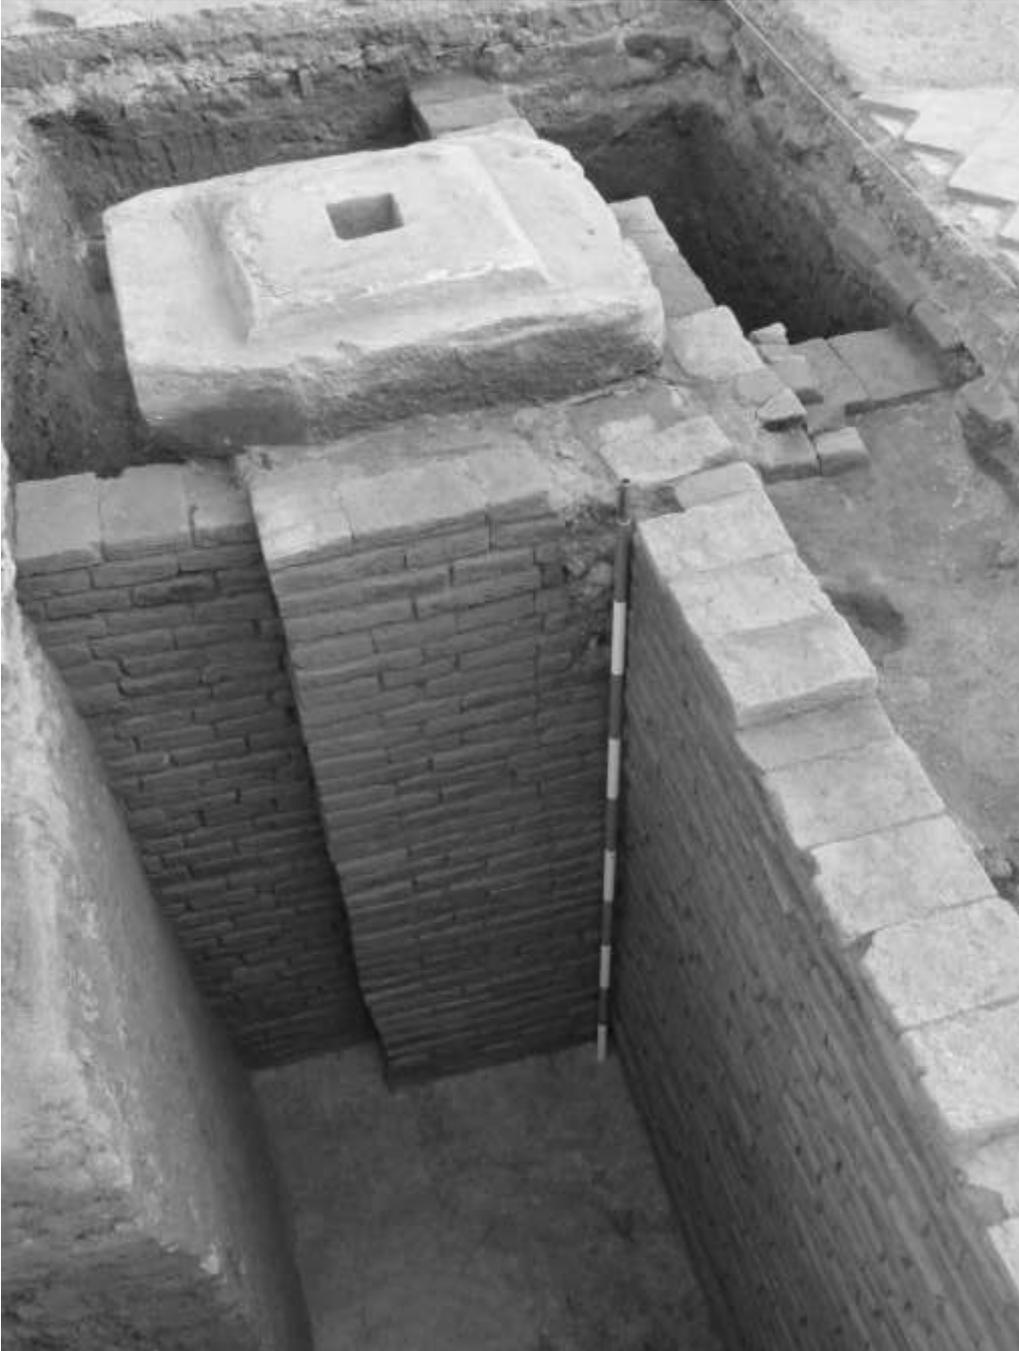
When we excavated to the north of this massive wall, in the interior of the monument, we identified a second major construction feature of the original monument – a massive freestanding brick pier. Underlying the large southwest saddlestone, which had supported one of the monument's four central wooden pillars, we exposed the 2.01 metre deep brick pillar with a width of c. one by one metres. Comprising 35 courses of brick set in clay, the exposed brickwork was extremely well preserved and showed no evidence of displacement of earthquake distortion (Figure 12). The brick bond was similar to that of the inner foundation wall and comprised patterns of two headers and two stretchers. Whilst excavating and cleaning these two foundation elements, it became clear that the Kasthamandap had been subjected to a major phase of secondary construction after its original establishment. This had involved the placing of four bracing cross-walls between

Figure 12: Brick pier below saddlestone, looking east.

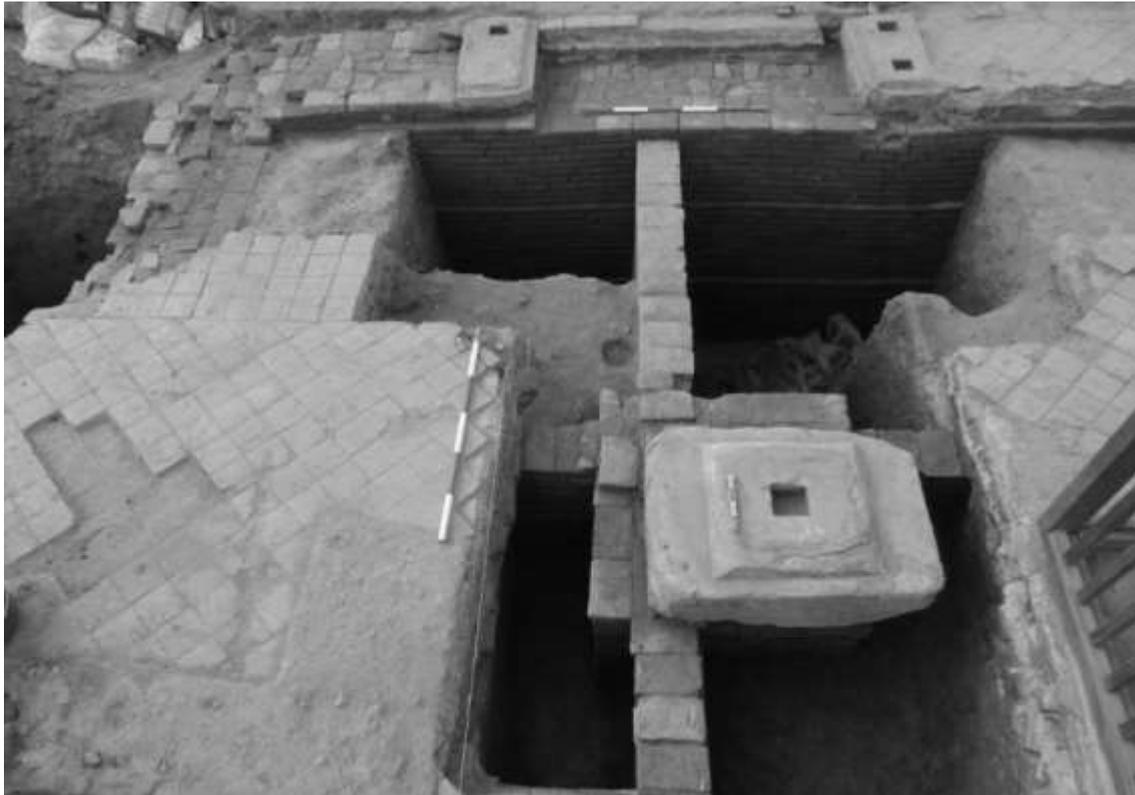
the freestanding pier and the massive outer foundation wall and, we assumed, the other piers (Figure 13). These cross-walls were only one brick thick but also went down to the same depth as the original foundations, 2.01 metres. Running between piers and the foundation wall, the cross-walls abutted the main foundation, not cutting into it, and most also abutted the brick pier, though one east-west cross-wall did cut into the upper courses of this pier. Moreover, the bricks were laid in a different bond of only headers.

Figure 13: Saddlestone with cross-walls connecting to the brick pier.

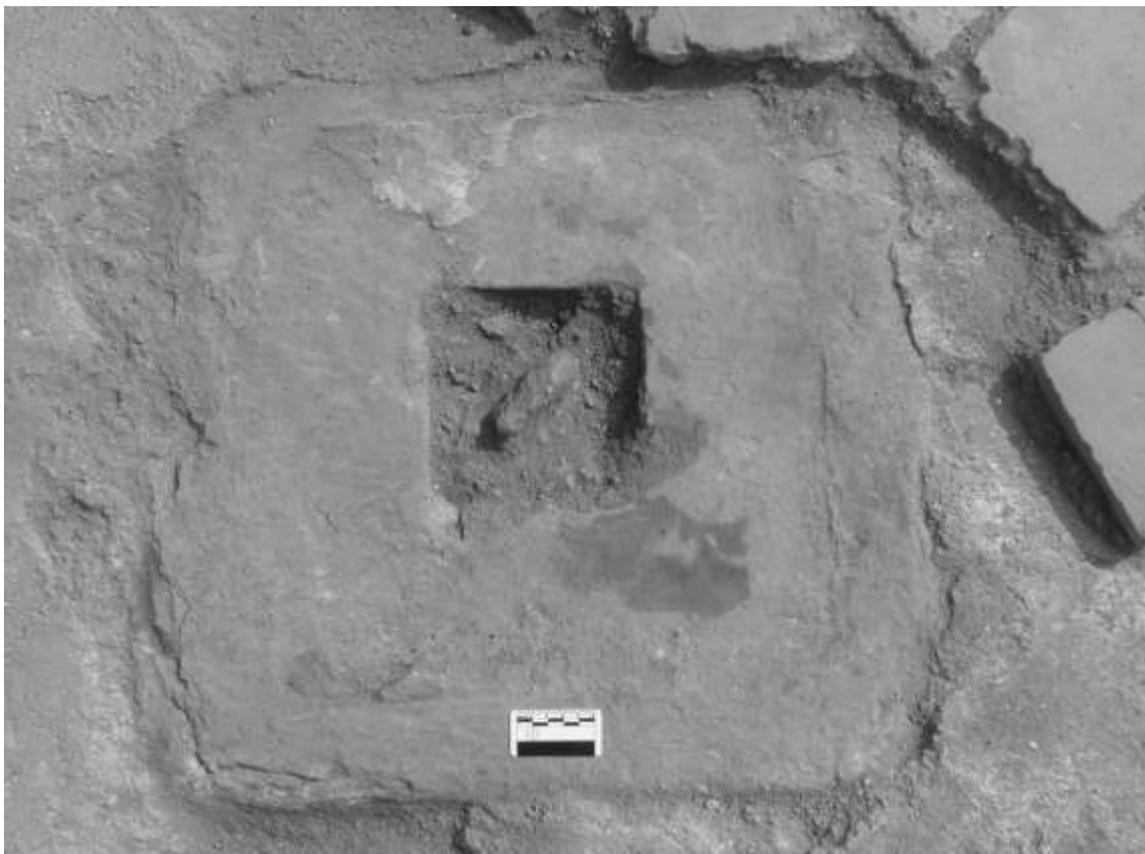
The saddlestone measured 0.50 metres square with a raised central square of 0.37 metres. The mortise socket for the wooden pillar's tenon tongue had been cut into the centre of this raised area and measured 0.14 by 0.14 by 0.14 by 0.135 metres and 0.06 metres deep. The presence of a roughly square copper alloy residue on the raised square portion of the saddlestone suggests that original wooden pillar was separated from its saddlestone by a copper alloy plate, perhaps acting as a damp proof course (Figure 14). Indeed, we identified one of the original central timber pillars from the Kasthamandap within the Durbar Square and found that it measured 6.2 metres long and 0.39 square. At the upper end of the pillar, it was equipped a 0.13 metre deep mortise socket and at the base of the pillar with a 0.07 metre long tenon tongue measuring 0.12 by 0.11 metres. This indicates that wooden tenon and stone mortise joint was designed to leave a small gap between the two, again perhaps a way of preventing moisture from leading to the rotting of the base of the timber pillar.

Figure 14: Copper corrosion visible on saddlestone.

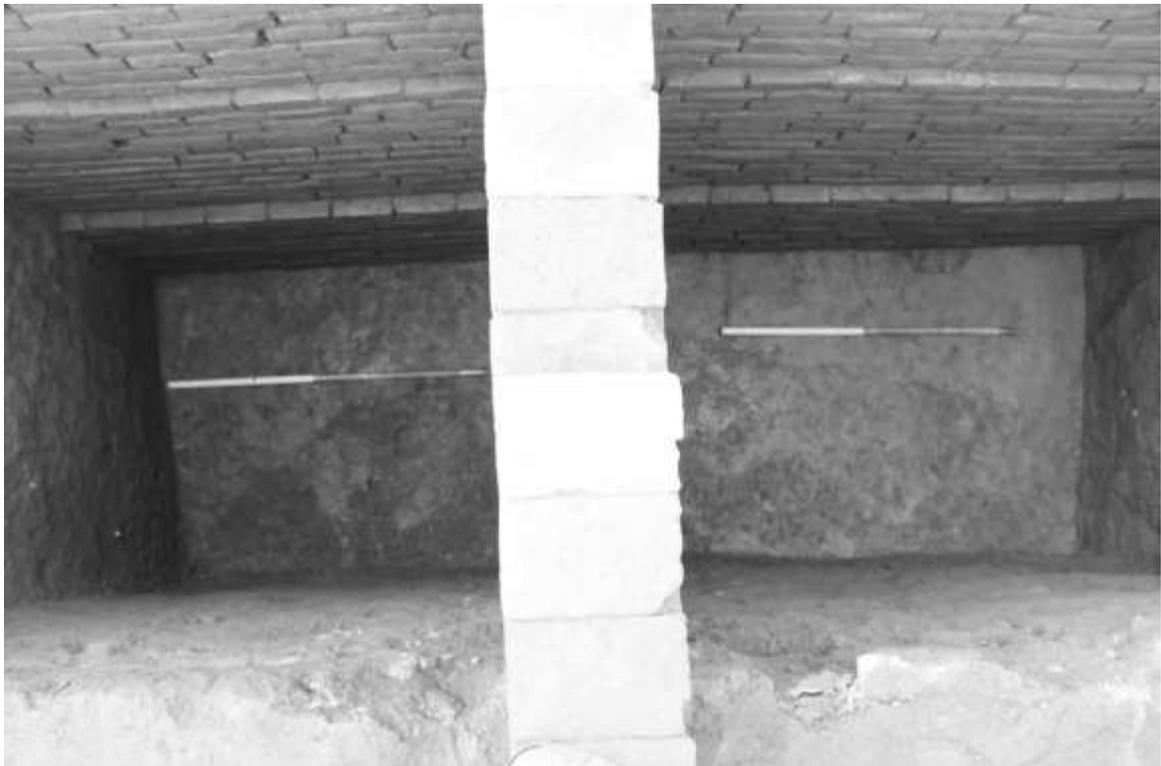
At the base of the cross-walls, brick pier and large foundation wall we identified evidence of pre-monument construction human activity. Below the homogenous fill material that was deposited within the cross-walls and foundation, was a smooth clay that might represent the natural. This ran underneath the cross-wall east-west cross-wall within the larger area of the trench. Very clearly, a rounded feature also cut into this material, to the east of the trench. Cut into the sterile clay, this feature contained inclusions of charcoal and ceramics. It was not fully excavated as water was reached at this depth and waterlogging also caused concerns of undermining the cross-wall and damaging the architectural integrity of the Kasthamandap foundations. This feature indicated that there was cultural activity at the site prior to the construction of the brick walls at the site (Figure 16)

Figure 16: Rounded feature visible below eas-west cross-wall within large foundations of Kasthamandap, looking west.

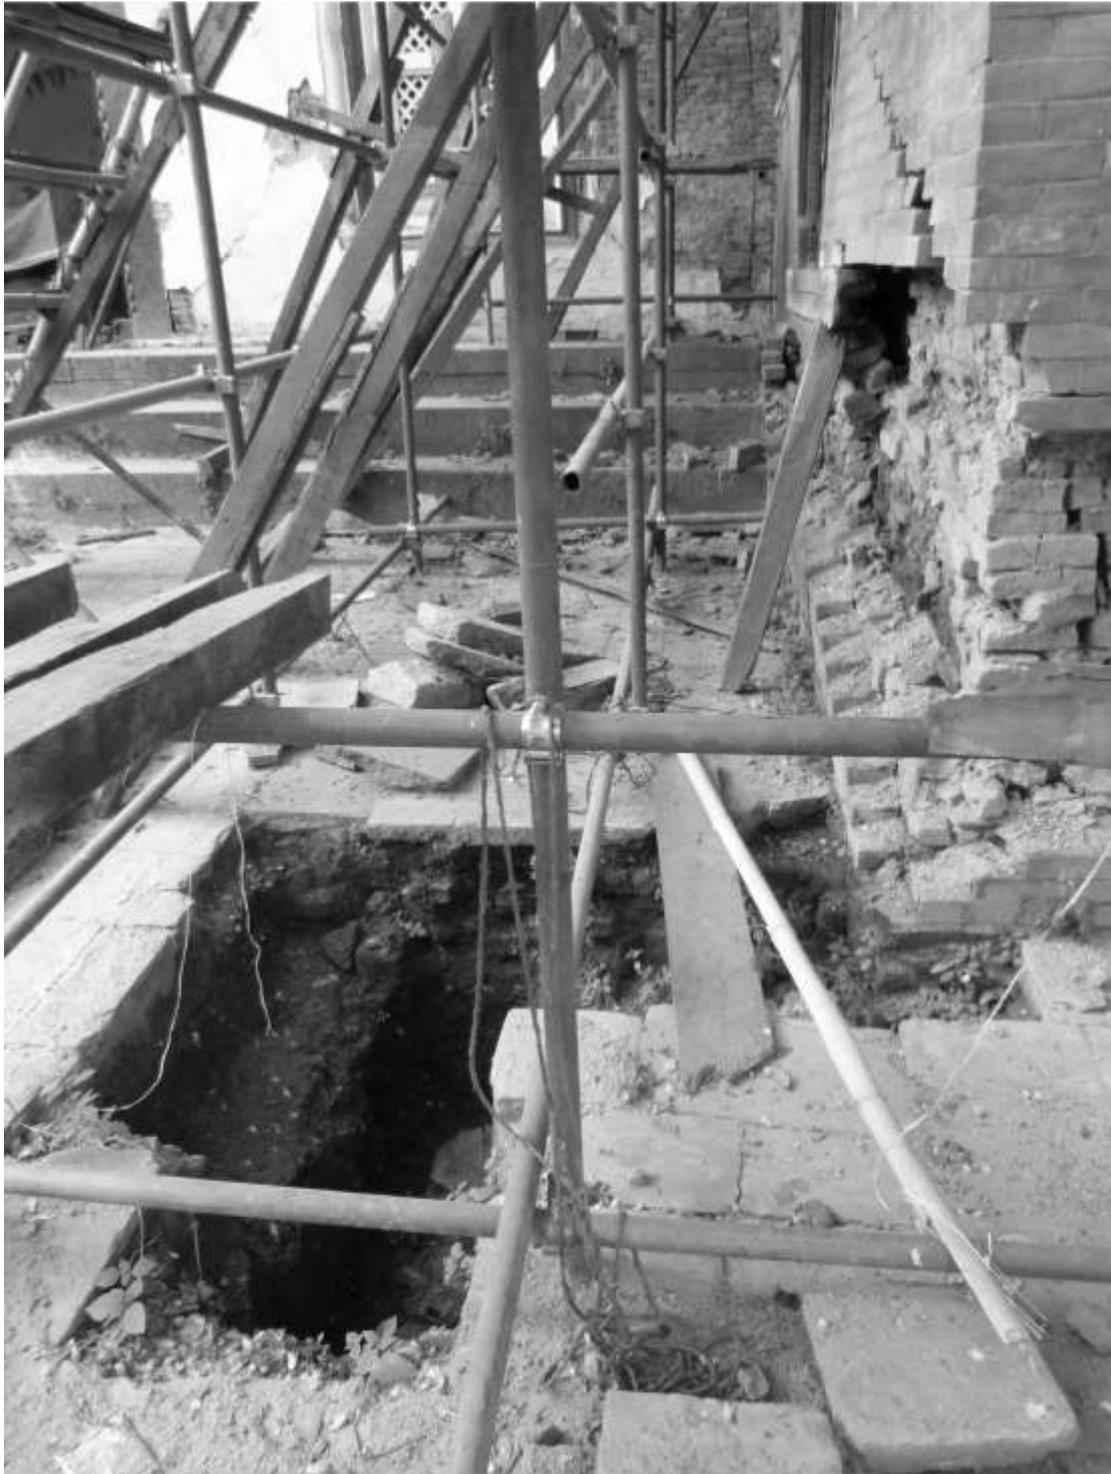
Universal Value. Indeed, we documented two examples of post-disaster interventions whilst within the Hanuman Dhoka. The first was represented by the cutting of evaluation trenches into the foundations of the Palace complex by engineers and architects without any archaeological recording (Figure 23). The second involved the cutting of foundations for new lampposts by the Municipality, again without any archaeological recording (Figure 24).

Figure 23: Unrecorded excavation trench cut alongside north facing wall of the Degutale Temple in Hanuman Dhoka's Durbar Square. Photographed in October 2015.

The damage caused by the earthquakes will require reconstruction and also the repair and laying of amenities in Hanuman Dhoka and whilst we do not recommend the suspension of the laying services and reconstruction we do advocate the mobilisation of rescue archaeology teams to undertake rescue excavations in advance of interventions (Coningham et al. 2016c). The Archaeological Risk Map for Hanuman Dhoka will provide information for site managers and stakeholders as to the risks posed to subsurface heritage and help guide future development (Figure 25). Indeed, from our observations and investigations, we feel there needs to be a heightened awareness that the cultural heritage of Hanuman Dhoka is not restricted to its standing remains and architectural treasures but that it should extend also to the foundations of these monuments and to preceding phases of cultural development, which are found below the current ground level. The Archaeological Risk Maps and our interventions should facilitate the development of this awareness and protect subsurface heritage whilst not being of detriment to reconstruction.

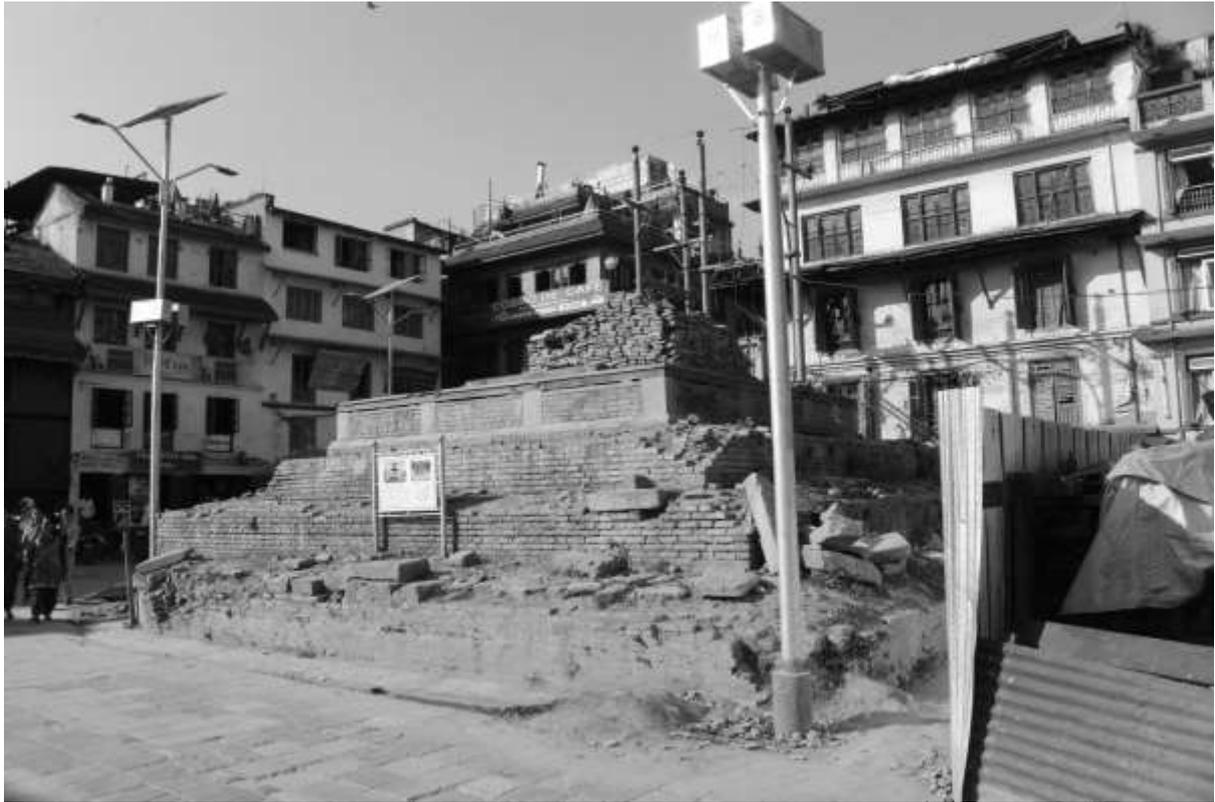
Figure 24: New lampposts installed on the corners of the Narayan Temple, Hanuman Dhoka Durbar Square.

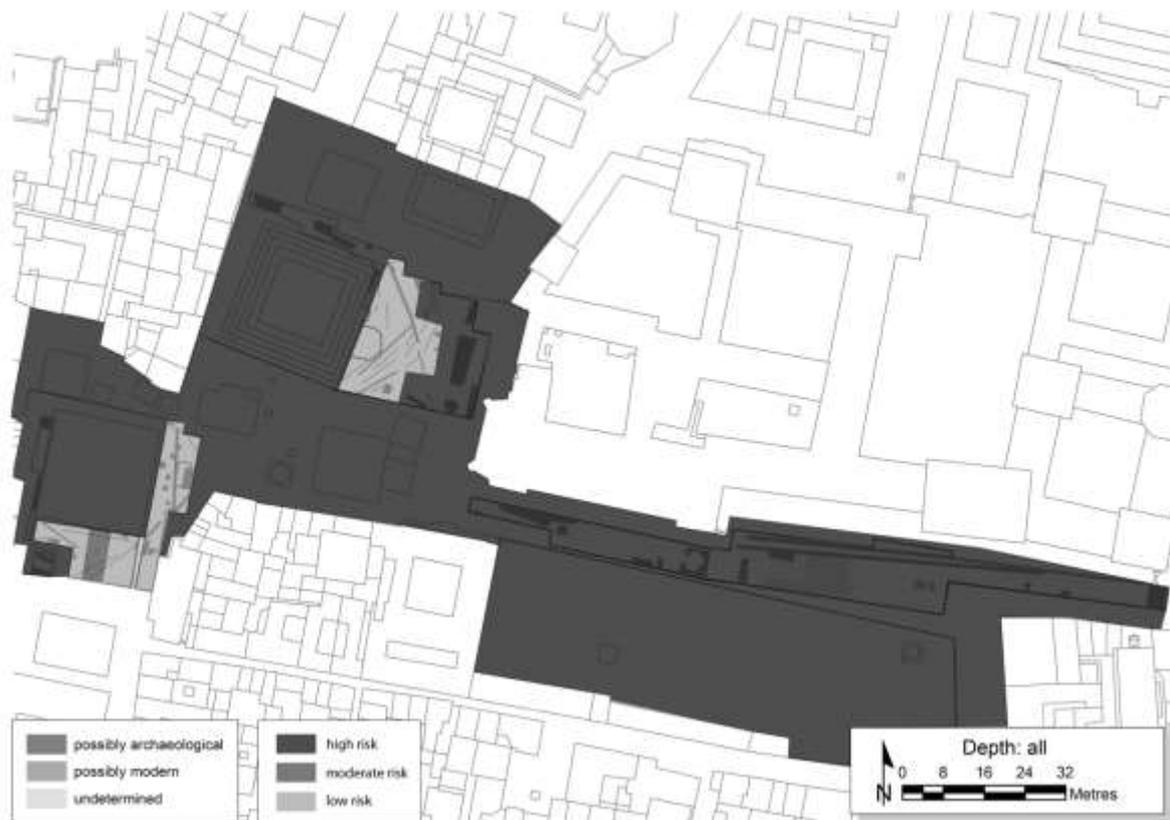
The archaeological investigations at the Kasthamandap and within Hanuman Dhoka's Durbar Square have illustrated the extent of subsurface heritage within the World Heritage site. The GPR survey has highlighted areas of potential archaeological features below the current square and excavations have revealed the character of some of these signatures. What is clear is that the Durbar Square was not always an open space but has developed over time, only in the last few centuries reaching its current configuration of standing monuments. One of the key features identified through GPR survey and excavation were pipelines and other amenities running through the Durbar Square, which we have demonstrated have cut through archaeological stratigraphy and earlier phases of human activity. Such interventions are therefore a concern as the laying of any infrastructure has the potential to damage and destroy subsurface heritage of this site of Outstanding

Figure 25: Provisional Risk map for Hanuman Dhoka's Durbar Square.
