A collaborative engineering and archaeology project to investigate decay in historic rammed earth structures: the case of the medieval preceptory in Ambel

This study assesses the structural vulnerability of part of a later medieval earthen building at Ambel (near Zaragoza, Spain), once a preceptory or monastic house belonging to the Military Orders. An inspection of its morphology and materials coupled with the results of an extensive campaign of static monitoring reveals marked structural inhomogeneities, the product of more than a thousand years of construction, failure and repair from the 10th century to the present day. Building materials are inappropriately juxtaposed, there are discontinuities between construction phases and fundamental concerns remain over the long-term stability of the structure. The current condition of the structure is mainly influenced by structural discontinuities introduced at the time of construction, the unintended consequences of repair and modification and the material decay that has affected the base of the rammed earth walls. The overall findings of the static monitoring show that there is no related damage, variations in crack widths are relate

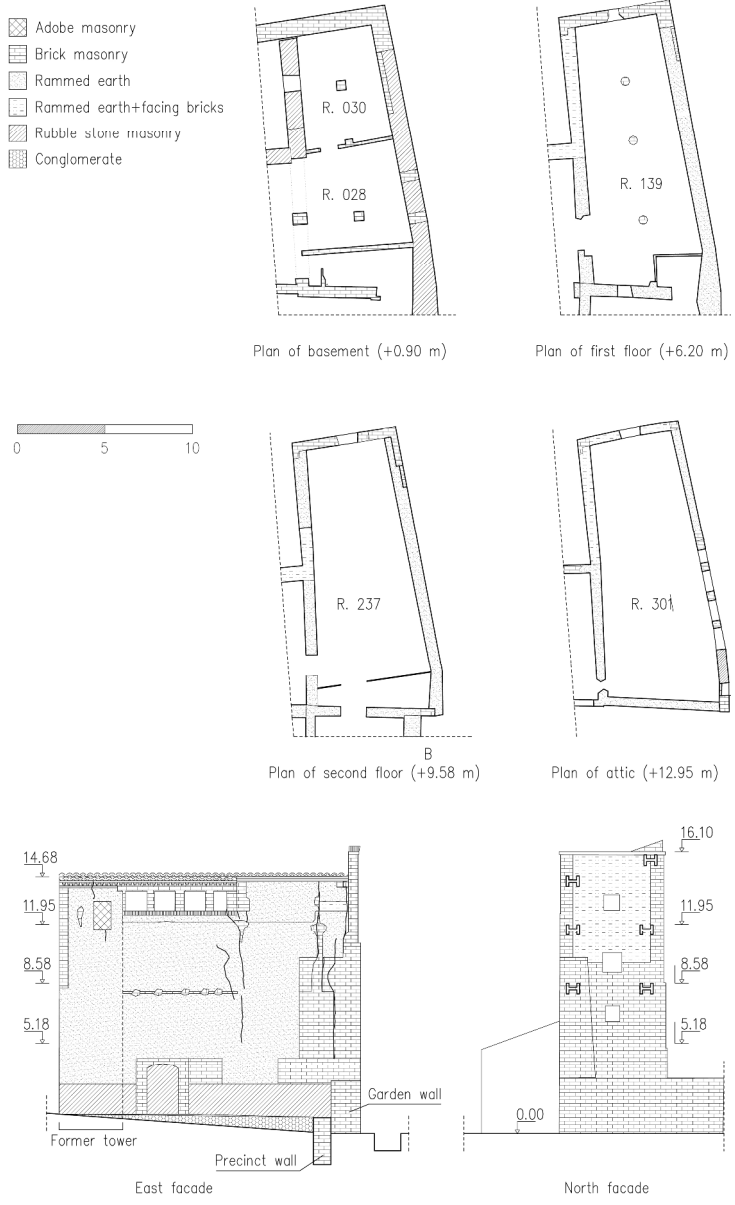
- Variations in wall thickness together with the height of the structure and presence of openings.
- The existence of discontinuities such as through-wall cracks as shown in Figure 5.

Figure 5. Results from the spatial characteristics survey, including structural discontinuities (cracks) and material discontinuities (variety of construction materials).

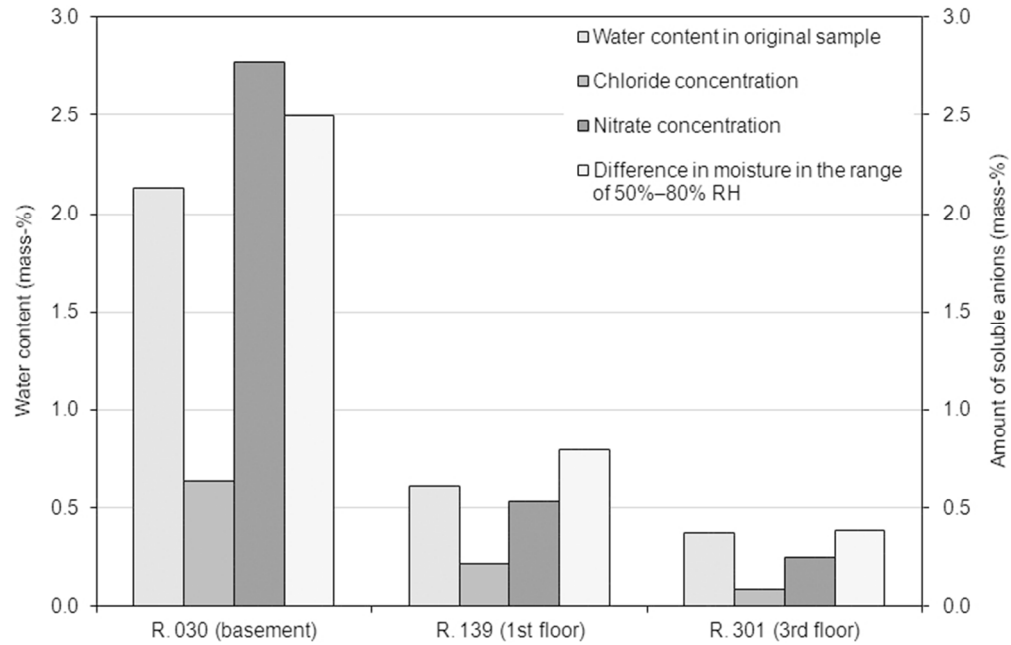
The high proportion of Ca^{2+} and SO_4^{2-} at a height above 5 m is possibly linked to gypsum in the binder
matrix or gypsum/anhydrite impurities in the earth at the time of construction. High percentage values of K^+ ,
 Na^+ and Cl^- meanwhile, **while they** can be **associated with** the presence of hygroscopic salts such as sodium
and potassium chlorides, were mostly found in the basement and generally **diminished** with height. On this
basis their presence might be due to capillary rise. For instance, some salts such as potassium sulphite might
have leaked into the basement walls as a consequence of its use for wine-making and storage; alternatively,

5
6 Chloride and nitrate levels are **both** quite elevated in all the samples taken, certainly with respect to values
7
8 permitted for fired brick masonry (WTA 1999), and particularly so at lower levels where there is a maximum
9
10 of 2.77 mass-% for nitrates and 0.63 mass-% for chlorides. Soluble salts have the same deleterious effects on
11
12 earth as on other materials due to crystallisation pressure. Furthermore, hygroscopic salts increase the
13
14 moisture content of the material as humidity rises. In this case the correspondence of humidity values and
15
16 nitrate and chloride contents (Figure 10) confirms that the salts have been transported from beneath the
17
18 ground through capillary rise.
19

Figure 10. Moisture content and soluble salts values in historic rammed earth at different wall heights in the east wall of the north-east granary tower.

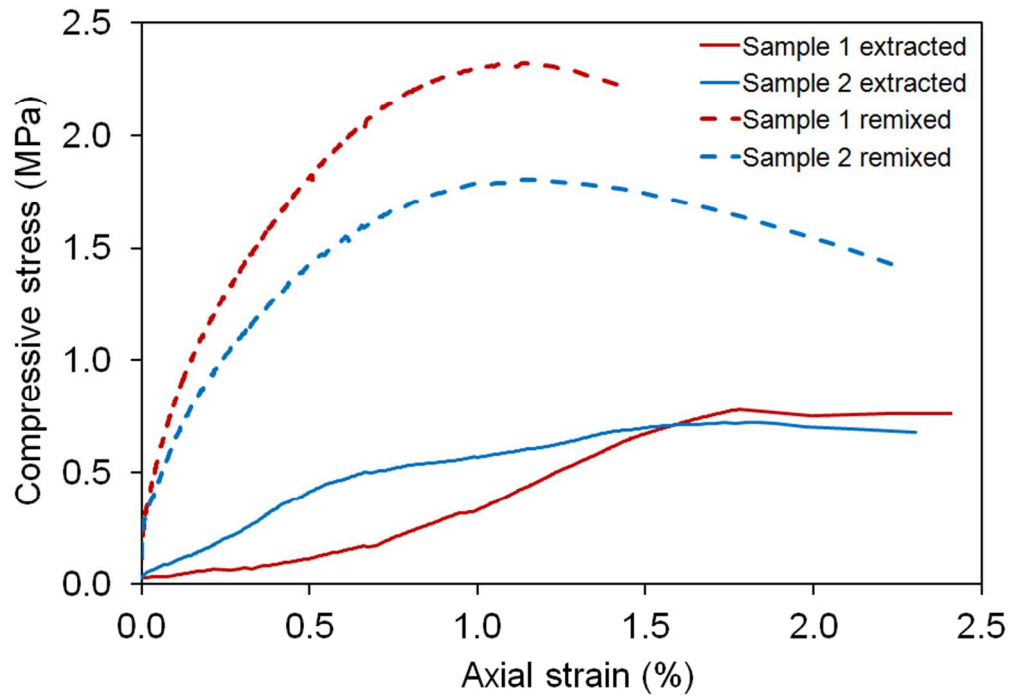
A comparison of mechanical properties (Figure 12) revealed that the remixed samples have more than 2.5 times higher compressive strength than the original samples extracted, and therefore within the range of minimum compressive strength required for load-bearing rammed earth (Volhard and Röhlen 2009). Young's modulus was also much higher for the remixed samples than for the original samples, even though the bulk density (DIN EN 1936 2007) of the original samples was similar. As no tests were carried out on the micro-structure of the materials, it is assumed that micro-cracks had occurred in the structure of the earthen material and that this explains the differences between original and remixed samples. Changes of temperature and humidity during the lifetime of the building or vibration during the various phases of extraction, transportation and sample preparation might all be responsible. Water content might also have played a key role. Summarising the mechanical properties of the rammed earth, the compressive strength of the rammed earth in the north-east tower might be slightly higher than the tested material from R. 307

Figure 12. Comparison of stress-strain curves between extracted sample and remixed samples.

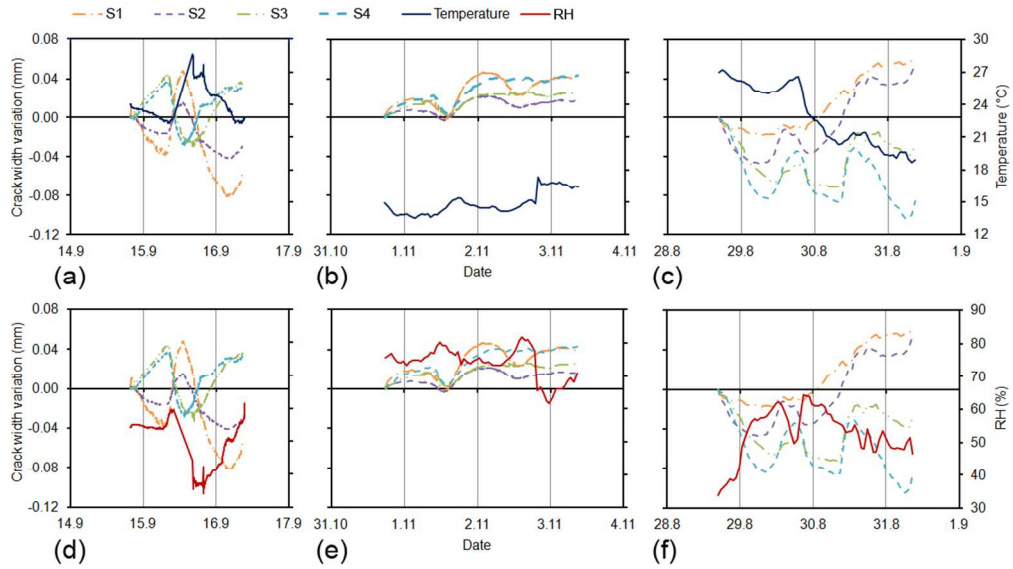
10 Figure 15 shows variations in crack width over the course of three/four days in three different monitoring
11 campaigns (Table 4), together with corresponding temperature changes and RH. For the first set of data
12 (Figure 15a,d) there is no simple linear relationship between temperature and moisture changes, although
13 there is an inverse proportionality between the two. Due to the high thermal inertia of rammed earth (Dong et
14 al. 2014), there is a gap between the temperature variation and the crack width variation shown on the
15 graphs. The LVDT measurements are coupled: S1–S2 belong to crack A and S3–S4 belong to crack B
16 (Figure 14a). Consequently, their observed behaviour is similar, the upper sensors S3–S4 exhibit stronger
17 levels of movement, possibly because the lower cracks are closer to the floor surface and therefore more
18 constrained.
19

20 During August (Figure 15c,f) and September (Figure 15a,d) the greater opening of the cracks is largely
21 related to diurnal temperature variation in the day-night cycle. At the end of August a temperature variation
22 of 8.5 °C associated to a RH variation of 30.5% leads to a maximum variation in the crack width of 0.10 mm.
23 As expected, during the measurements in November (Figure 15b,e) where the temperature variation in the
24 day-night cycle is lower than in summer, the variation of the crack width is limited. A temperature variation
25 of 3.8 °C associated to a RH variation of 20.0% leads to a maximum variation in crack width of 0.05 mm.
26

30 On the upper set of graphs (Figure 15a–c), sensors S3–S4 behaviour are inversely related to internal
31 temperature: as drying occurs and internal temperature decreases, so the crack width increases. This
32 behaviour is expected; since each section of rammed earth should undergo linear shrinkage and decrease in
33 length as temperature increases, so crack width must be expected to increase too. However, sensors S1–S2,
34 which belong to the crack located between the fired brick and the rammed earth, exhibit a very different
35 behaviour in which the width of the crack is directly proportional to the increase in temperature, that is to
36 say, the crack width decreases slightly with a decrease in temperature. This is unexpected, but is best
37
38
39
40
41
42
43
44
45
46
47
48
49
50
51
52
53
54
55
56
57
58
59
60

Figure 15. Short-term monitoring with LDVTs: crack width variation, inside temperature and RH in different seasons; summer 2011 (a,d), winter 2011 (b,e), summer 2012 (c,f).

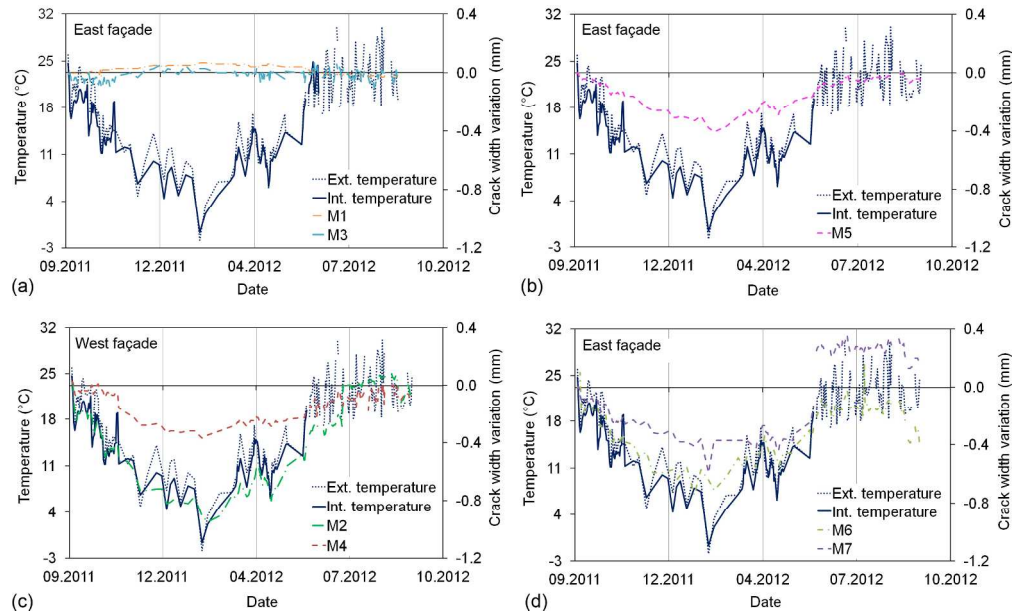
35 In detail, sensors M2 and M4–M7 exhibit increasing displacement over time, by showing the progressive
36 decrease in displacement with rising temperatures. The decrease in displacement after the turnaround is of
37 the same order of magnitude as the previous increase (i.e. about -0.30 mm), indicating a progressive crack
38 closure with an almost complete recovery. Sensors M2 and M7 record the highest differences in
39 displacement, showing positive peaks of 0.26 mm (M2) and 0.65 mm (M7) during the warmest months
40 (Figure 16c,d). In the case of sensor M2 (Figure 16c), the variation in peaks of crack width of 1 mm is
41 related to a temperature variation of 24 °C. The cracks then close as the temperature falls and the width
42 variation corresponds to the linear thermal expansion expected for a steel beam of length equal to 3 m. This
43 behaviour would not be expected if it were not for the steel beams. On the other hand, sensors M1 and M3

44 controlling the most worrying crack at the corner with the north façade (Figure 16a) behave exactly as might
45 be expected for earthen materials, by decreasing in width due to the expansion of sections as the temperature
46 rises, and vice-versa. This might be due to a lower weight placed on the steel elements (here, only the weight
47
48
49
50
51
52
53
54
55
56
57
58
59
60

1
2
3 of roof, which is minor) which therefore do not influence movement in rammed earth. Another possibility is
4 that the wall is damaged enough to consist of single sections. These sensors show limited displacements in
5 the range of 0.08–0.12 mm over the whole monitoring period (Table 5).
6
7
8
9

Figure 16. Medium-term monitoring with digital crack meters: crack width variation and temperature on east and west façades. A positive sign denotes a crack or interface closing. Sensors M1 and M3 (a), M5 (b), M2 and M4 (c), M6–M7 (d).

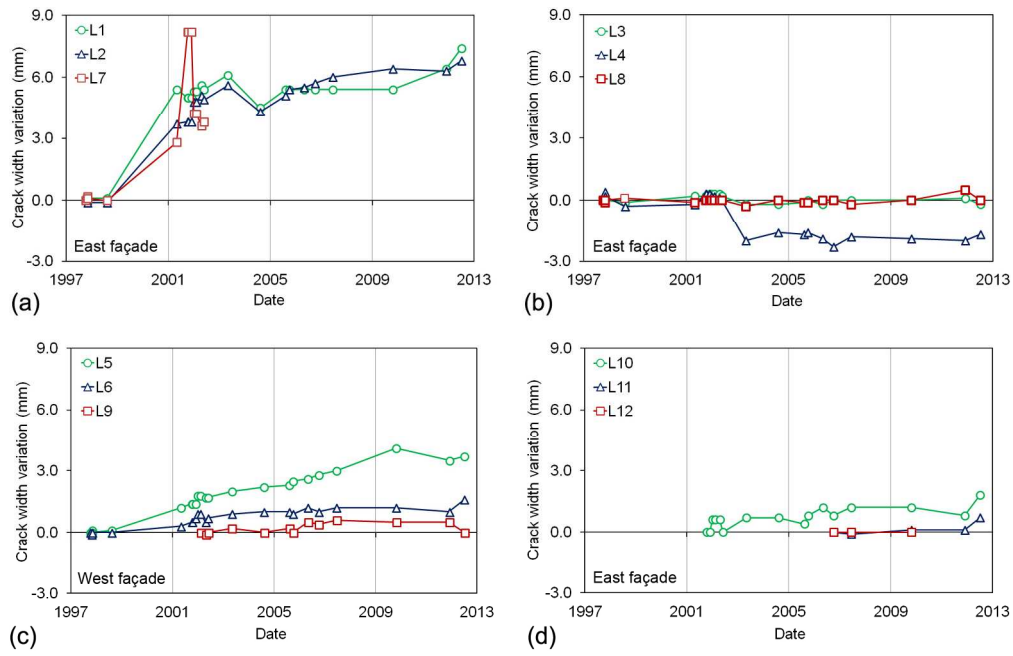
11 Long-term monitoring demonstrates that the upper façade-east wall crack has opened (Figure 17a),
12 indicating rotation outwards, with the upper crack opening at a higher rate (and up to 5 mm over the space of
13 3 years) than the lower one until the steel elements were inserted after 2000. Up to this point in time, the
14 northern-most crack on the second floor, measured with sensor L7, had also increased in width by a similar
15 magnitude (5–7 mm) but, after the anchors were introduced, its width actually decreased by 4 mm. In the
16 attic, the same crack measured with sensors L1 and L2, showed an increase in width with similar magnitude
17 until 2000, then, after the anchors were introduced, although the cracks continued to widen, its
18 increase ratio decreased significantly in comparison with the data measured before the intervention.
19
20
21
22
23
24
25
26
27
28

29 The adjacent crack on the east wall measured through the attic and the second floor with sensors L3, L4 and
30 L8 (Figure 17b) is stable, no relevant increase in crack size were detected from the beginning of the
31 monitoring. The behaviour of sensor L4, showing an unusual increase in crack size between 2002 and 2003,
32 is due to an unexpected movement of one of the reference points and not related to any crack displacement.
33 For this reason, the crack magnitude measured by sensors L4 must be considered the same as that shown by
34 sensors L3 and L8. Sensor L5 (Figure 17c), controlling one of the largest cracks at the corner with the north
35 façade presents a constant increase in width comparable with the values shown after 2001 by sensors L1 and
36 L2. A similar trend, although with more limited magnitude, is shown by sensor L6 controlling a crack at a
37 greater distance from corner with the north façade.

48 For the lower part of the building, no similar increase in crack size (Figure 17a,c) can be observed from the
49 data available. Indeed, the crack measured by sensors L10–L12 (Figure 17d), although in proximity to the
50 corner with the north façade, shows an increase in width constant but not comparable with the value reported
51 by the upper cracks. This result strongly suggests that the rotation of the upper façade, possibly on top of the
52 garden wall, might be another structural pathology in addition to non-uniform settlement of the tower.
53
54
55
56
57
58
59
60

Figure 17. Long-term crack monitoring 1997–2012. Sensors L1–L2 and L7 (a); L3–L4 and L8 (b); L5–L6 and L9 (c); L10–L12 (d).
