**Preliminary Results of Post-Disaster Archaeological Investigations at the Char Narayan Temple and within Patan's Durbar Square, Kathmandu Valley UNESCO World Heritage Property (Nepal)**

### **3. Archaeological Excavations at the Char Narayan Temple and Patan's Durbar Square**

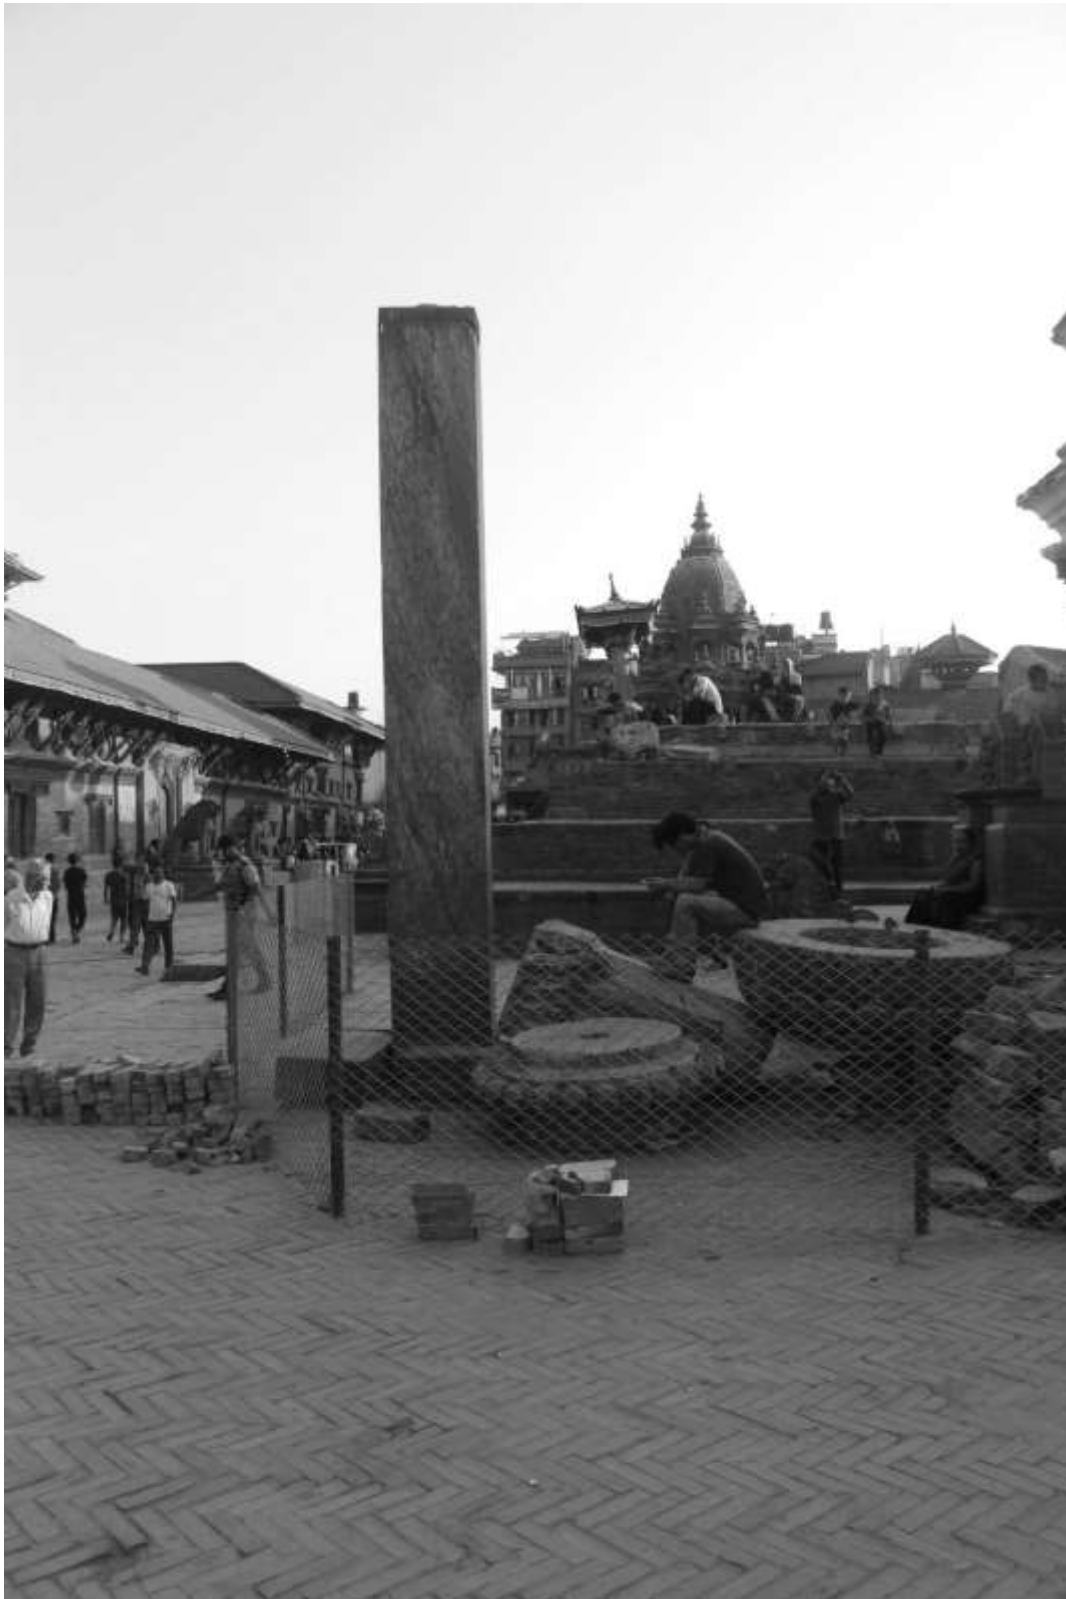
Several monuments within the square were damaged during the earthquake of the 25th April 2015 (Figure 1). These include the palace structure, which houses Patan Museum, where the octagonal Temple of Telgua in the north-east corner of the Mul Chok was damaged. Damage was sustained to several other monuments in the square, which are now strengthened through supporting wooden props, such as the Krishna Temple. Monuments that collapsed included the Mani Mandapa at the top of the steps of the Mani Dhara, or jewel fountain, which tradition states was consecrated in 1694 CE and renovated in 1701 CE (Gellner 1994: 144) (Figure 2). The three-storeyed Harishankar Temple, which is stated to have been constructed in 1706 CE by Rudramati, Yog Narendra Malla's (r. 1685-1705 CE) sister (ibid.: 148), also collapsed during the earthquake. Finally, the other major monument to have collapsed was the Char Narayan Temple (Figure 3). Of these monuments, the Char Narayan Temple was identified for investigation on two accounts. Firstly, it was generally considered to be one of the oldest standing monuments in Patan's Durbar Square and, secondly, its location afforded the opportunity to excavate a slot trench east-west across the current brick paved square.

Figure 1: Damage in Patan's Durbar Square, including the damaged pillar of the statue of King Siddhi Narasingh Malla, and the collapsed Harishankar Temple, looking south.

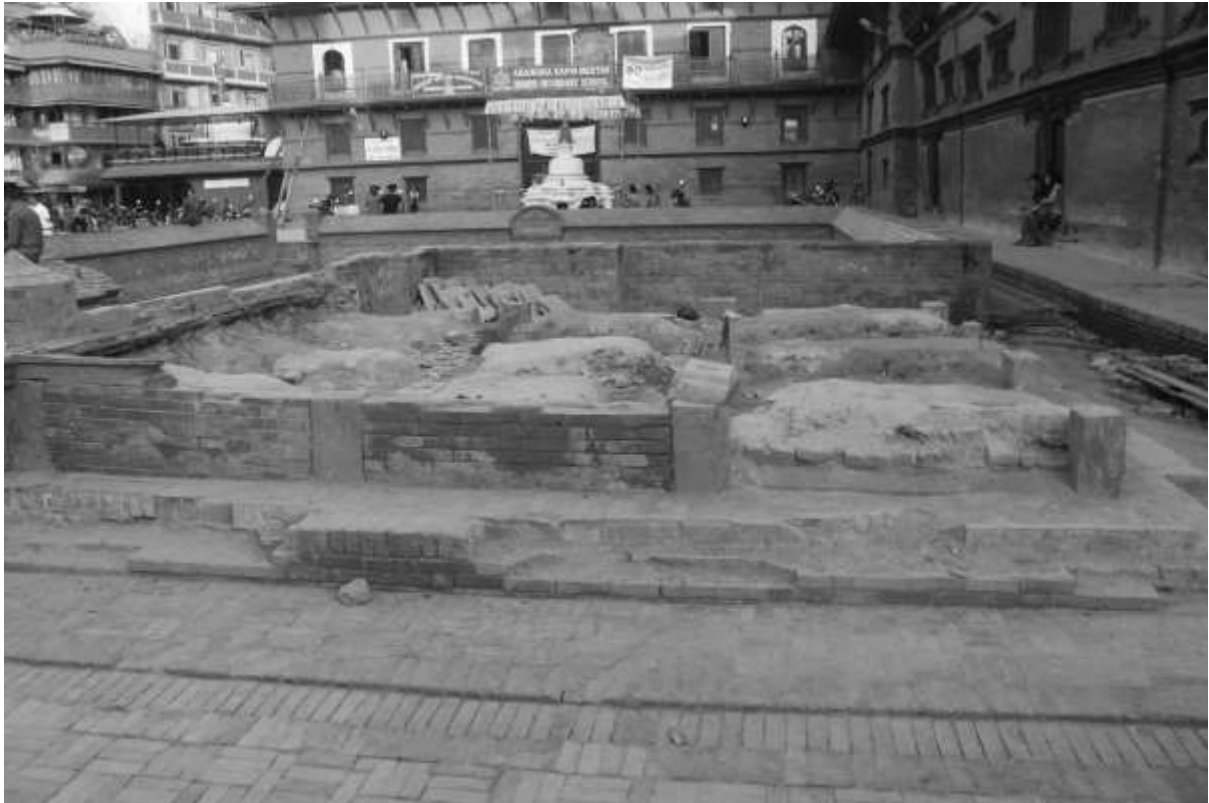
Figure 2: The collapsed Mani Mandapa, looking east.

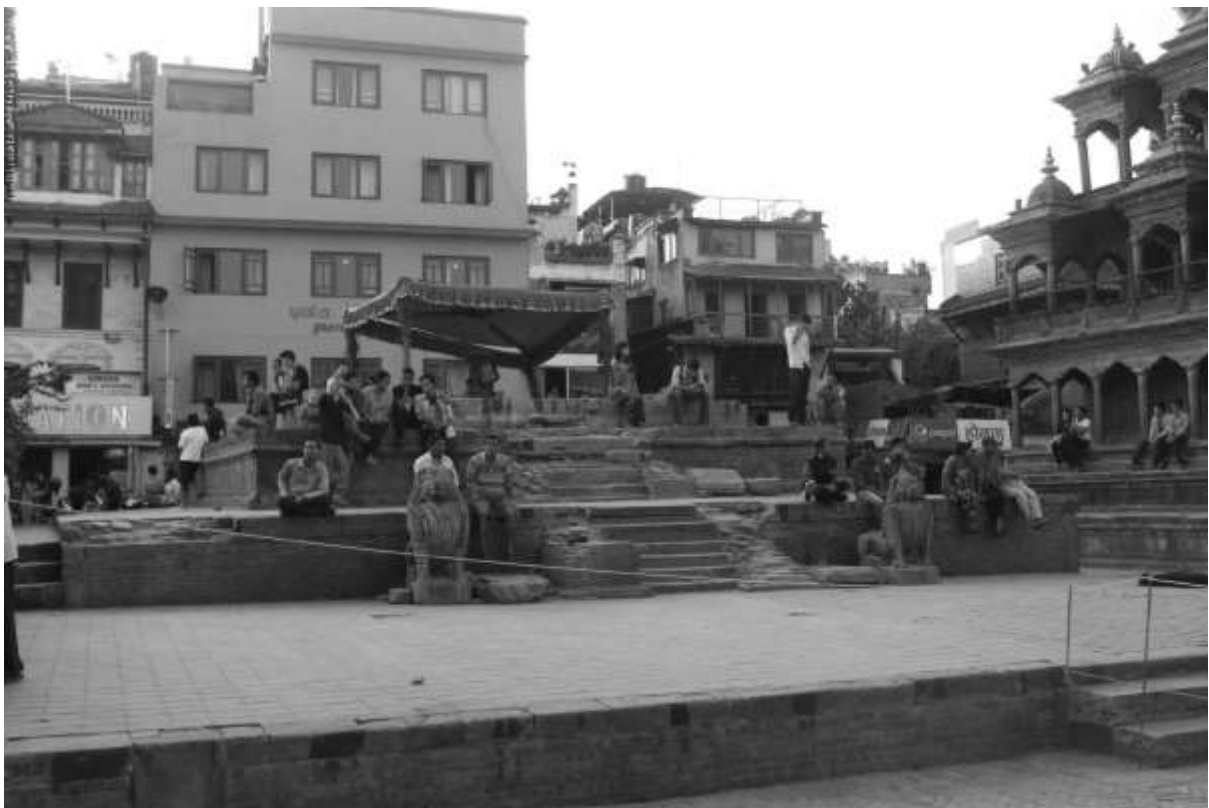
Figure 3: The collapsed Char Narayan Temple.

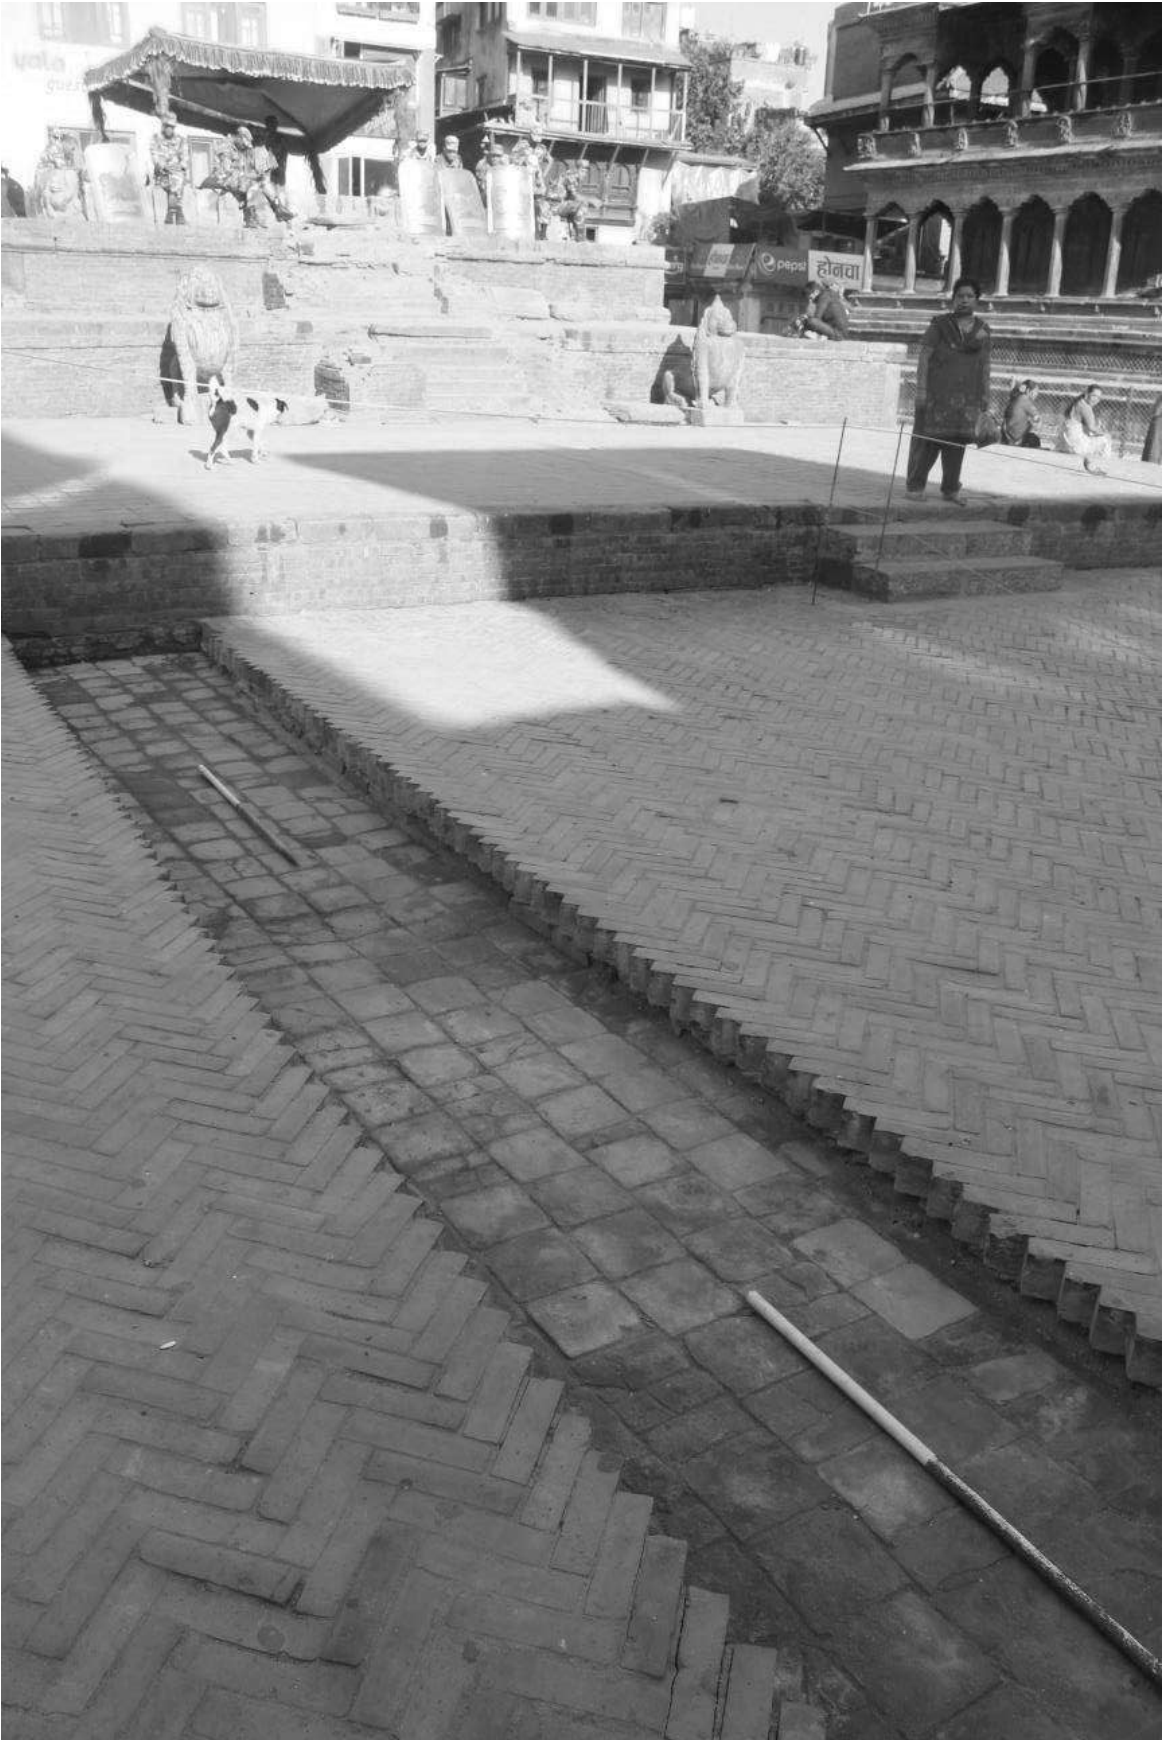
Representing an earlier surface over the Durbar Square, this pavement was formed by a single regular course of square tiles that individually measured 0.18 by 0.18 by 0.045 metres (Figure 4). This paving appears to be on a slightly different alignment from that of the

Figure 4: Tiled paving surface below the current paved Durbar Square, in Trench 1A.

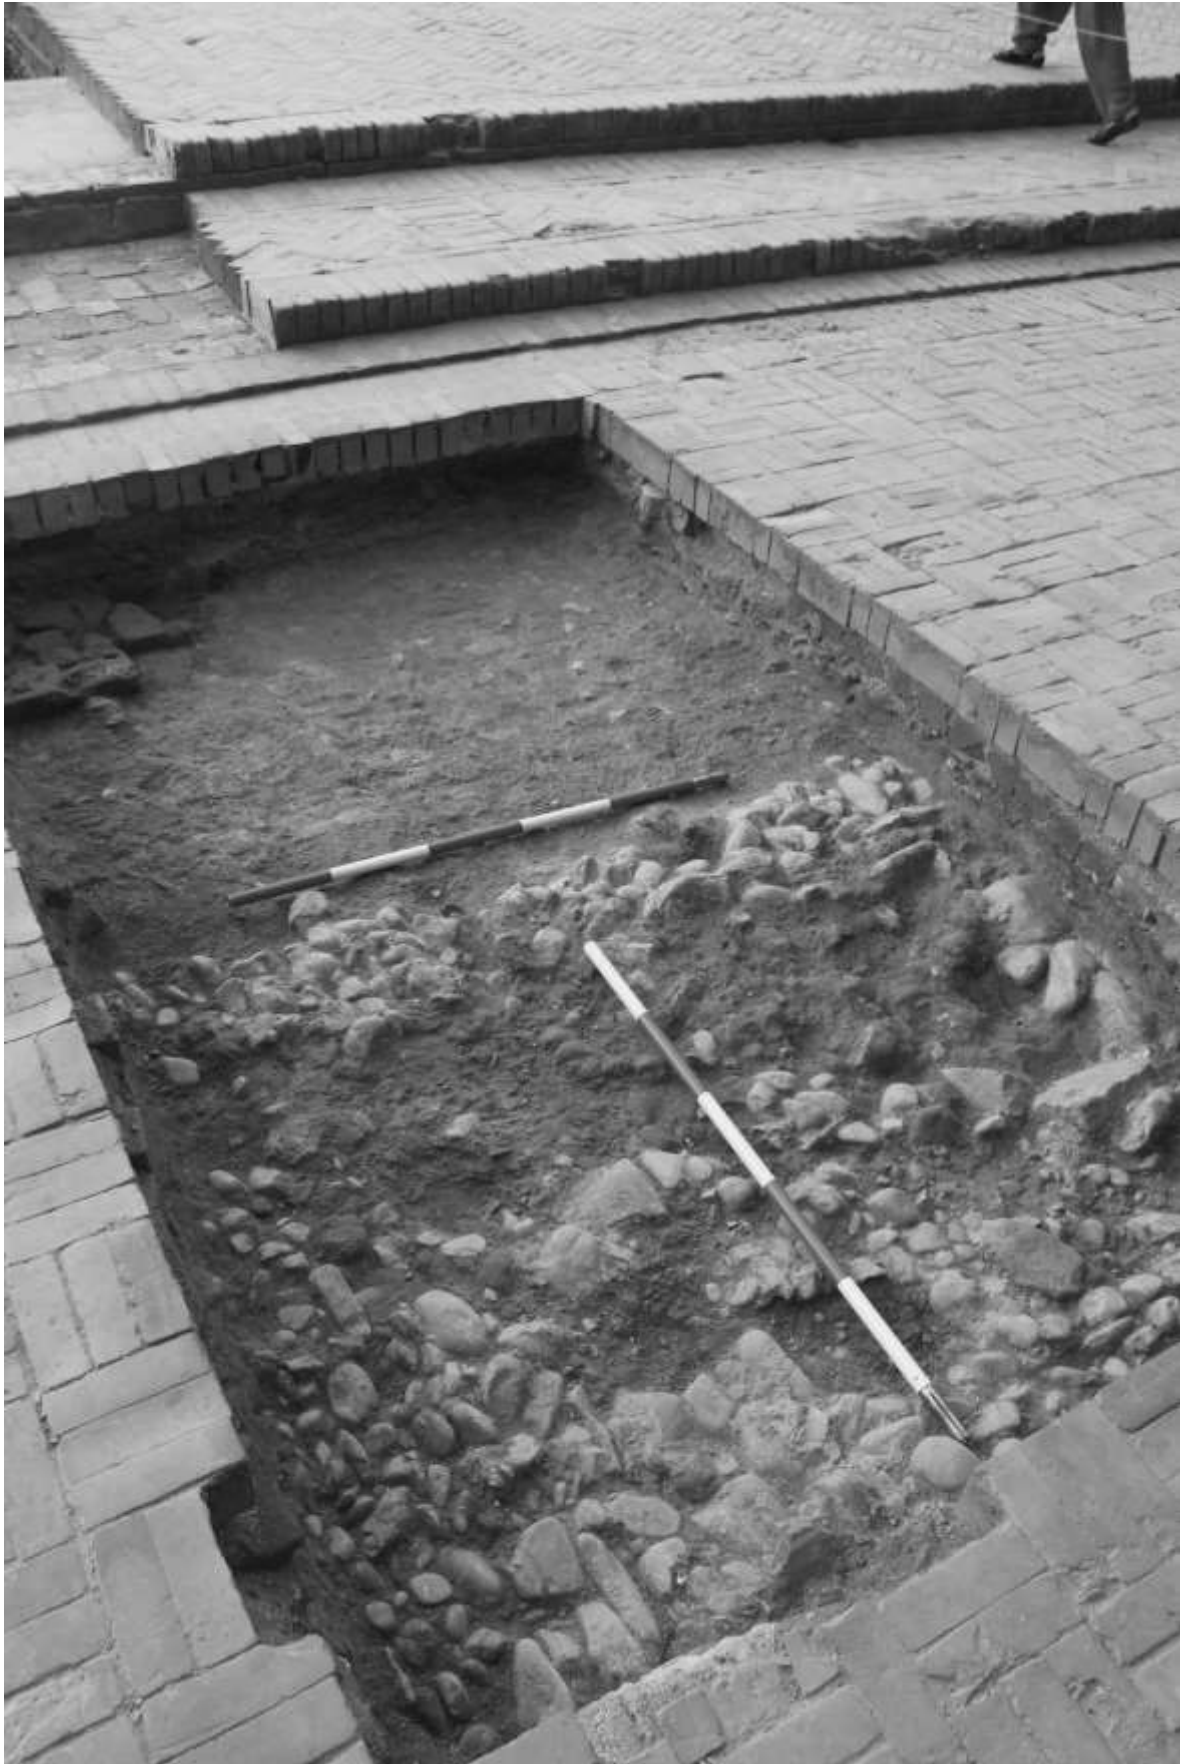
Below this material was a surface of stone cobbles to the east of the trench (Figure 6). These cobbles may represent an earlier episode of surfacing of the square or may have been related to an earlier structure. Also at this level were the remains of a brick wall stump,

Figure 6: Stone cobbled surface below current paving of the Durbar Square, looking North West in Trench 1B

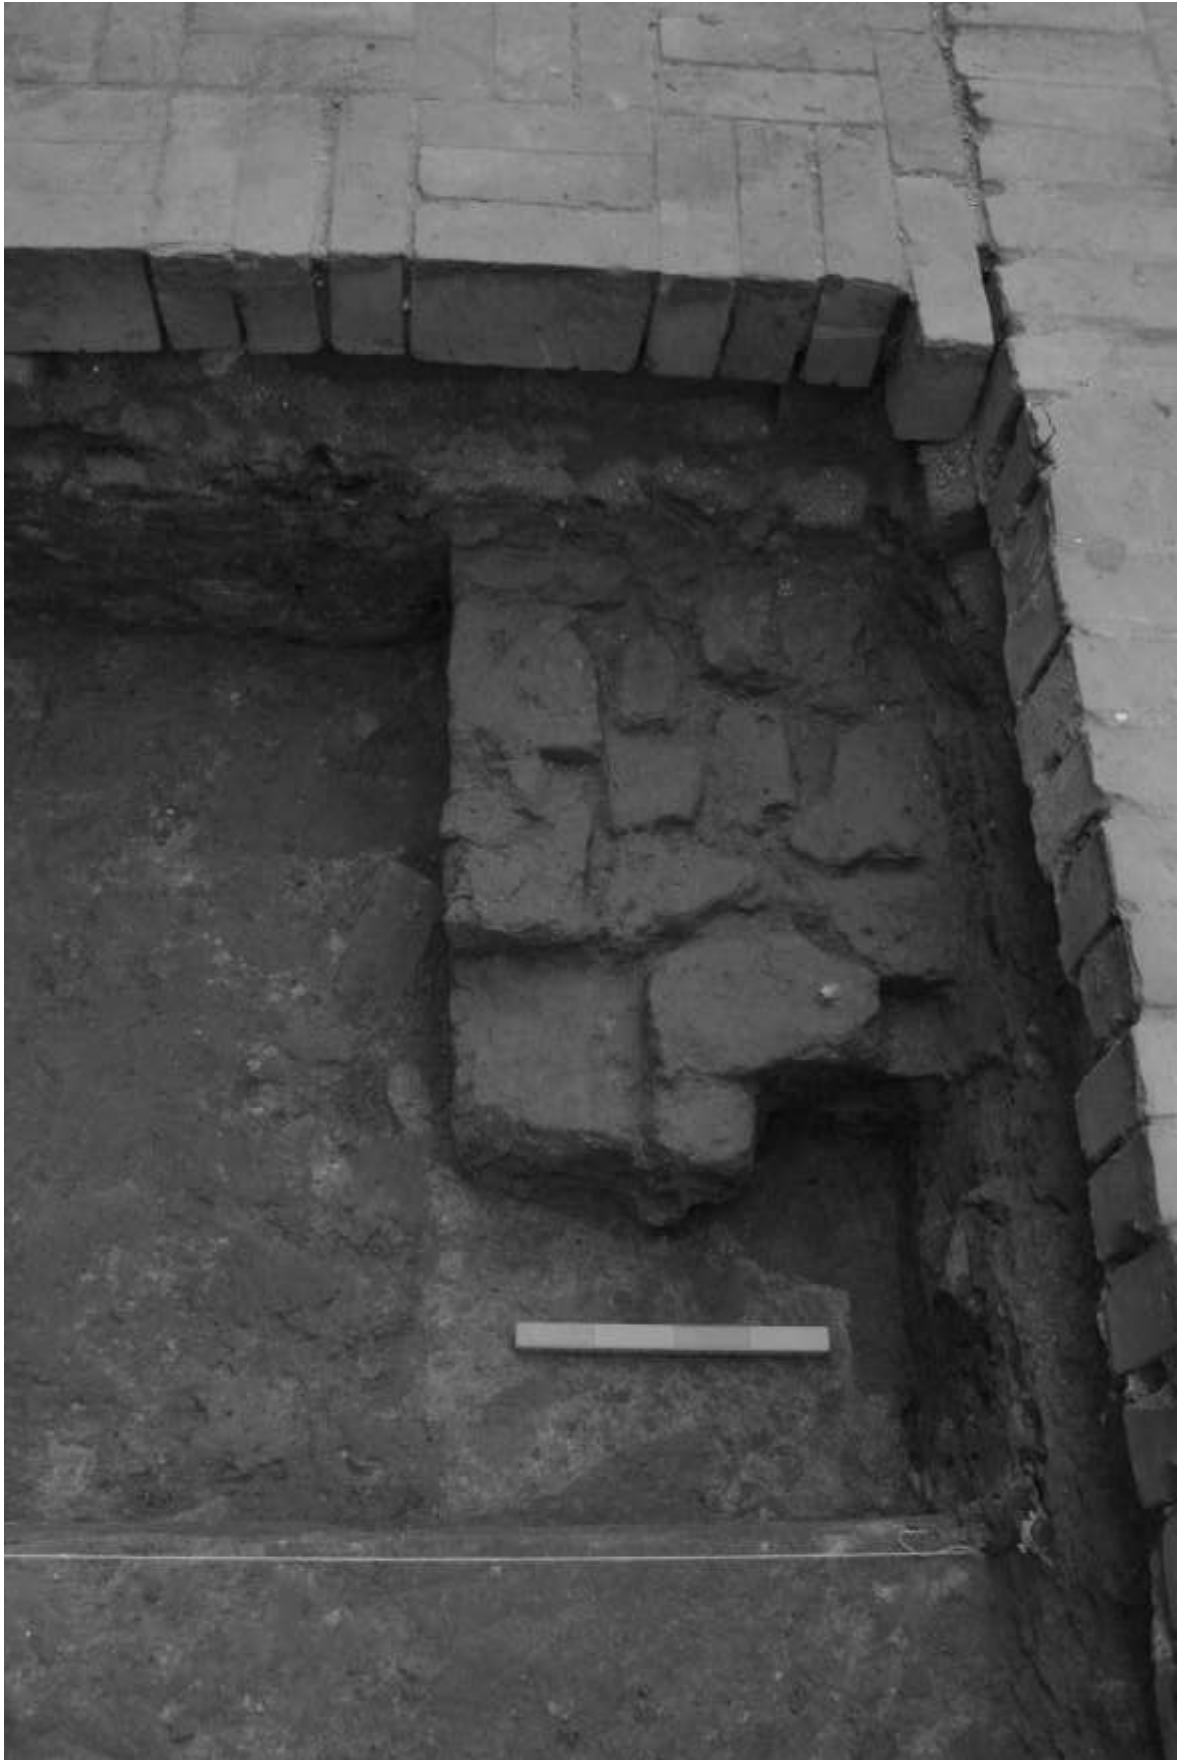
which survived to two courses (Figure 7). These features were cut by modern pipelines, running north-south in line with the current thoroughfare through the Durbar Square. As these features did not cut-through the two levels of brick paving and were sealed by these surfaces, it would appear that these interventions had occurred before the current paving of the Durbar square was laid. The stone cobbled surface and brick wall stump clearly illustrate the presence of archaeological features and surfaces below the current level of brick paving in the Durbar Square. The pipelines that cut through these features also highlight the need for future archaeological assessments and archaeological watching briefs before any intrusive digging across Patan's Durbar Square.

Figure 7: Brick wall, looking south west, Trench 1B.

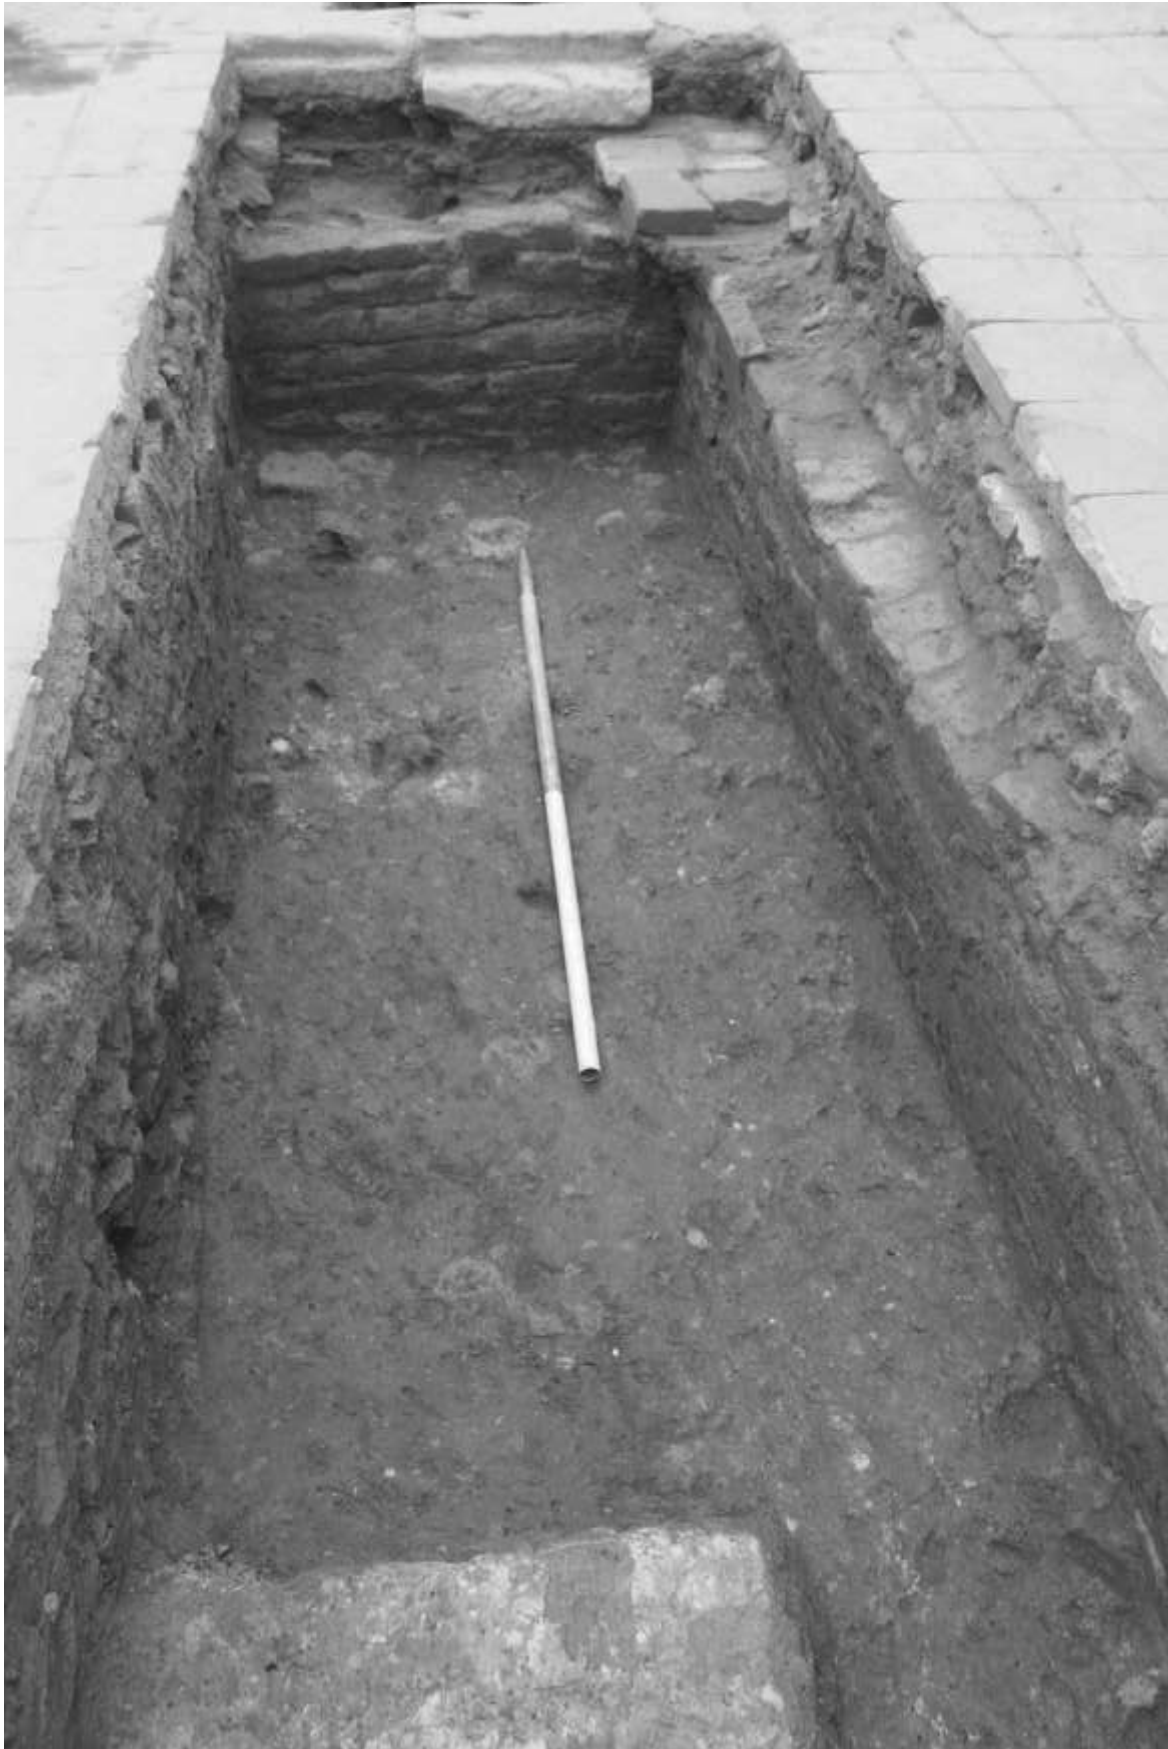
Figure 8: Wall alignment below current paving in Trench 1C, looking east.

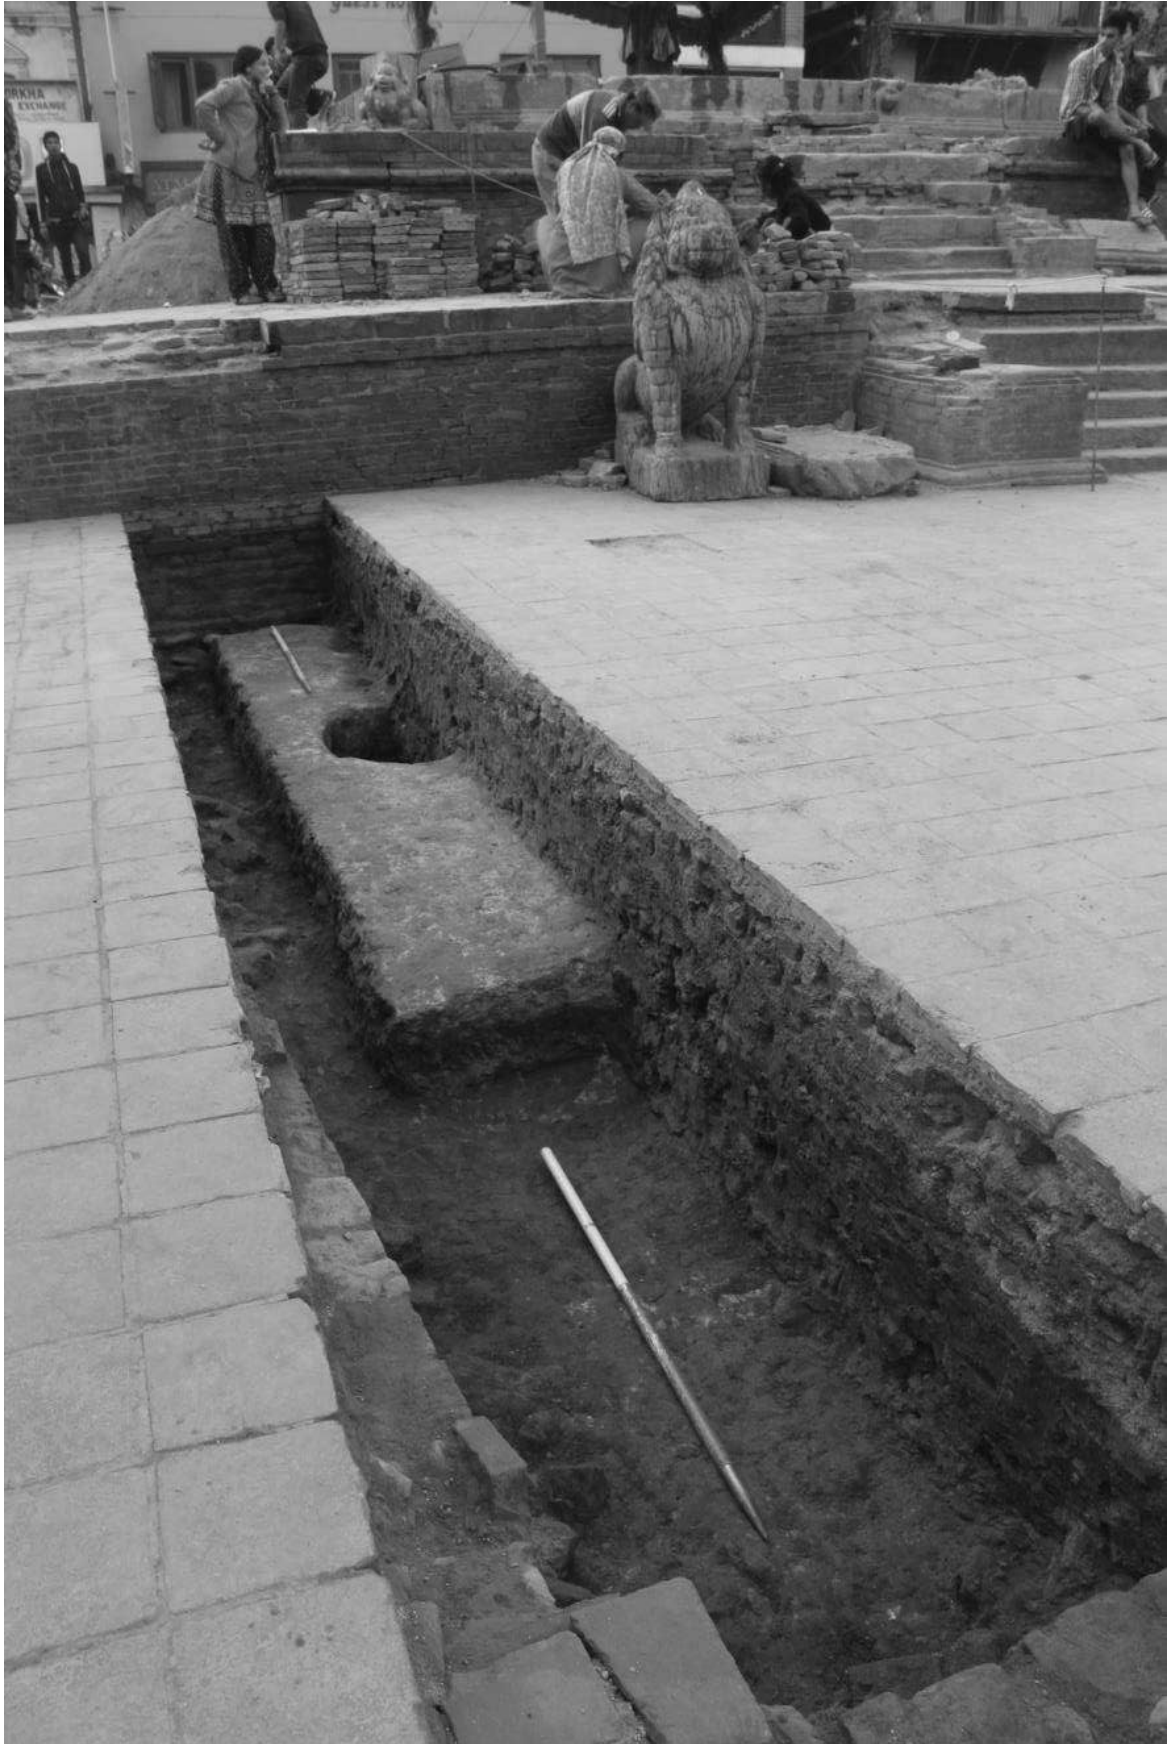
of the current Char Narayan Temple (Figure 9). This clay platform suggests that the site of the Char Narayan Temple had hosted non-durable monumental architecture prior to the construction of the current brick, stone and timber Temple, or that earlier configurations of the Temple incorporated such architecture before the square was paved with tiled or brick surfaces. Several phases of clay platforms were removed on this same alignment and these were cut by a large semi-circular feature that ran underneath the south-facing section. This cut, with its fairly firm silty clay fill, which included brickbats and ceramics, was evidence of a large posthole cut. Most likely for a large timber architectural element, this feature and associated clay platforms may relate to an earlier Temple footprint, constructed from non-durable materials. There is also a possibility that it might relate to a non-durable architectural element associated with the current Temple, perhaps relating to a pavilion or more temporary shelter located to the east.

Figure 9: Earlier clay platform with large posthole, in Trench 1C, looking west.

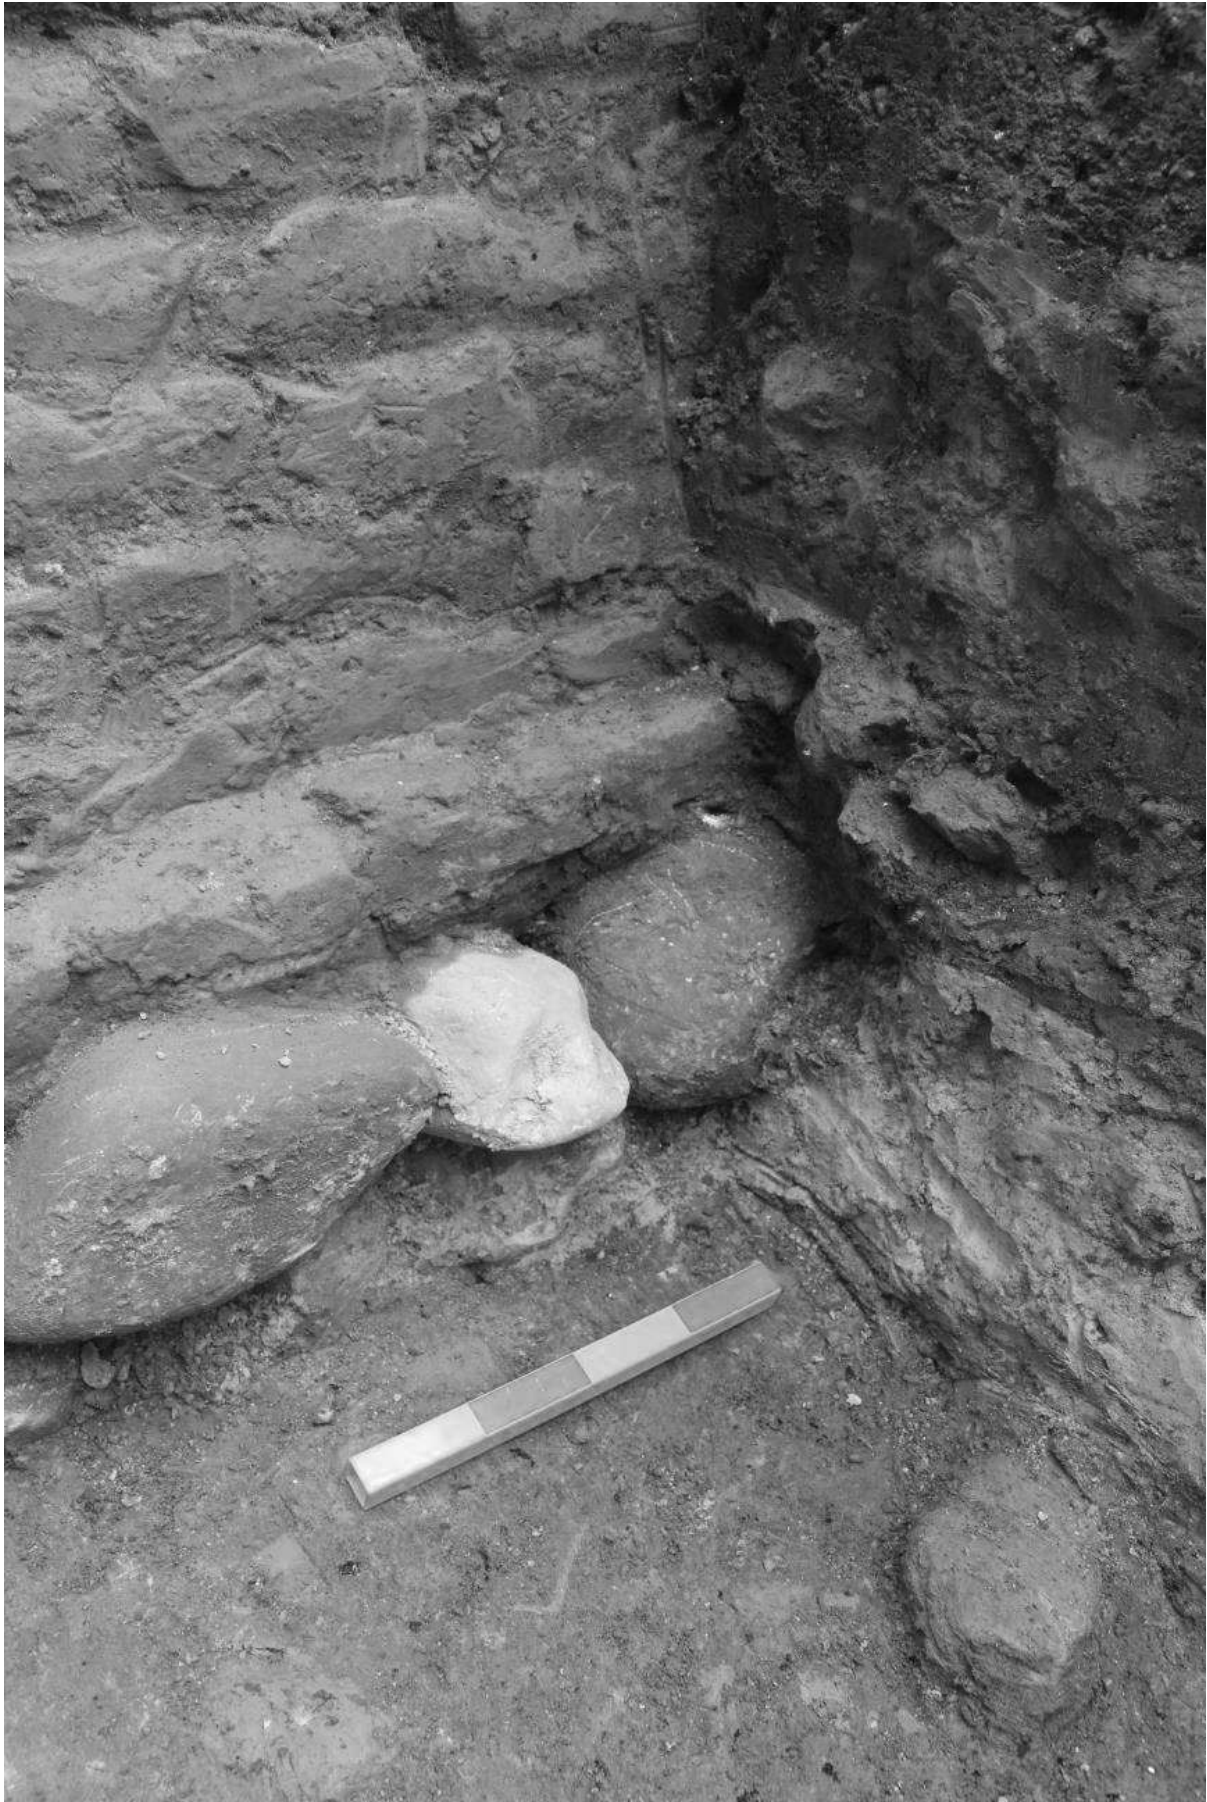
However, before we are able to process scientific dating samples, we believe that it is more likely to represent an earlier phasing of construction as the brick wall of the Char Narayan Temple in the west-facing section cuts through these platforms, suggesting that the current Temple is later in date (Figure 10). The foundation wall of the current Temple included a course of tiles, forming a conservation line below the currently visible conserved and repointed bricks. Below this course of tiles were seven courses of original brick, which then sat on top of three visible irregular courses of stone cobbles (Figure 11). The slot that this wall sat within appeared to be cut through the earlier clay platforms, suggesting the placement of stone cobbles and the brick courses were a later intervention at the site.

Figure 10: Stone cobble foundations, cutting through clay platform, in Trench 1C.

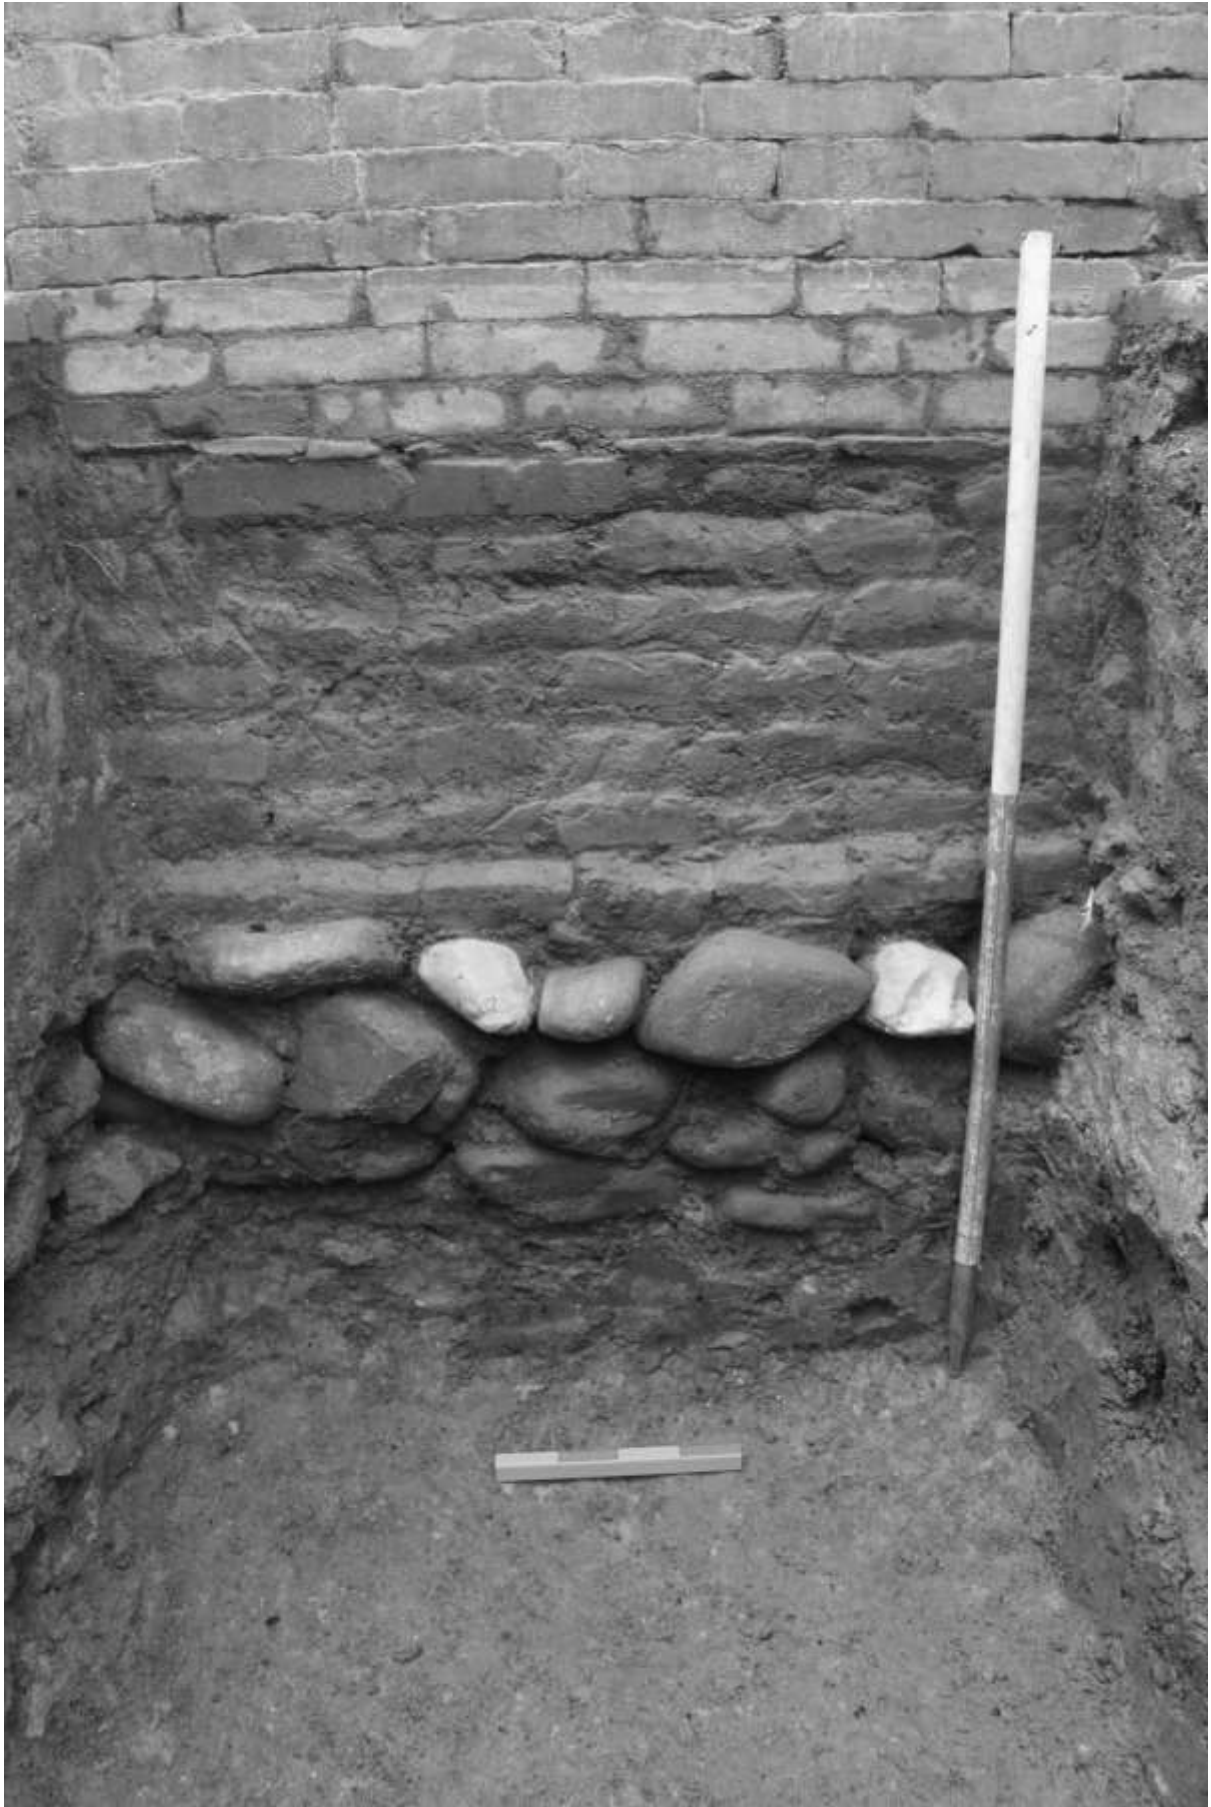
Figure 11: Stone cobble and brick foundations of Char Narayan Temple in Trench 1C.

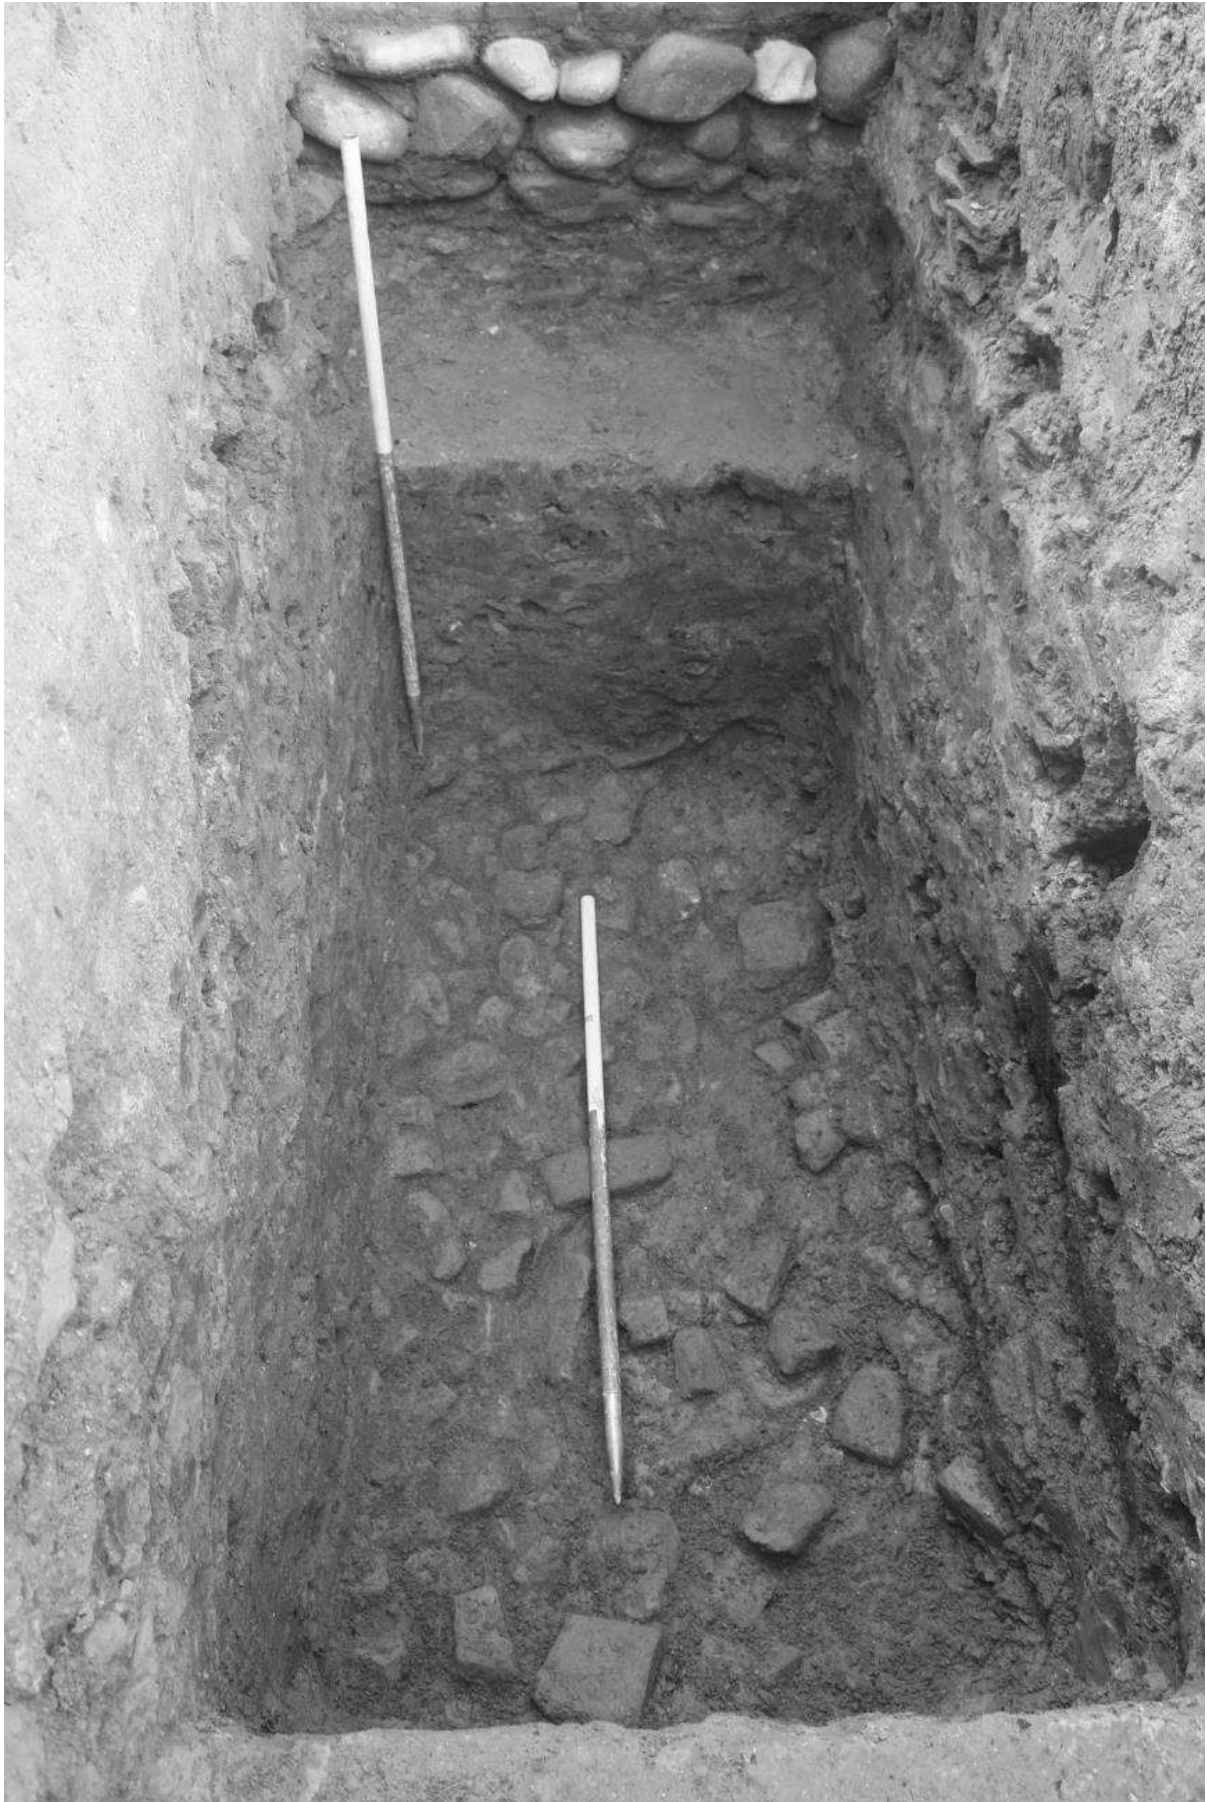
Figure 12: Brickbat surface in Trench 1C, looking west.
