**Preliminary Results of Post-Disaster Archaeological Investigations at the Char Narayan Temple and within Patan's Durbar Square, Kathmandu Valley UNESCO World Heritage Property (Nepal)**

### **3. Archaeological Excavations at the Char Narayan Temple and Patan's Durbar Square**

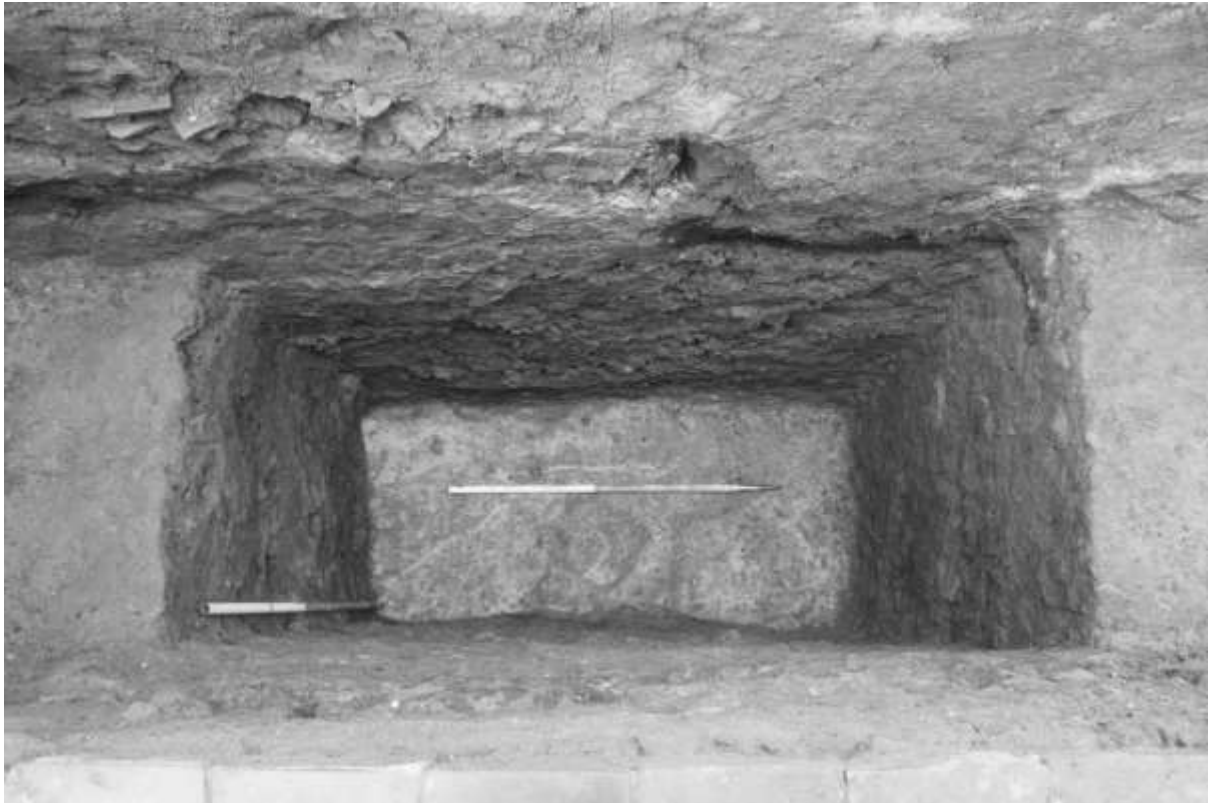
The clay platforms sat on a surface that comprised small brickbat pieces. Once this was exposed in the entirety of the trench, a small sondage, measuring two metres east-west by one metre north-south was opened to gain a deep sequence. This was opened 0.5 metres from the east facing section. Several deposits were removed, with a concentration of brickbats potentially representing an earlier surface at a depth of c. 0.5 metres from the top of this sondage (Figure 12). Below this brickbat spread was a greyish silty clay deposit, which may have related to the deposit found at the base of the sequence in Trench 1A. This overlaid a very thin deposit of dark charcoal rich silt, which itself covered a very compact brown material containing small brickbat fragments. Forming a rectangular shape in plan, this material may represent an early floor surface. Once removed, a yellow sterile clay, lacking any indication of cultural material, and potentially representing the natural soil, was reached at a depth of 2.50 metres from the top of the current paved surface of this platform within the Durbar Square (Figure 13).

Figure 13: Possible natural at the base of the sequence of Trench 1C, looking north.

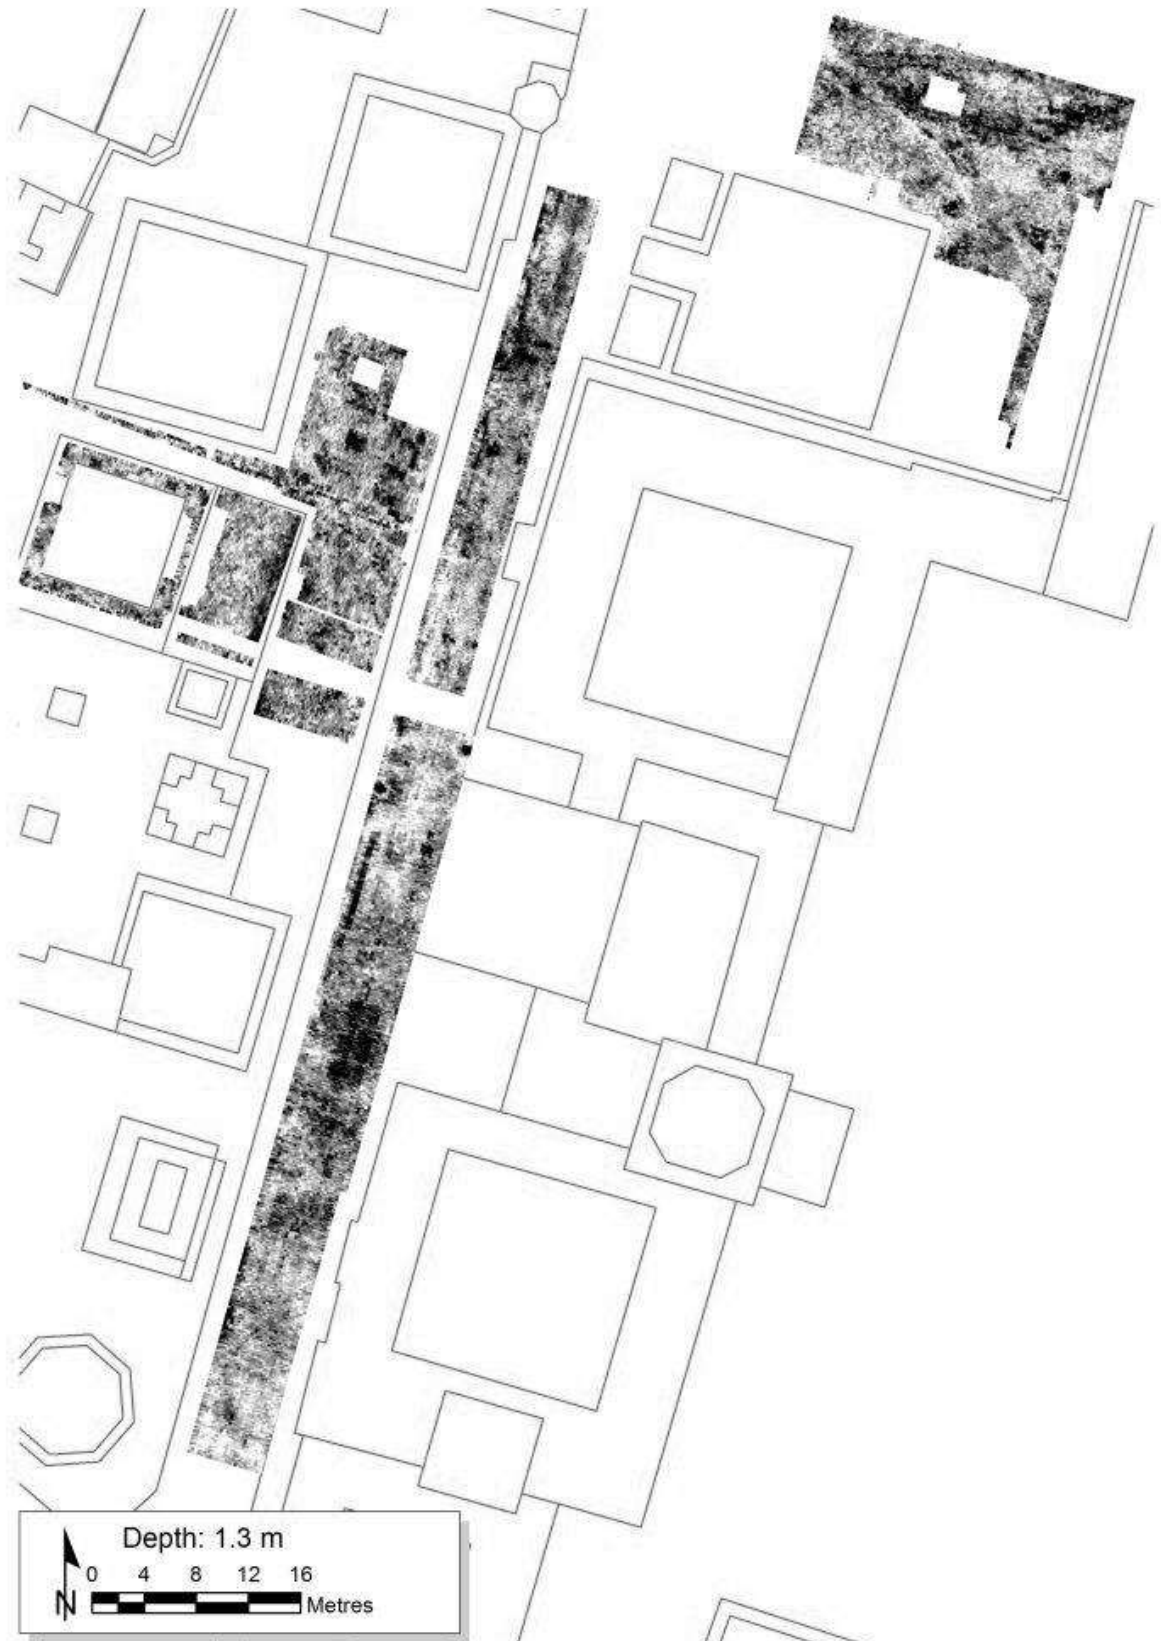
Figure 15: GPR results from Patan's Durbar Square at a depth of 1.3 metres.

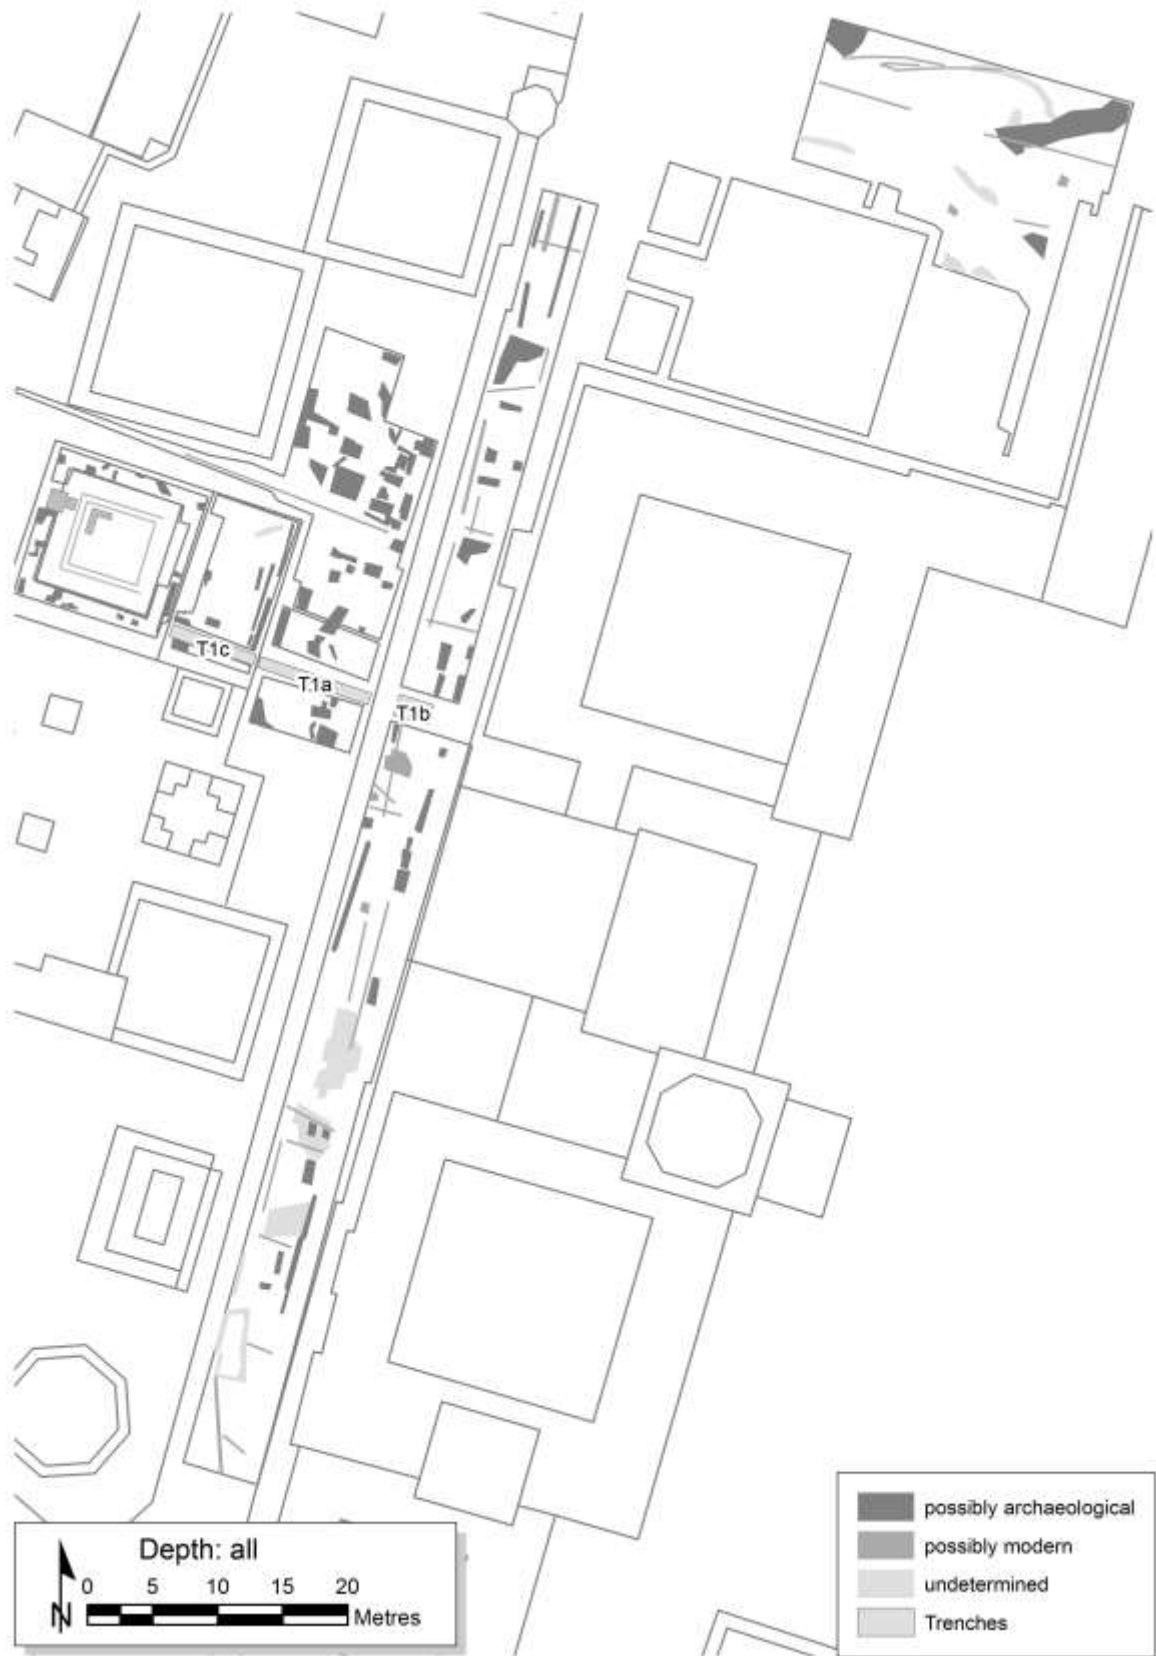
Figure 16: Interpretation of GPR results at Patan's Durbar Square.

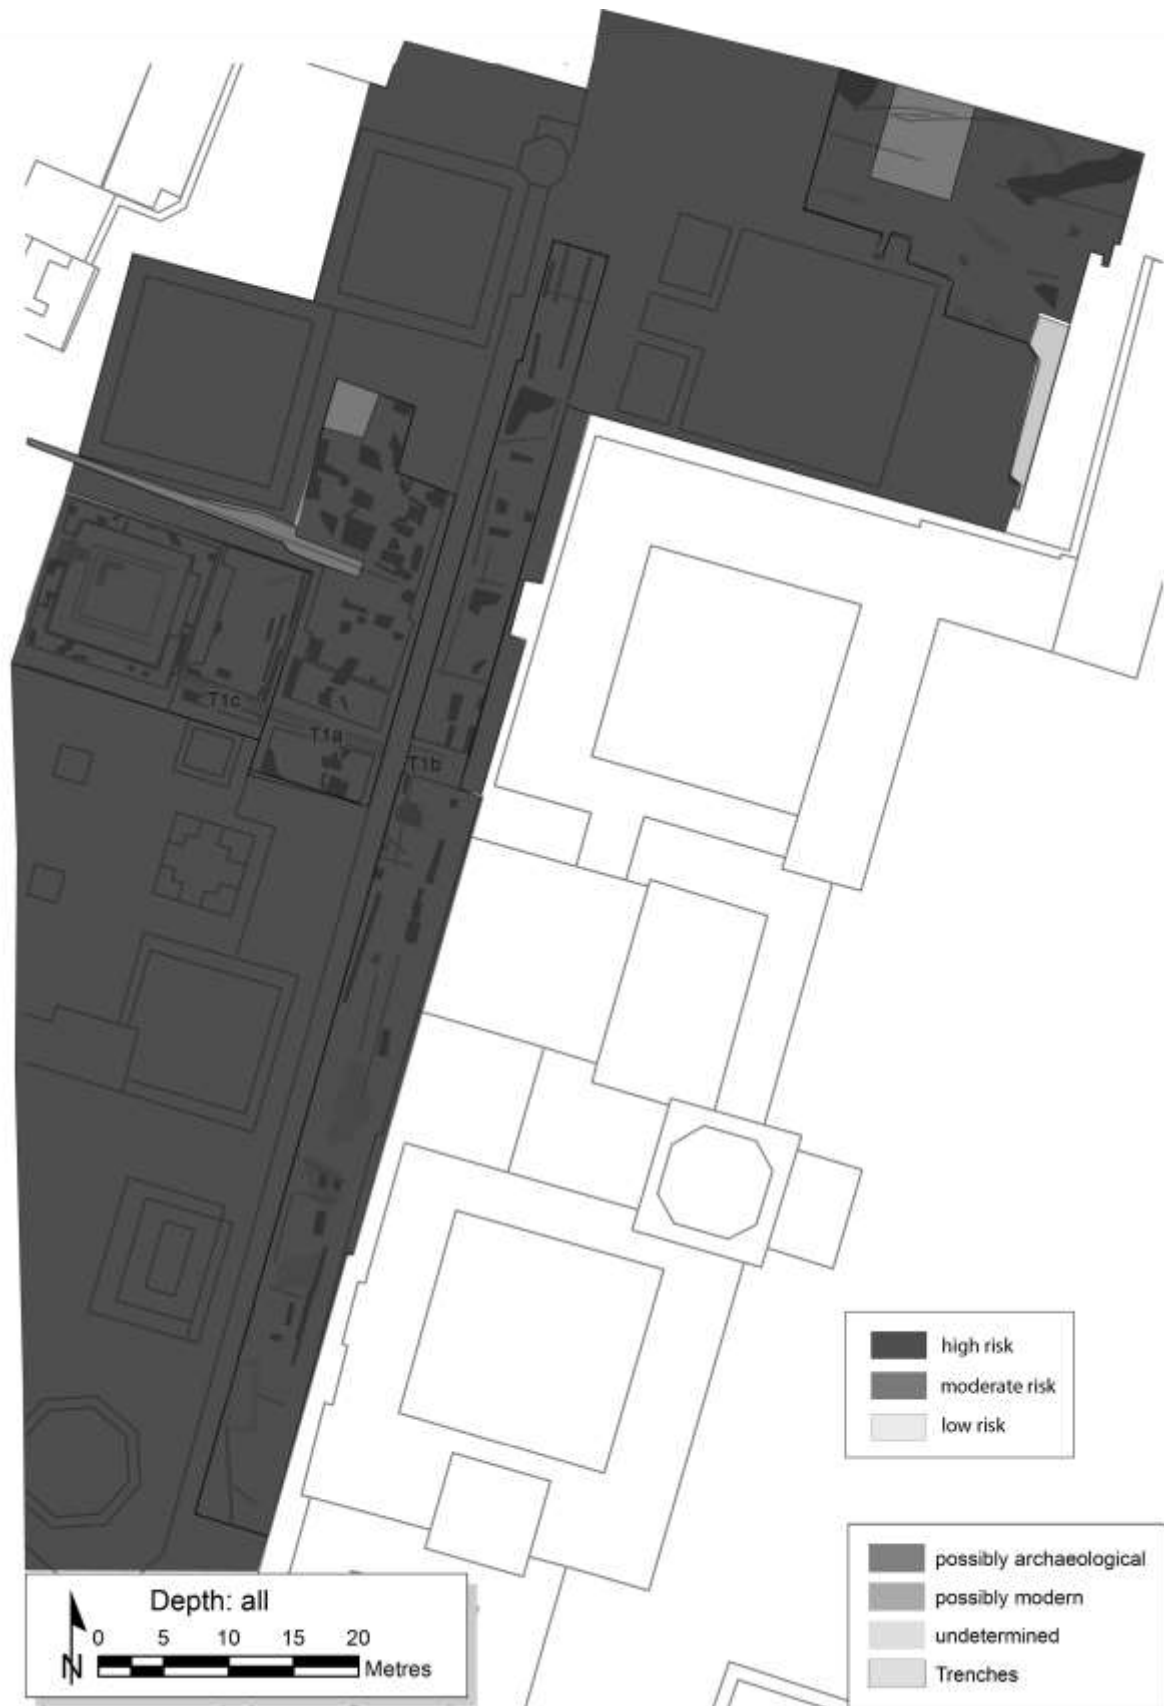
The archaeological investigations at the Char Narayan Temple and within Patan's Durbar Square have illustrated the extent of subsurface heritage at this World Heritage site. The GPR survey has highlighted areas of potential archaeological features below the current square and excavations have revealed the character of some of these signatures. What is clear is that the Durbar Square was not always an open space but has developed over time, only in the last few centuries reaching its current configuration of standing monuments. One of the key features identified through GPR survey and excavation were pipelines running through the Durbar Square, which we have clearly demonstrated have cut through archaeological stratigraphy and earlier phases of human activity. Such interventions are therefore a concern as the laying of any infrastructure has the potential to damage and destroy subsurface heritage of this site of Outstanding Universal Value.

Figure 17: Provisional Archaeological Risk Map for Patan's Durbar Square.

The damage caused by the earthquakes will require reconstruction and also the repair and laying of amenities in Patan and whilst we do not recommend the suspension of the laying services and reconstruction we do advocate the mobilisation of rescue archaeology teams to undertake rescue excavations in advance of interventions (Coningham et al. 2016c). The Archaeological Risk Map for Patan will provide information for site managers and stakeholders as to the risks posed to subsurface heritage and help guide future development (Figure 17). Indeed, from our observations and investigations, we feel there needs to be a heightened awareness that the cultural heritage of Patan is not restricted to its standing remains and architectural treasures but that it should extend also to the foundations of these monuments and to preceding phases of cultural development, which are found below the current ground level. The Archaeological Risk Maps and our

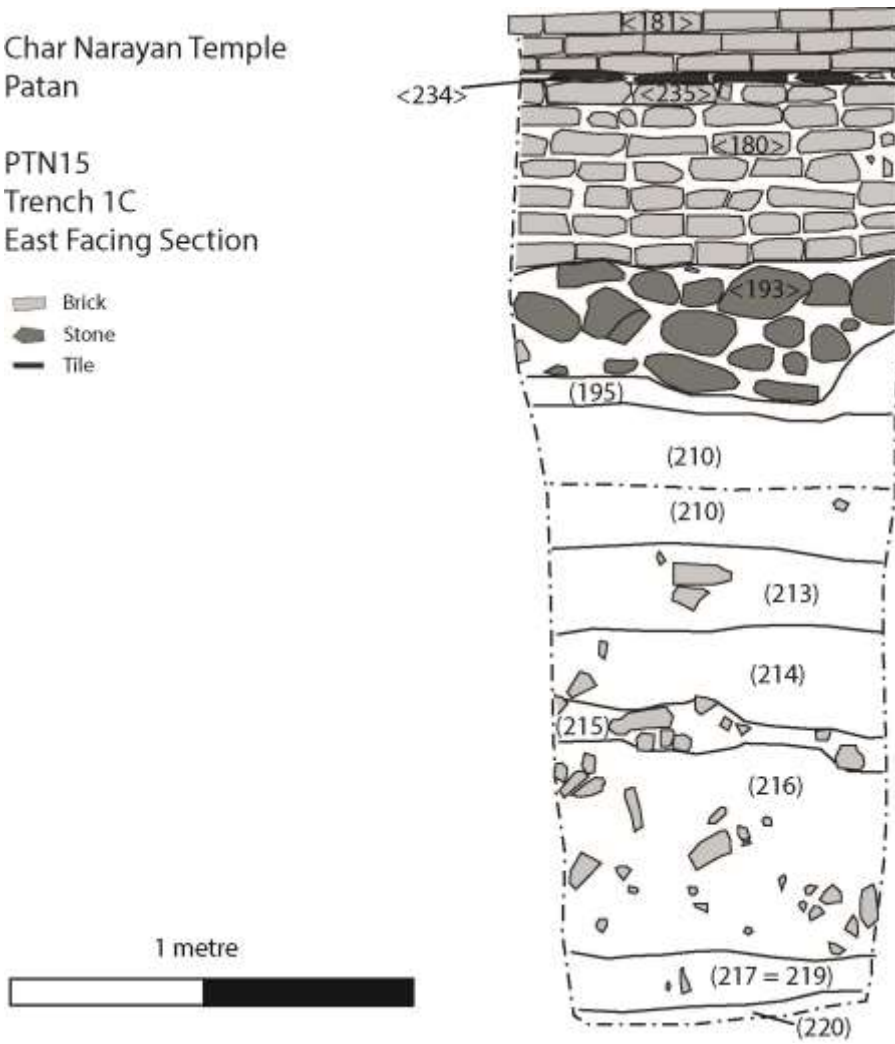
Figure 18: East facing section of Trench 1C.

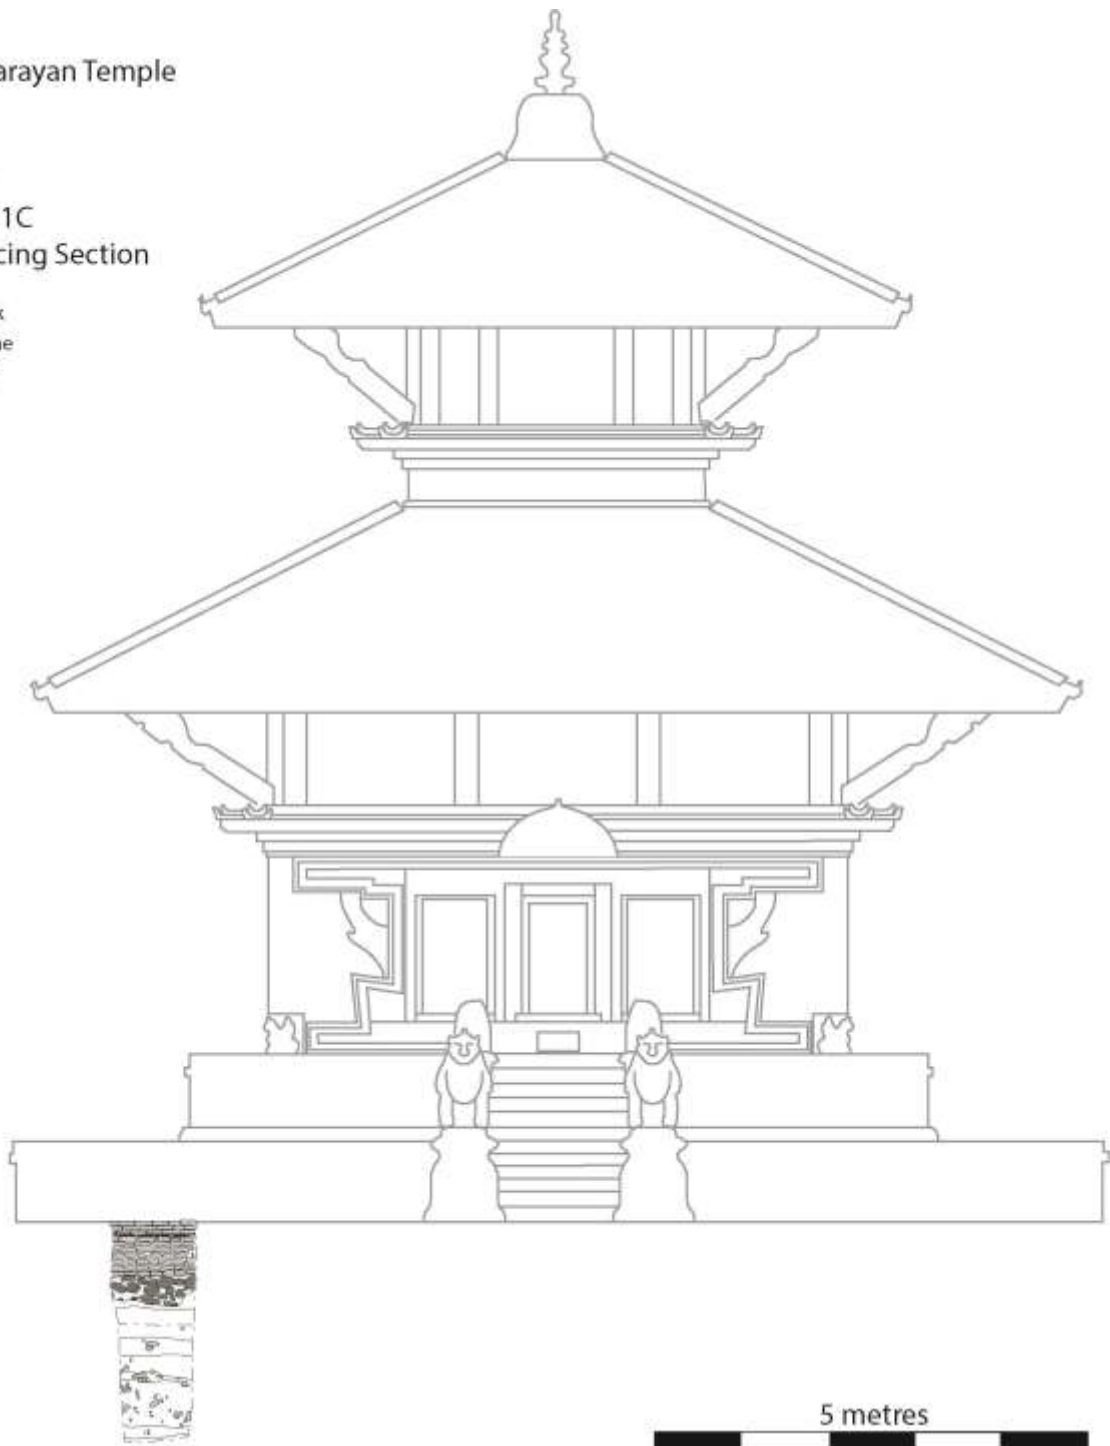
Figure 19: East facing section of Trench 1C, illustrating depth of foundations, with superimposed elevation of the Char Narayan Temple before collapse (Elevation of Char Narayan Temple after Korn 2007).

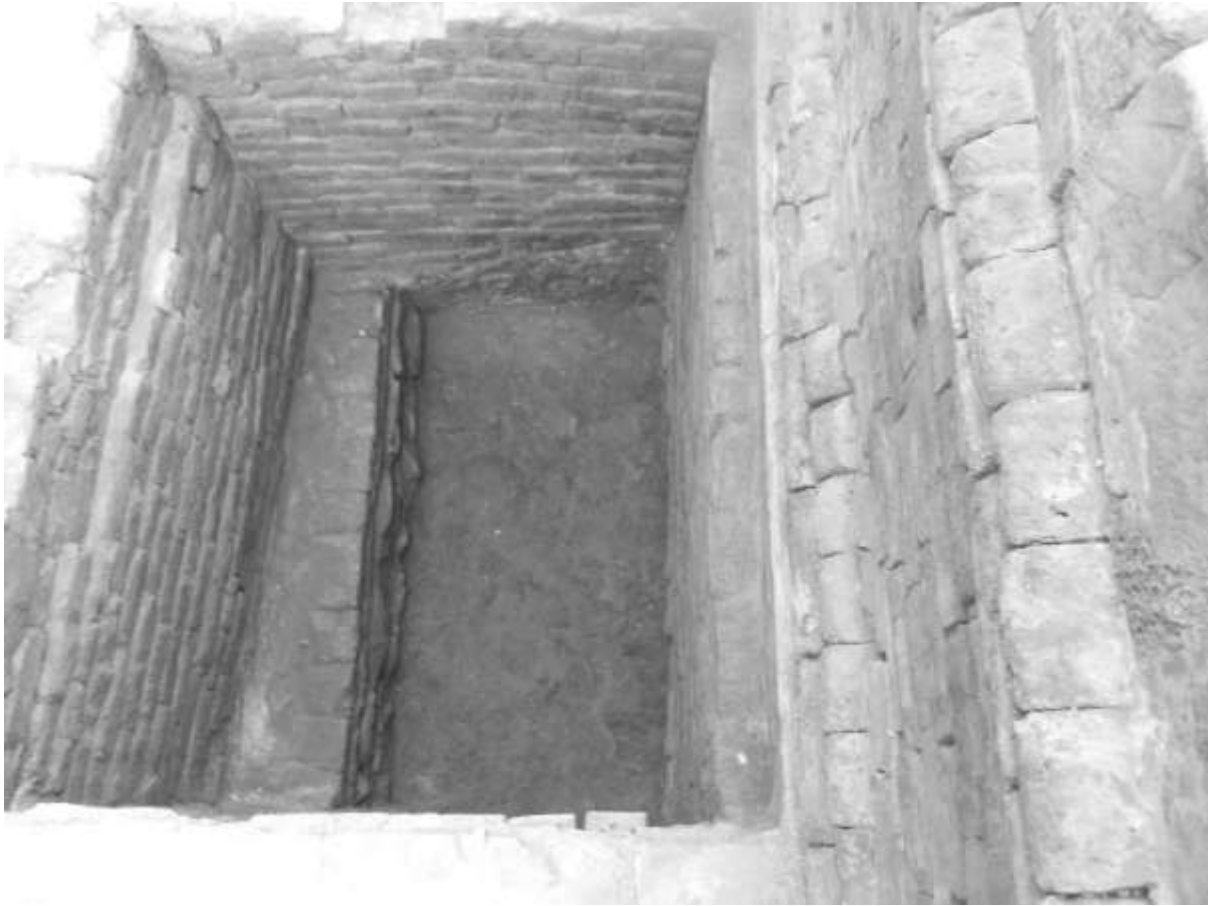
Our investigations have also provided the first published indications of how the foundations of the Char Narayan Temple were configured. Similar to those exposed within the cuttings undertaken by KVPT on the western platform edges of the Char Narayan Temple, which are yet to be published (Figure 20) (Coningham et al. 2016c) and those at the Vatsala Temple in Bhaktapur's Durbar Square (Coningham et al. 2016b), the brick walls rested on stone cobble foundations. Preliminary results from the GPR survey indicate wall stumps within this platform and indications from the subsurface interventions next to the foundations suggest that the platforms of the temple may have been formed through bracing cross-walls, similar in plan to those exposed by the rescue excavations at Kasthamandap (Coningham et al. 2016a). However, further processing of the GPR survey data is required as well as further investigations of the platforms through formal archaeological excavation to fully substantiate this postulation. However, it must be emphasised again that any subsurface investigation that is undertaken requires scientific excavation and systematic recording of the soil and artefacts that are removed as well as the masonry that is exposed.

Figure 20: Stone cobble foundations visible in trench cleaned by the team that was left open by KVPT on the western side of the Char Narayan Temple, looking north.
