**Preliminary Results of Post-Disaster Archaeological Investigations at the Vatsala Temple and within Bhaktapur's Durbar Square, Kathmandu Valley UNESCO World Heritage Property (Nepal)**

Coningham, R.A.E.<sup>1</sup>, Acharya, K.P.<sup>2</sup>, Davis, C.E.<sup>1</sup>, Kunwar, R.B.<sup>3</sup>, Tremblay, J.C.<sup>1</sup>, Schmidt, A.<sup>1</sup> and Simpson, I.<sup>4</sup>

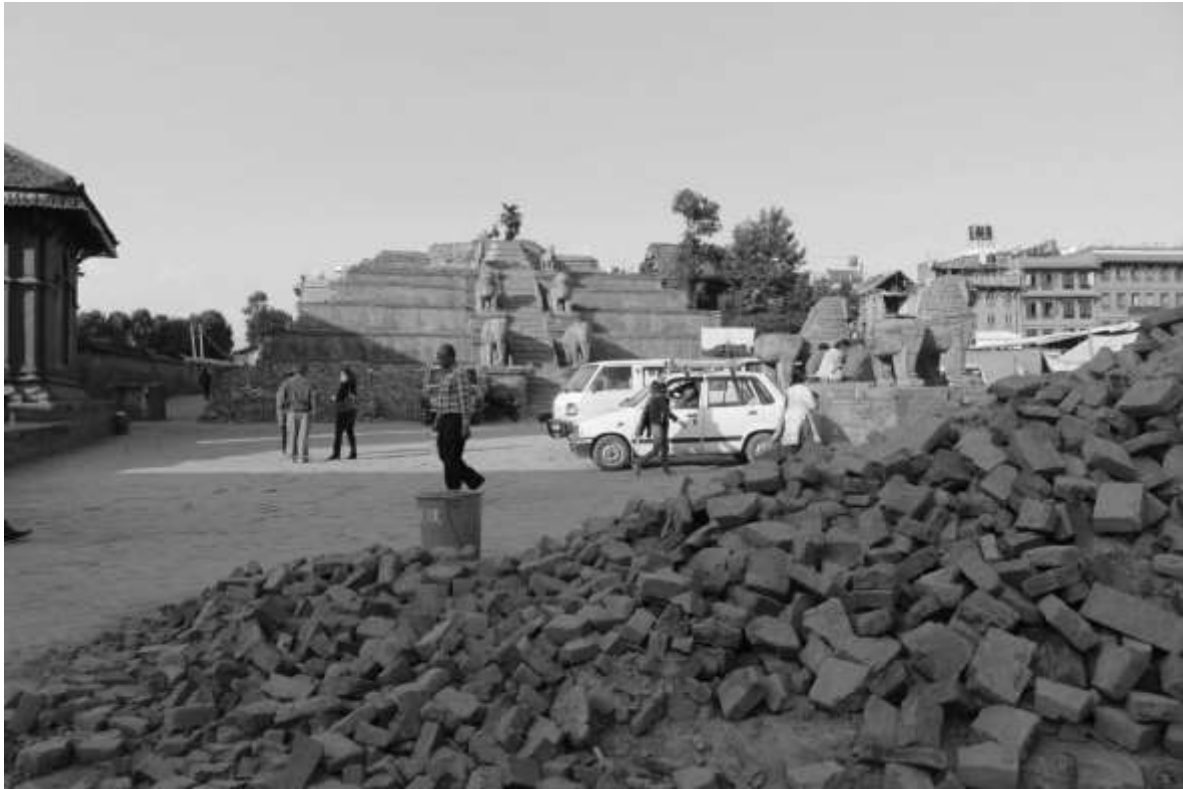
The Neo-classical shelter of the Silu Mahadev completely collapsed during the 2015 earthquake and, much like the post-1934 situation, the five-stepped plinth survived relatively unscathed (Figure 1). A portion of a structure to the south of this temple also collapsed (Figure 2). Furthermore, many monuments have visible signs of damage, including the brick sikara of the Siva temple, located in the west of the Square. Many of the structures of the palace complex were also damaged, particularly the building complex that now houses the National Museum of Art, which provides the Durbar Square with its northern edge, and is currently supported by wooden props. In the 2015 earthquakes, the most visible loss with the Durbar Square was the superstructure of the Vatsala Temple (Figures 3 and 4). Before discussing this Temple in detail, it should also be noted that the monuments of the Square did not suffer as much catastrophic damage as the vernacular settlement of Bhaktapur, with many properties damaged and destroyed. One of the major risks to its heritage is the loss of traditional architecture if these residential structures are rebuilt using modern material and styles.

Figure 1: Silu Mahadev, or Fasu Dega (Tahacho Dega) Temple photographed in November 2015.

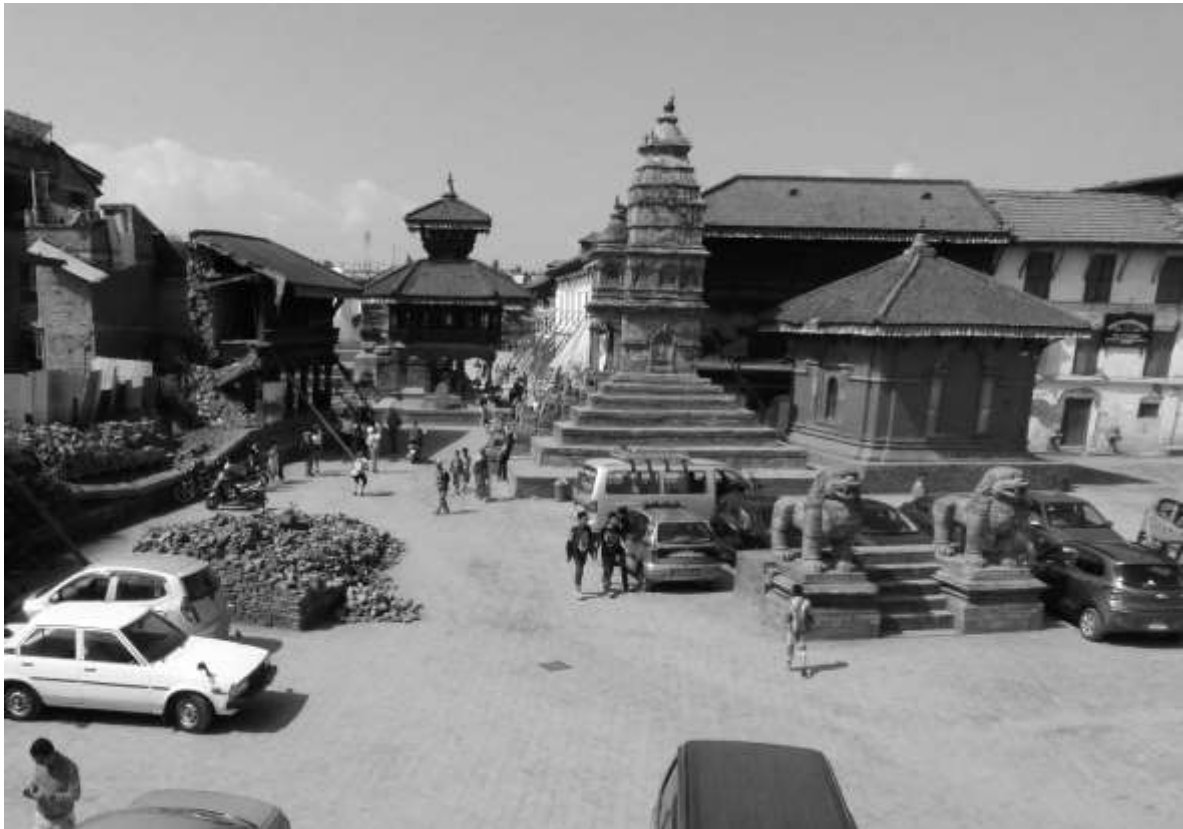
Figure 2: Earthquake damage in Bhaktapur's Durbar Square.

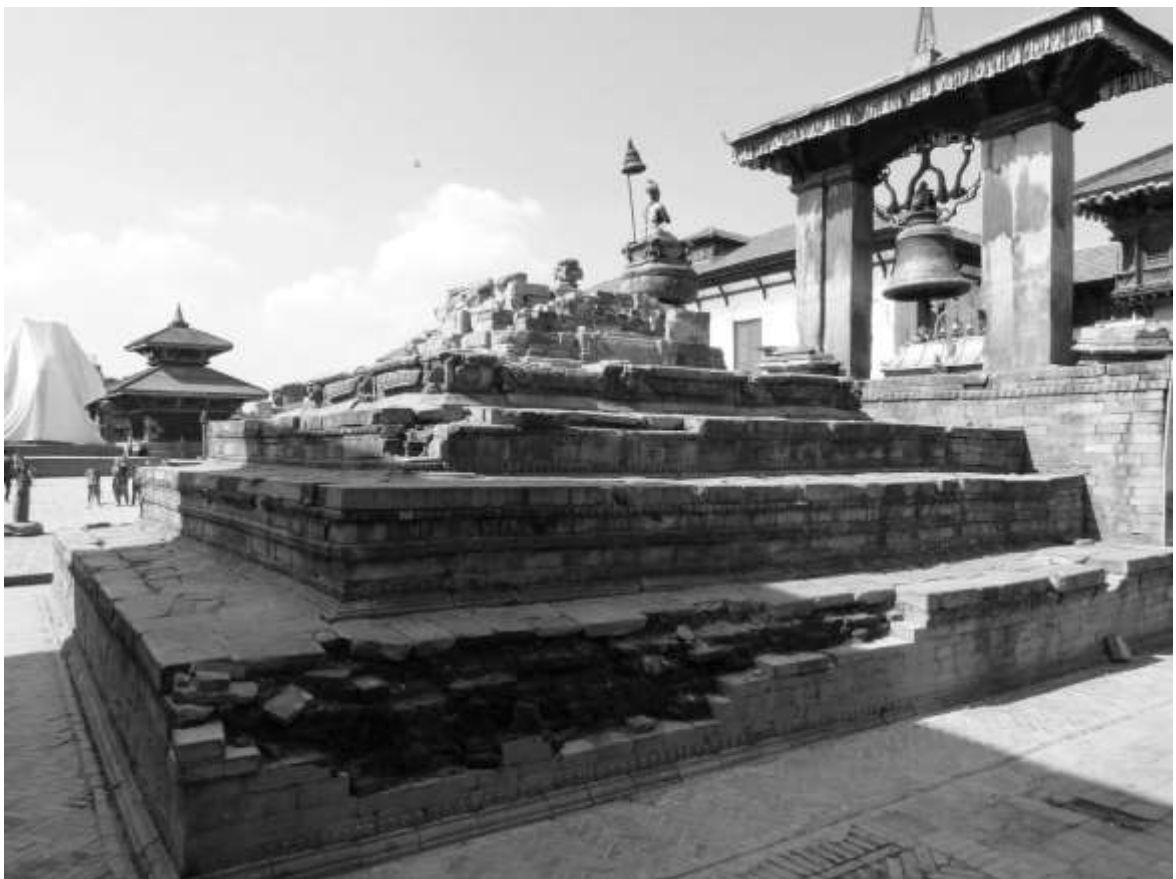
Figure 4: The collapsed Vatsala Temple on surviving plinth.

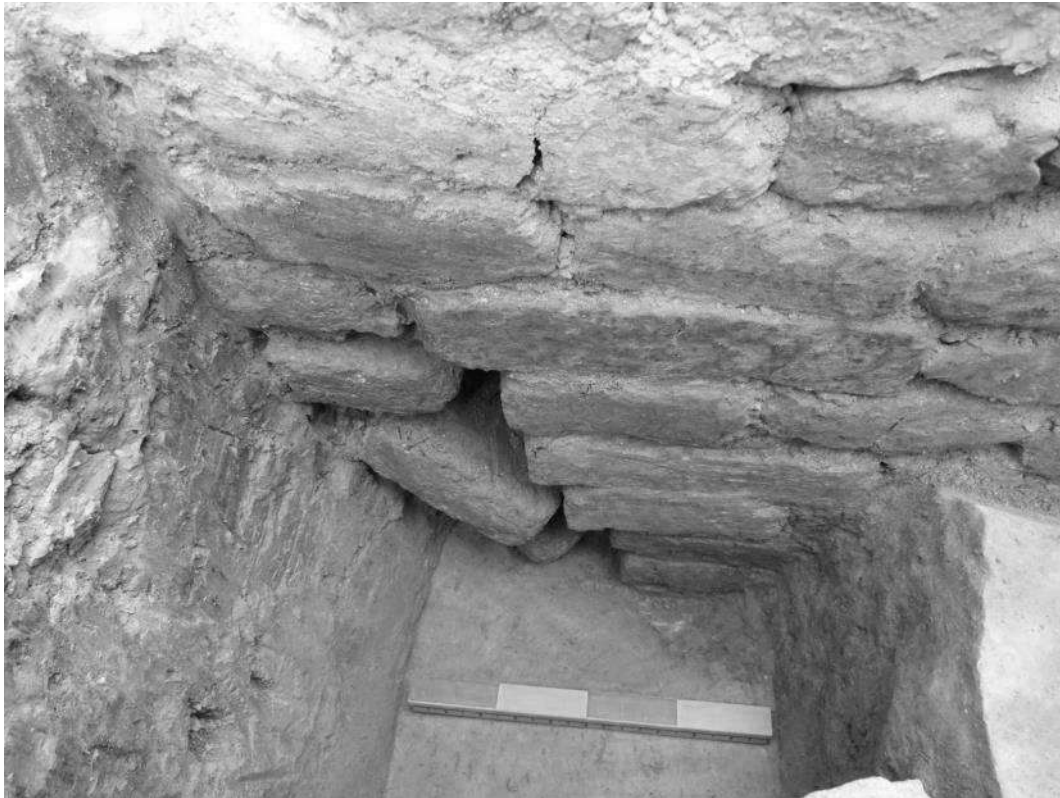
Figure 10: Shear crack of wall within Trench 1 indicating possible earthquake damage.

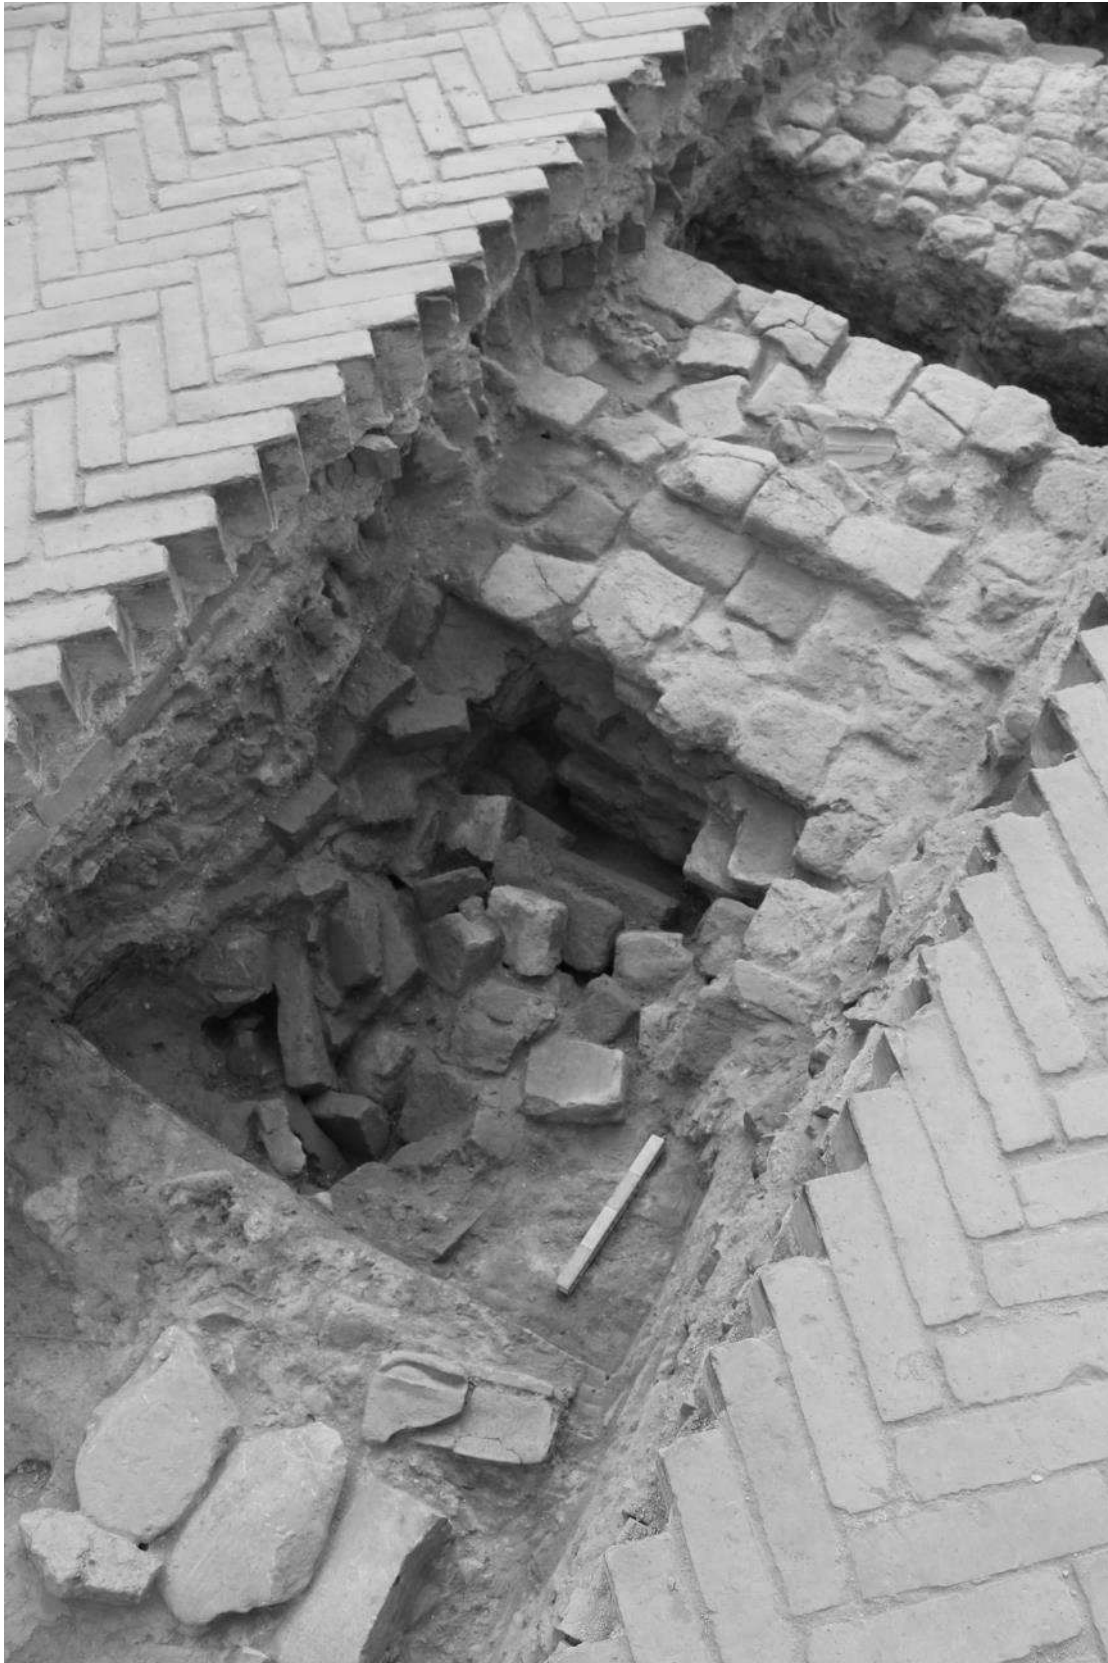
Also running north-south across the trench, was a defined surface of smaller squared bricks. Again, initially thought to be a wall, excavation revealed that this feature was one course thick and actually represented another paved area (Figure 9). Several walls were identified in the trench that also ran on a north-south alignment. To the east of the paving and west of the drain were two wall alignments, very close together. Due to their proximity and the leaving of the walls in situ during this pilot season, we could only identify eleven courses of brick, but several more were probable. We also identified potential signs of penetrative fractures or shear cracks within the west-facing elevation of the more western wall (Figure 10), which is one of the key classifications of Earthquake Archaeological Effects (EAW) that can be identified in the archaeological record (Giner-Robles et al. 2009: 13). The wall to the east of this appeared to be cracked and had a split running north-south across the alignment. The wall was tilted and displaced to the east and also was associated with a brick scatter, probably relating to a wall collapse (Figure 11). These indicators on these two

walls suggest evidence of damage caused by earlier earthquakes, most likely relating to the events of 1934.

Figure 11: Wall collapse in Trench 1, indicating possible earthquake damage, looking south west.

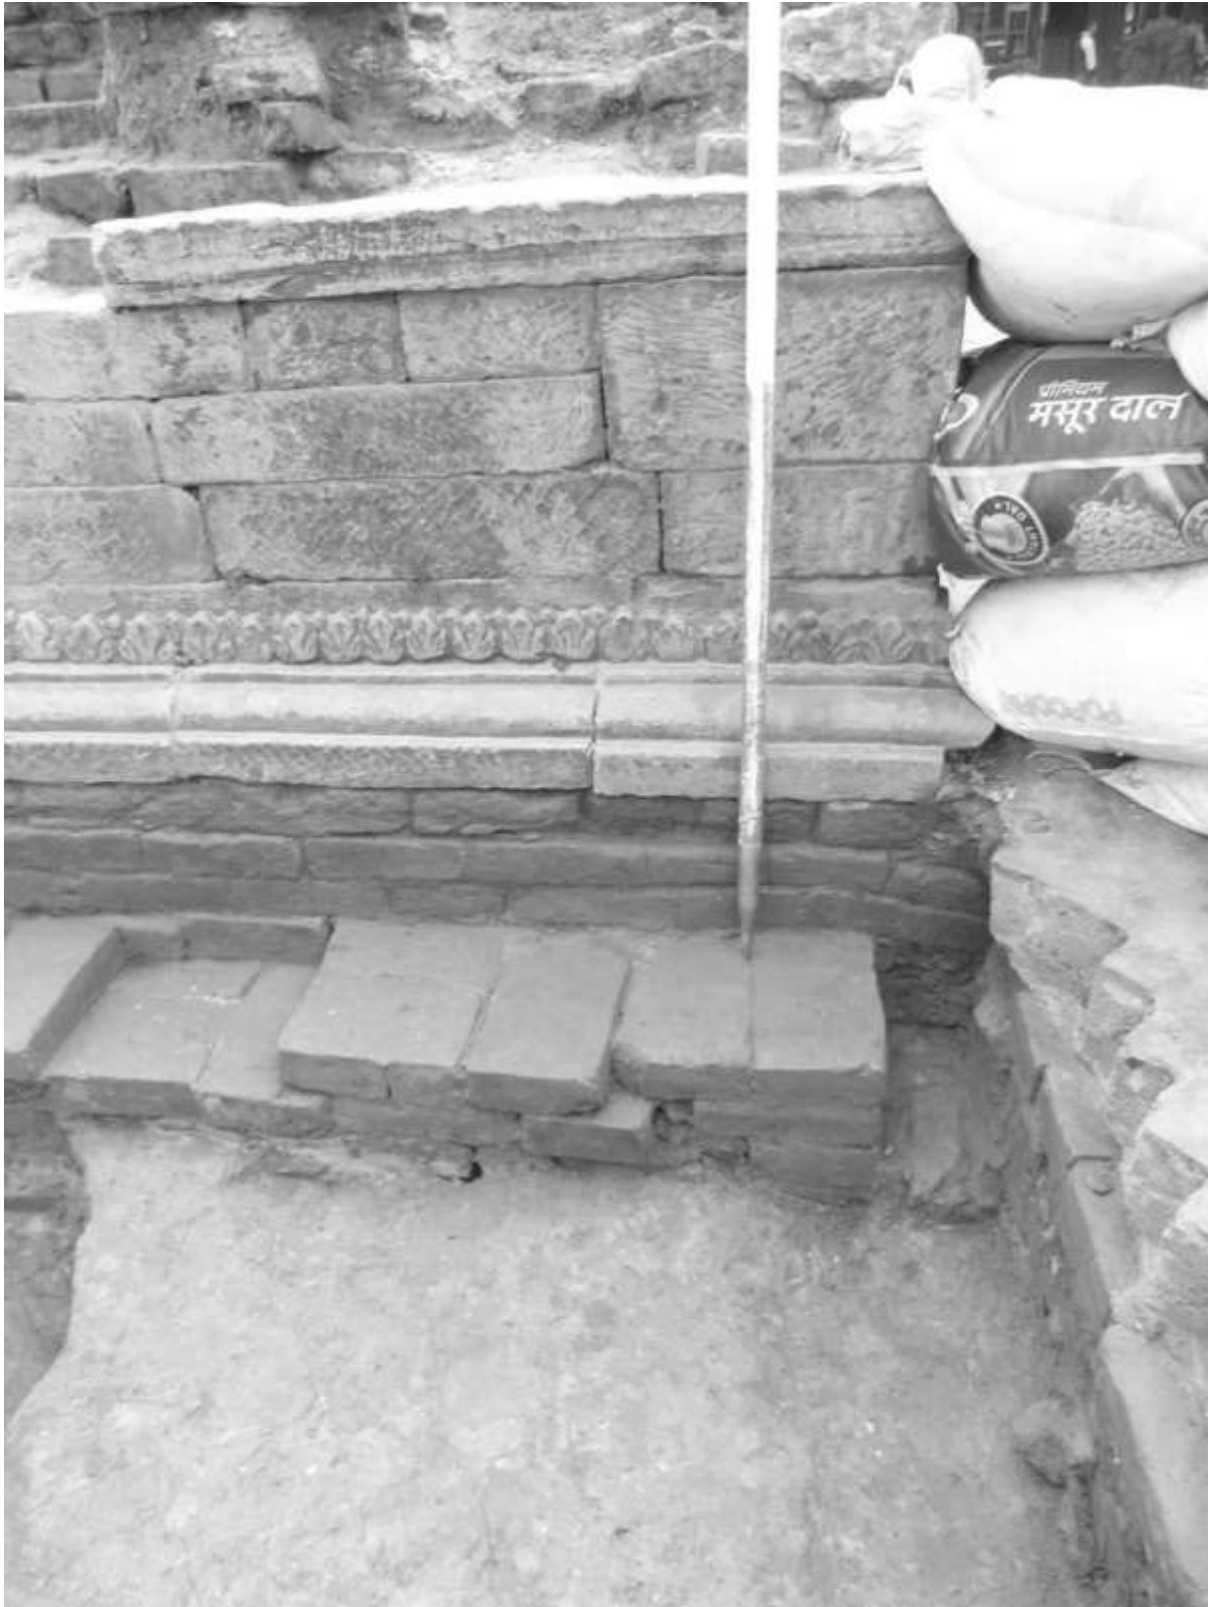
Figure 13: Later brick courses overlying earlier footprint of the Vatsala Temple at the south-west corner.

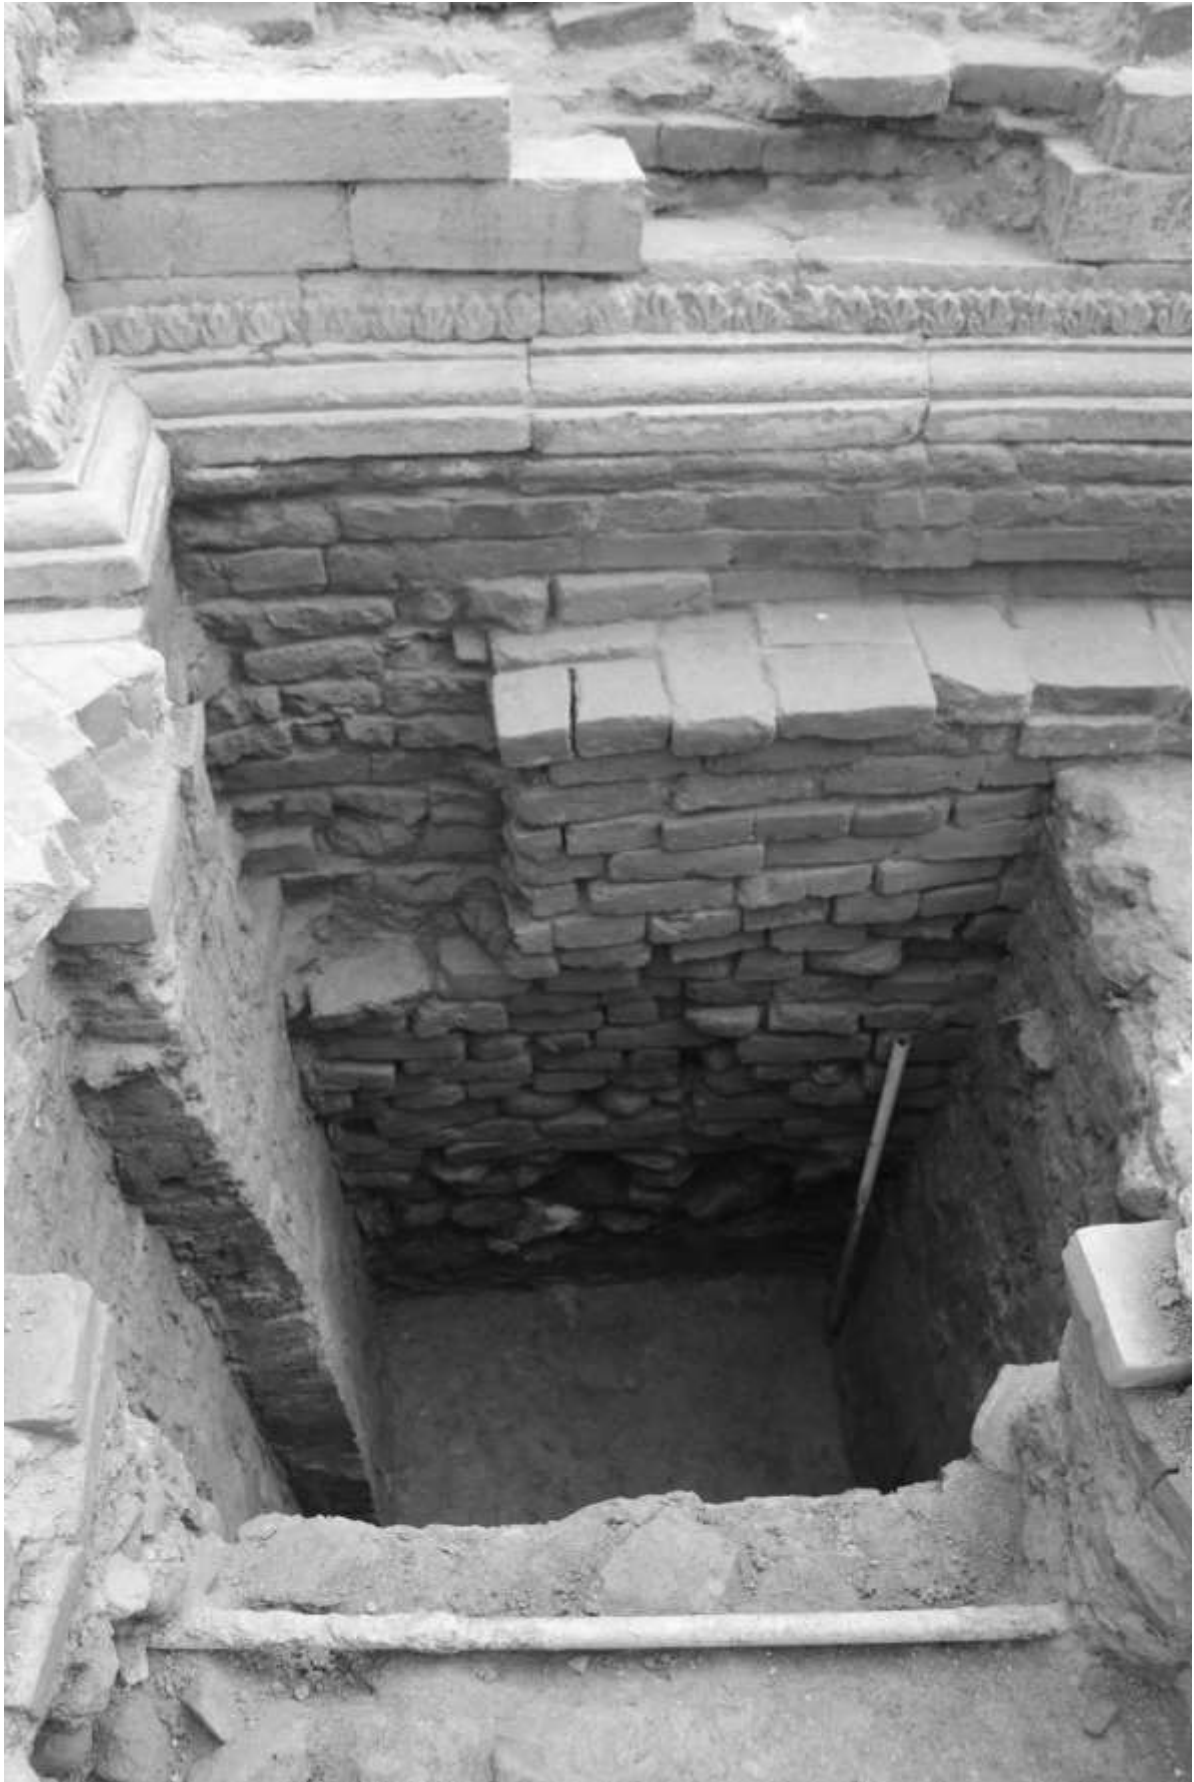
Figure 17: Stone cobbles at base of brick foundations of the Vatsala Temple, looking east with water pipe at base.

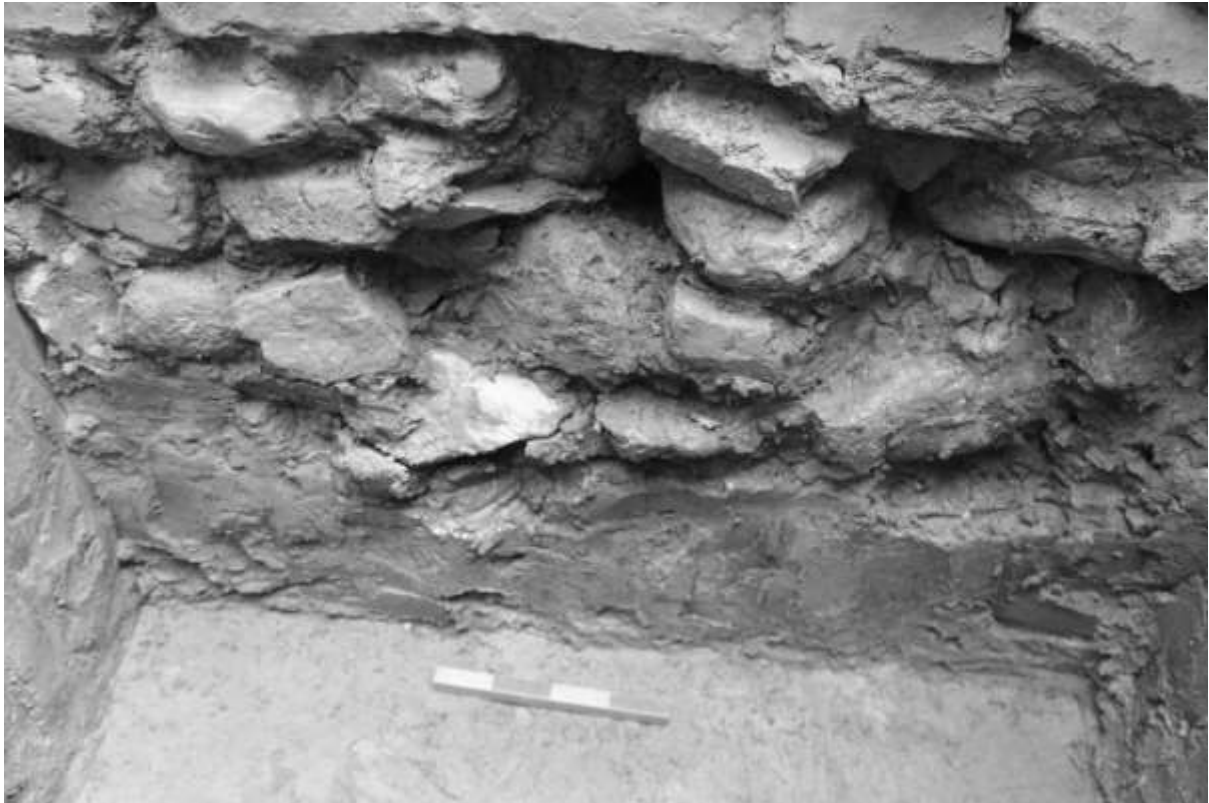
Figure 18: Detail of stone cobbles at base of foundations of the Vatsala Temple.

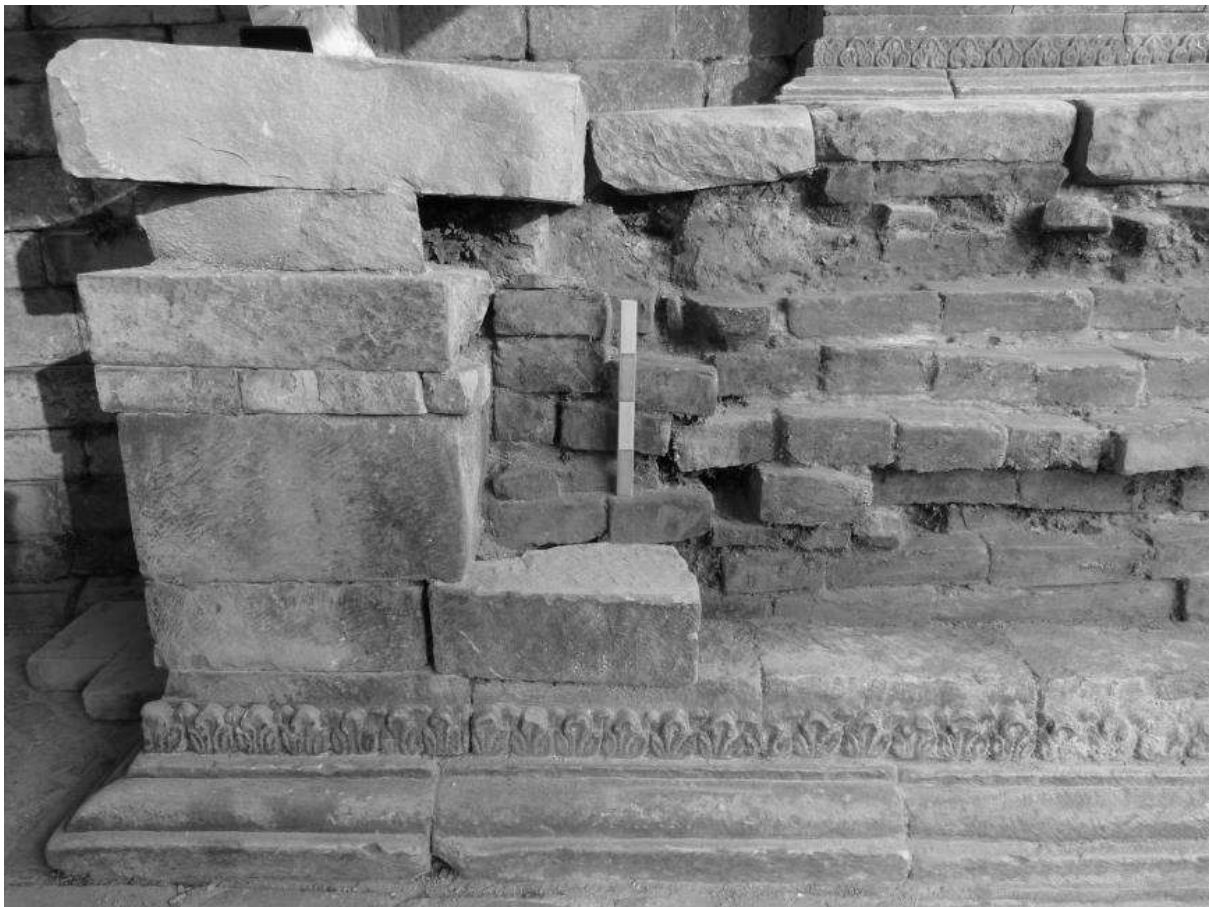
Figure 19: Differing phases of construction and bonding of brick and stone block masonry in Trench 1B.

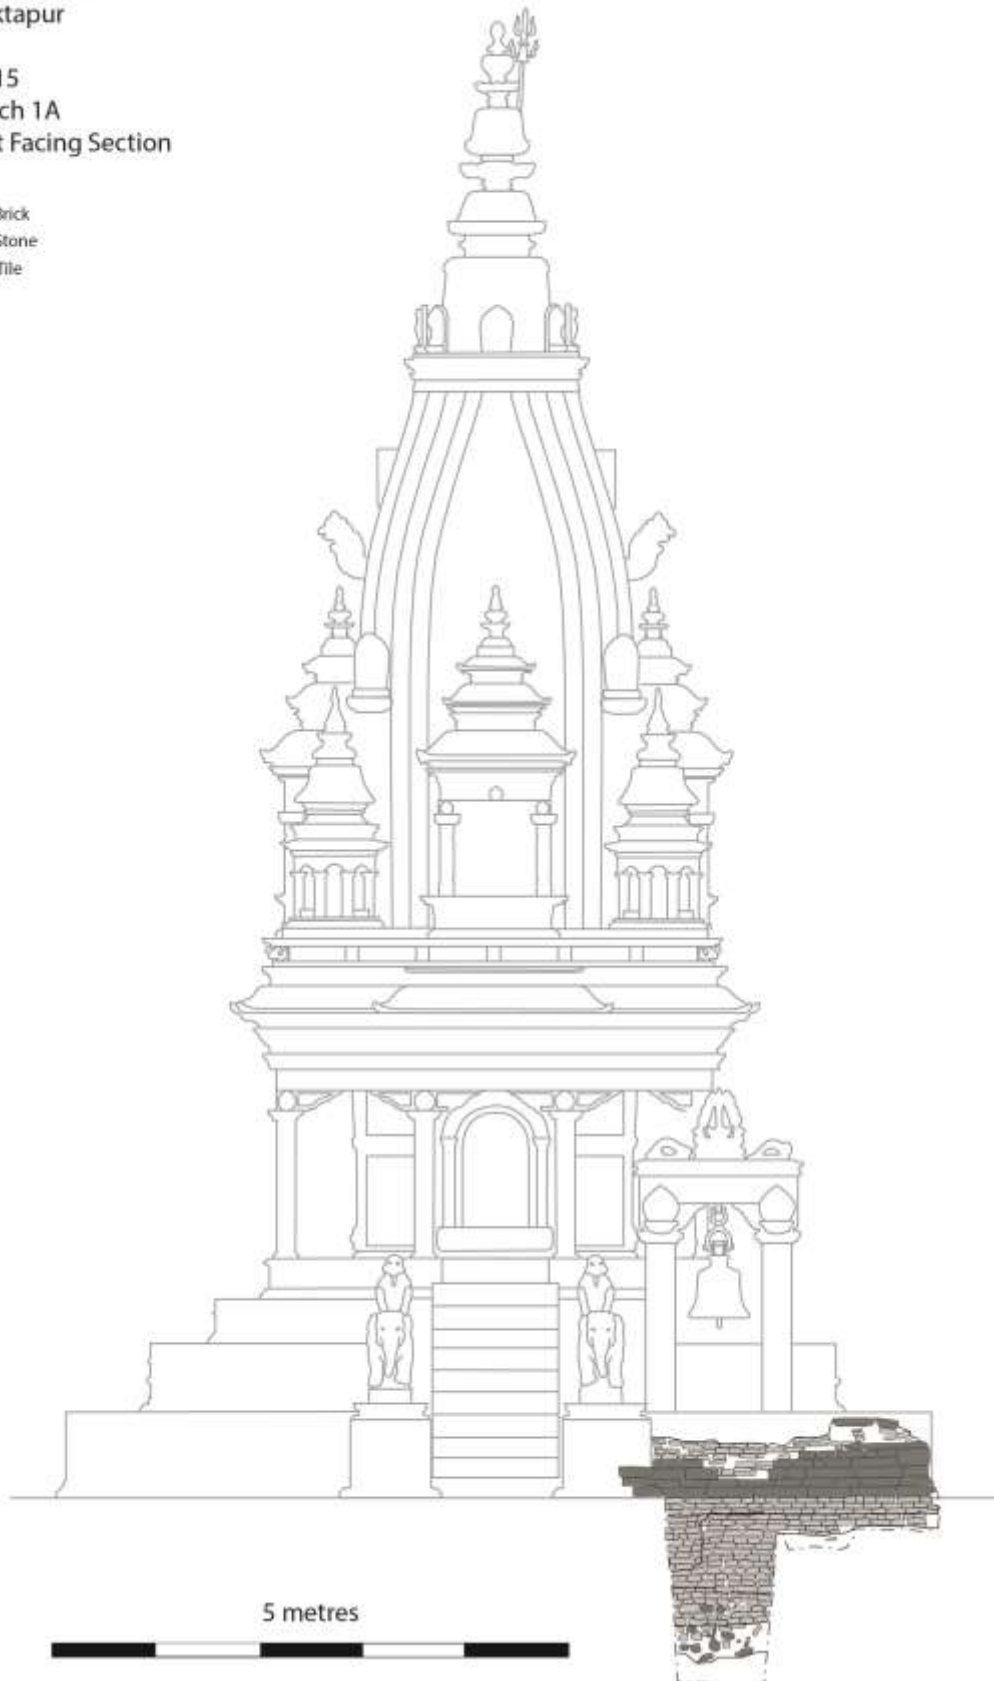
The excavations on and adjacent to the Vatsala Temple in Trenches 1A and 1B have provided an understanding of the construction technique and phasing of the monument as well as some reasons as to why the monument may have collapsed in the earthquake of the 25<sup>th</sup> April 2015. Once loose material was removed, it was clear that the stone blocks were only cladding, not keyed in or mortared to each other or the underlying brickwork and belonged to a later construction phase. Currently, we cannot ascertain whether this was relatively soon after the construction of the brick core or sometime after but the evidence points towards two quite separate phases. This lack of bonding and the weight of stone blocks for the cladding possibly left the Vatsala Temple open to the displaced masonry earthquake damage. Indeed, unlike many monuments that were damaged in 1934 and not in 2015 or vice versa, the Vatsala Temple has now been badly damaged in both seismic events, suggesting a structural flaw in the interface between the monument's superstructure and foundations.

Figure 28: West facing section of Trench 1B, illustrating depth of foundations, with superimposed elevation of Vatsala Temple before collapse (Elevation of Vatsala Temple after Basukala et al. 2014).
