THE DURHAM CATHEDRAL DOORS

by C. Caple

Durham Cathedral Door: Figures

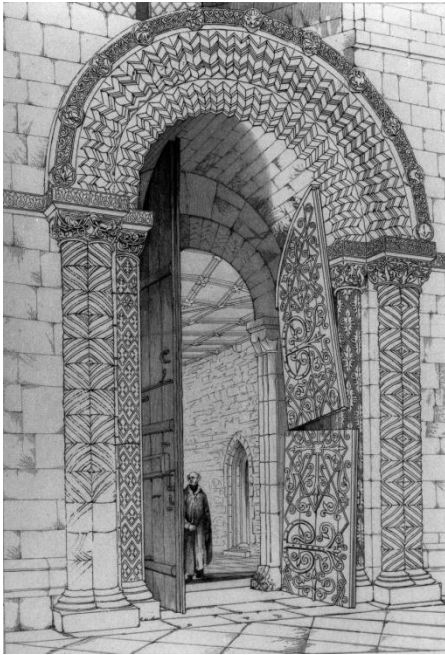
Figure 1: South (Monk's) Door: *Engraving from Billings 1843*

Note the curve backed 'wedged ledges' on the back of the door, though details of the jointing to the vertical planks are not accurately drawn

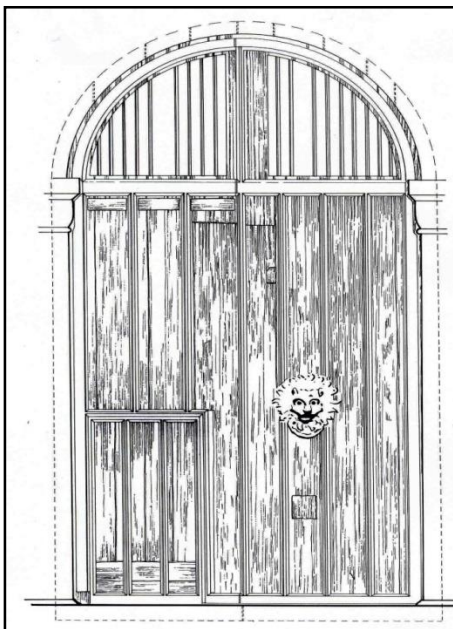
Figure 2: North Door, 1900 - 1990 AD: *Drawing by the Cathedral Architect, courtesy of the Dean and Chapter of Durham Cathedral*

On the front of the north door, smaller raised vertical mouldings of wood were added to cover the long vertical jointing between the planks (Figure 2). This would have had the effect of making the door more waterproof. A similar raised moulding, of slightly wider form, was added to frame the outer edge of the door. These vertical and edge framing mouldings are a common decorative and functional device of the late medieval period, often added to earlier doors as is the case for the north doors of Wells Cathedral (Hewett 1985). In the case of the west leaf of the north door the raised exterior moulding which initially cover the plank joints, maintains a constant spacing, even when the planks become wider nearer the hinge. Thus the decorative function outweighed the functional weatherproofing role of these additions. The south (monk's) door is covered with iron strapwork, nailed onto the door which Geddes suggests on the basis of the swaged profiles for the strapwork, the design and decoration of the scrolls and the decorative form of the hinges was probably of late 12th century date and the work of Bishop le Puiset (Geddes 1982). This may have replaced thinner, plainer earlier 12th century strapwork (Geddes per comm.). This strapwork undoubtedly improved the rigidity of the door. The presence of occasional iron nailshanks in the north door and traces of raised patterns in the doors surface (Figures 4 and 5) indicates that it too originally was covered in iron strapwork and that this was subsequently removed and the vertical raised moulding was attached. Three short pieces of thin iron bar are present beneath the raised edge moulding on the west side of the west leaf of the north door and may be remains of the original strapwork or derive from later strengthening of the door. The observation that the nailshanks and raised ridges were concentrated in the outer margins with little evidence of them in the centre of the door suggests that the iron strapwork only formed a decorative outer zone on the north doors. On the south (monk's) door and other surviving examples of decorative iron strapwork the hinge itself is always an integral part of such designs on the front/exterior of the door. Thus the hinges, described as 'cranked band and gudgeon hinges' (Emery pers. comm.) are primarily affixed to the front of the door and are bent through 90° in order that the hinge loop is at the back of the door so that the door can hinge properly. The present hinges on the north door are at the back of the door and thus can not have been part of any decorative strapwork scheme.

- i) they are bowed and distorted
- ii) they have a horizontal cut across the plank near the top of the door. The upper and lower parts of the plank appearing very different
- iii) there are nails attaching these planks to two of the three ledges, this is unnecessary in the original construction

These features indicate that these two planks have at one time or another been wrenched off the door. This resulted in the splitting, loss and damage to the edges of the adjoining plank which is now visible and has partially exposed the free tenon between the planks. At a later date these central planks, or replacements, were reattached to the door. The present planks are bowed, unlike any other planks in the door and thus may be replacements, less well seasoned than the originals. The upper portions of these planks above the horizontal cut appear intact original planks, only the lower parts were damaged and possibly replaced.

A small wicket door known as 'the eye of the needle' has been cut into the east leaf of the north door, Figure 2. It is framed and edged by the raised moulding and has two vertical raised mouldings dividing the door surface. As this moulding appears to be the same as that used on the rest of the door it appears likely that the wicket door was created at the same time as the moulding was applied, though it has been subsequently altered with the sill being lowered to permit easier access in both the 19th and 20th centuries (Curry pers. comm.).

Note the tympanum having the vertical louvred form created in the 19th century which obscured the original vertical planked form and the various repairs to the planking of the door. The vertical and horizontal cross sections refer only to the remaining evidence of the original door construction

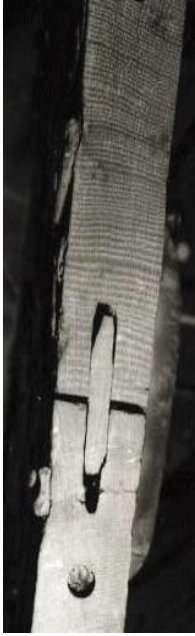
Figure 3: Cross Section Through Plank 2 (Q8795), West Leaf of the South (Monk's) Door: Photograph by Trevor Woods, Department of Archaeology, University of Durham
Note the free tenons between the mortised planks and the circular holes resulting from the removal of the samples for radiocarbon dating.

The leaves of the north door of Durham Cathedral are composed of a series of substantial planks which have grooves or mortices cut into their sides, into which are slotted free tongues or tenons, separate long thin strips of wood, which run the length of the plank, Figure 3. The leaf of each door is composed of 4 or 5 planks, with 3 or 4 free tongues or tenons. Three thin tapering horizontal ledges are present on the back of the door to hold the vertical planks together. The ledges are roughly semi circular in cross section and are attached to the planks having been slid into shallow dove-tailed grooves which have been cut across the full width of the back of each door plank. Thus the 'wedged ledges' hold the door planks firmly in position without any need for nails. The door with its ledges partially cut into the vertical planking is both thinner and lighter than other medieval doors. The use of the countersunk 'wedged ledges' is paralleled by Hewett (1980, 1982) in the doors of Eastwood, Heybridge and possibly Elmstead churches in Essex all of which are believed to date from the later half of the 12th century. Hewett's drawn description of the Durham cathedral doors (Hewett 1985) which indicates tongued planking is incorrect and should be modified to the free tenon format, Figure 3. Hewett (1980, 1985) gives no other examples of doors made with free tenons running the length of the planks, though short free tenons are used to join planks edge to edge on doors such as those of Kempley Church which are dated to circa AD 1100. The south door of
