DAMAGE IN HISTORIC RAMMED EARTH STRUCTURES: A CASE STUDY AT AMBEL, ZARAGOZA, SPAIN

Paul Jaquin* (United Kingdom)
Integral Engineering Design

Christopher Gerrard** (United Kingdom)
Department of Archaeology, University of Durham

Charles Augarde*** (United Kingdom)
School of Engineering and Computing Sciences, University of Durham

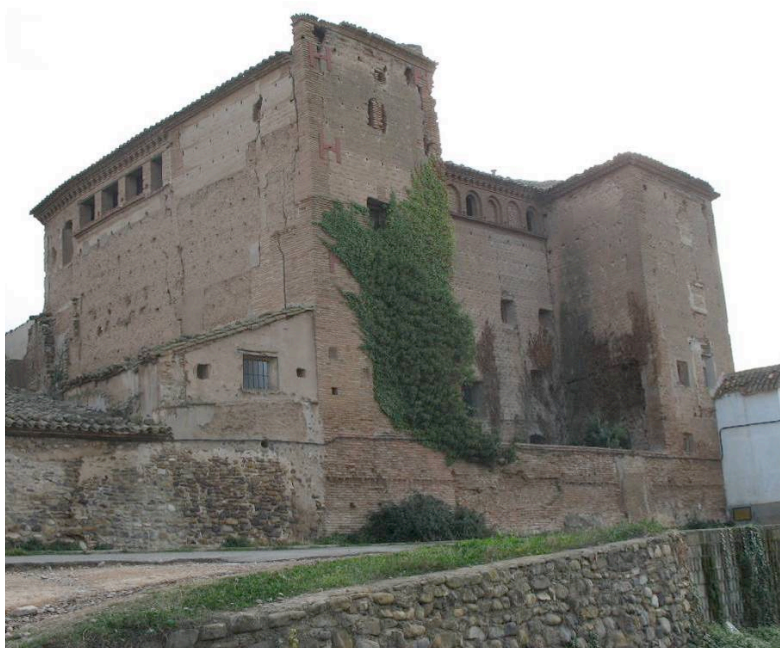
Today there are two independent sets of cracks in the east elevation (Fig. 1) – two slightly inclined cracks in the centre of the building; and two vertical cracks at the north end of the east elevation, which are related to the lean of the north gable end wall. This wall leans outwards from ground level to mid-height of the second storey, with the section above this being built vertically on top of a leaning wall. The current owners of the building installed crack monitoring points in the early 1990s and this monitoring shows the continued opening of the cracks at the northern end of the tower. As a result,

Fig. 1. The preceptory at Ambel, north-east elevation. The gallery of arches between the towers is typical of 16th century architecture in this region. The first phase precinct wall reaches the base of ivy and stands 3m high.

shows that there is no structural tie between the between the two. Any structural movement therefore results in an opening of the joint. This is particularly a problem in later medieval architecture, where brick quoins are used, and structural movement (for example of the gable end of a structure) is unrestrained and leads to an opening of the joint. An example of this can be seen on Fig. 1 immediately below the eaves at the northern end of the tower.

Where water has been allowed to gather and run down the face of a wall, cast structures, such as described in Section 4.1, are observed on the face of the wall (Fig. 5). However, these have served as a forewarning of further damage and caused the building owners to undertake repairs. As a result, there are no deep incisions into the rammed earth as shown in Fig. 4, and as observed at other historic rammed earth sites (Jaquin, 2008b). However, the eaves do not protrude on any of the faces, and this may have allowed a water flow down the face of the wall. If water is allowed to gather behind the render, then the rammed earth may become locally saturated, meaning the liquid bridges providing a bond between the render coat and the rammed earth may become saturated, causing the render to spall away from the wall (Fig. 1).

tie bars were placed at ceiling level at the ground, first and second storeys in 2000. These are fixed internally by bolting onto the ceiling beams and protrude externally to link to H-shaped bars on the facade which were positioned so as to overlap the brick quoins (Fig. 1).

may have succeeded in stiffening the north end of the structure, but because ground movement has not been halted, further deformation and cracking has occurred. In 2000 H-shaped spreader plates were fixed to the face of the wall, which are affixed to 150 mm x 80 mm I-beam sections running through the length of the building. These I-sections are bolted to the transverse ceiling timbers at each side of the building at ground, first and second floor levels.

Although this intervention follows sensible principles, it may be noted that the horizontal component of the lean of the gable wall is transferred directly to the transverse timbers through bolting, which maybe prove unsatisfactory, with the bolts shearing from the timber with increased horizontal load from the gable wall. Monitoring of crack growth shows that the placement of this system has not arrested the growth of the cracks, suggesting that it is yet to engage or is proving ineffective. Future work is now being suggested which will involve the placement of spreader plates on the outside of the south wall, allowing the I-beam sections to span the whole length of the building and thereby stiffen the whole structure.

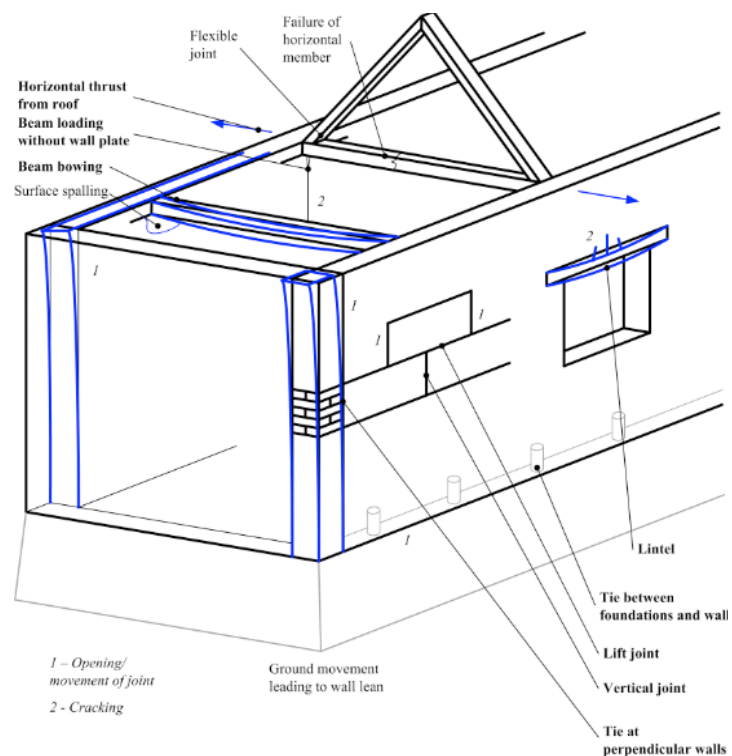
Fig. 2. Examples of failures of structural elements

or later alteration to the structure, there is the potential for shear failure of the wall beneath the loaded beam. Out of plane failure can also occur where a beam joining a wall is insufficiently stiff and bows under loading. This causes an increased load at the face of the wall, and can lead to spalling of the material at the face (Fig. 2).

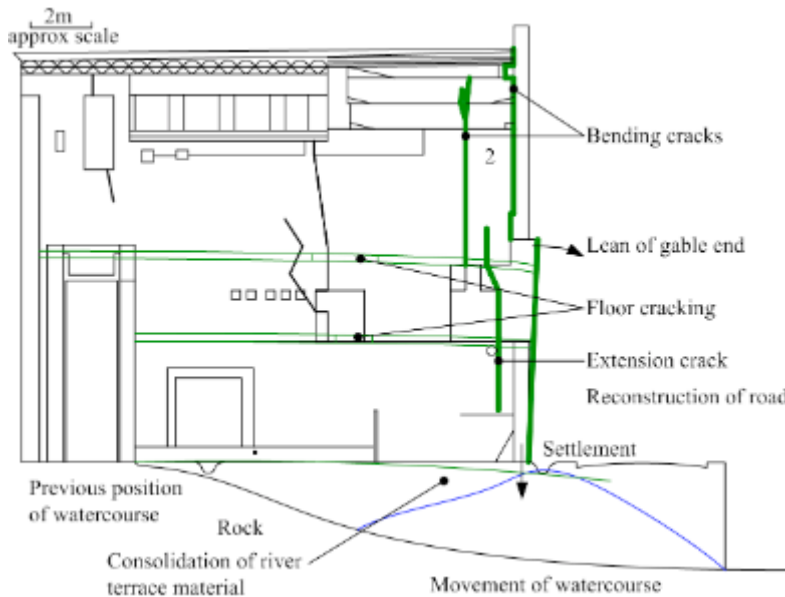
The gable end wall of the north-east granary at Ambel is showing a significant outward lean at the head of the wall, and monitoring of the cracking patterns shows that the cracks continue to open. The cause of this lean is assumed to be an ineffective retaining wall to the north of the gable wall, allowing continued settlement of the ground. The nature of the foundations of the tower is not known. As it is not currently possible to reinstate this wall, or to upgrade the road, hard intervention techniques have been used.

In the late 18th century a number of hard repair measures were already being enacted at to prevent collapse of the leaning north wall. There is no structural tie between the rammed earth north and east walls, and the brick quoin at the corners. As described above, a further storey tower may have existed at the north of the granary, and this tower may have provided a structural tie between the gable end and the transverse walls. Analysis of the architectural fabric suggests that timber buttressing was placed against the external wall, and repairs were carried out to the ceiling arches at each floor. In addition, battens were embedded at the north end of the east and west walls, spanning to the leaning north wall. Their effectiveness is questionable, as cracks are present in the wall at the south end of these timbers. This indicates that the timbers

gable end wall. This timber is causing in-plane cracking of the rammed earth wall because of the lack of a wall plate.

Fig. 3. Cracking patterns and causes, east-facing elevation of the north-east tower at Ambel

Where the cause of the structural problem has been mitigated, then a soft repair of filling of the cracks is recommended. This will not only improve the appearance of the building but also prevent water ingress. At Ambel, cracks in the centre of the long east wall are thought to have formed prior to the movement of the gable end, and have therefore been filled. The filler is brick, which would originally have matched the scored rendered original face of the rammed earth, although this is now removed. Filling with similar fallen material in rammed earth is problematic, though the column method is recommended by Pearson (1997) and other possibilities are suggested in Jaquin (2008a).

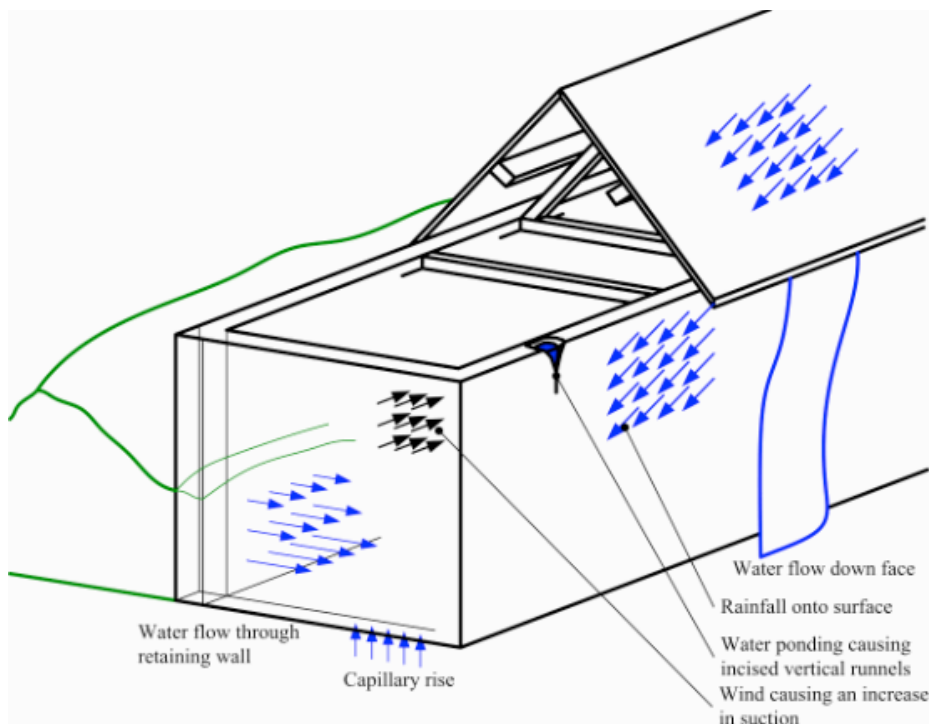
Fig. 4. Causes of damage by water

to flow down the surface of a wall. This usually happens where it is allowed to gather (pond) at the head of a wall, and flow down the face. Because of the larger volumes of water involved, the rate of water infiltration overtakes the rate at which water is removed from the wall by evaporation, and so a drip forms on the surface of the wall. This may allow the surface of the rammed earth to become saturated, and for soil particles to become suspended within the liquid and flow. This mechanism can be seen in the formation of worm cast type structures where material has first flowed into a slurry, then dried to leave mounds of fine material on the wall face. The presence of these structures indicates the downward movement of material and is thus indicative of past water flow. The likely cause of the formation of the structures is the slow downward movement of water down the face of a wall, for example a drip which is able to pick up material and transport it in solution down the wall, until such a point as the drip evaporates and the material is returned to the wall. Inspection of these structures indicates that they contain only very small particles, as it is only these which may be picked up by the water. The rate of infiltration of water into the body of the wall is sufficiently slow that the drip of water is able to continue down the face of the wall, saturating and therefore picking up smaller soil particles, before all the water is absorbed by capillary action into the wall and those smaller soil particles redeposited. If the rate of water flow is increased, such as by an ineffective drain, then larger soil particles and larger volumes of material are picked up by the water flow, and incisions form in the vertical face of the wall (Fig. 4). This mechanism involves the movement of material down the wall causes a

Repair of rammed earth walls damaged by water should only be attempted when the cause of the water flow has been addressed. It has been argued that the main repair strategy for water damage is reinstatement of the head of the wall to prevent further water flow down the face. This has taken the form of concrete ring beams for the restoration of the towers at Biar and La Rambla (Jaquin, 2008a) or as bamboo matting at Ait Ben Haddou in Morocco. If it is possible, then the roof of the structure must be reinstated, and the drainage from this correctly positioned.
