Field monitoring of soil-moisture to understand the hydrological response of a road-cut slope

Samprada Pradhan^{1*}, David G. Toll¹, Nick J. Rosser¹, and Matthew J. Brain¹

¹ Institute of Hazard, Risk and Resilience, Durham University, UK.

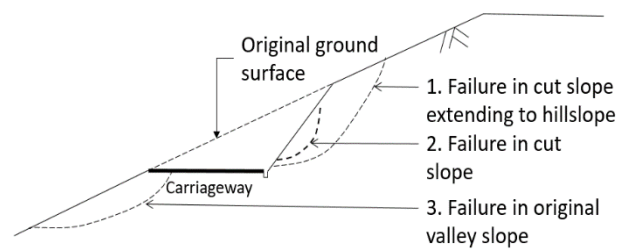
Fig. 2 Major failure types along Daklang-Listi Road (modified after [11])

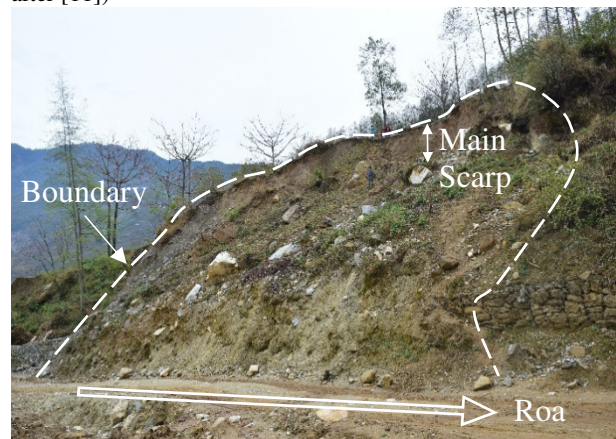
Fig. 3 Photograph of the Kanglang landslide

Length	25 m
Width	45 m
Depth of sliding surface	~1.5 m
Failure type	Translational slide [12]
Aspect	North-east
Elevation	1442 m to 1463m
Cut slope angle	~70°
Hillslope angle	~23°

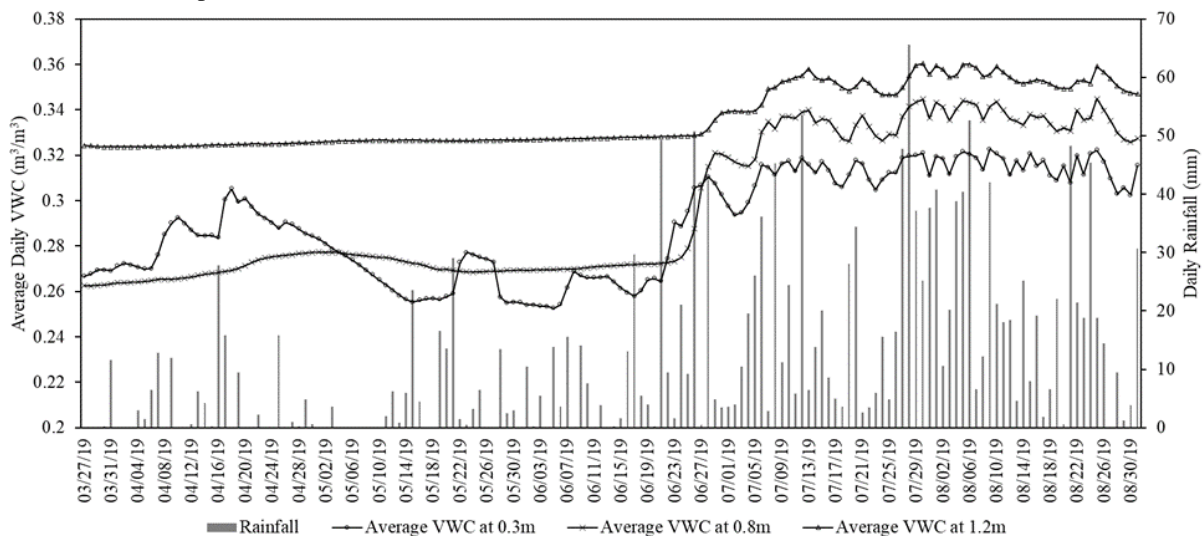
The fluctuations in the VWC at 0.3 m was found to be directly connected to the amount of rainfall. The VWC at this layer responded quickly during and after the rainfall event, which can be attributed to the presence of surficial cracks that dominate the hydraulic conductivity of the soil near the surface. In contrast, the VWC at 1.2 m depth remained almost constant (<1%

change) until 31 May 2019, which indicated that the rainwater may have infiltrated beyond 0.8 m, but did not reach to 1.2 m.

It should be noted that the VWC at 0.3 m did not increase on 15 May 2019 after the rainfall event, which was comparable to the rainfall on 16 April 2019 that caused a significant increase in the VWC. This could be the effect of the prolonged dry period that existed before 15 May 2019, which caused a significant lowering of the VWC and approximately 8% decrease in the degree of saturation (Fig. 7(a)). Such a decrease may be due to evapotranspiration and vegetation roots that take up water during drying. The effect of atmospheric drying decreased with increasing depths from the surface as shown in Fig. 7(a). As a result, the soil at 1.2 m was wetter than the upper layers, which explains the consistently high VWC at this depth until 31 May 2019.

Fig. 6 Average daily VWC (m^3/m^3) and daily rainfall (mm) between 27 March 2019 and 31 August 2019.

In the case of Kanglang landslide in July 2018, slope-cutting for road was carried out during the dry season. Due to the additional shear strength imparted by soil suction during this period, the slope may have remained stable. As observed during the 2019 monsoon (Fig. 6), rainfall infiltration in July 2018 caused increase in the VWC and hence a loss of suction can be expected in the soil layers below 1.2 m. This loss of suction, and hence loss of shear strength, consequently could lead to failure.

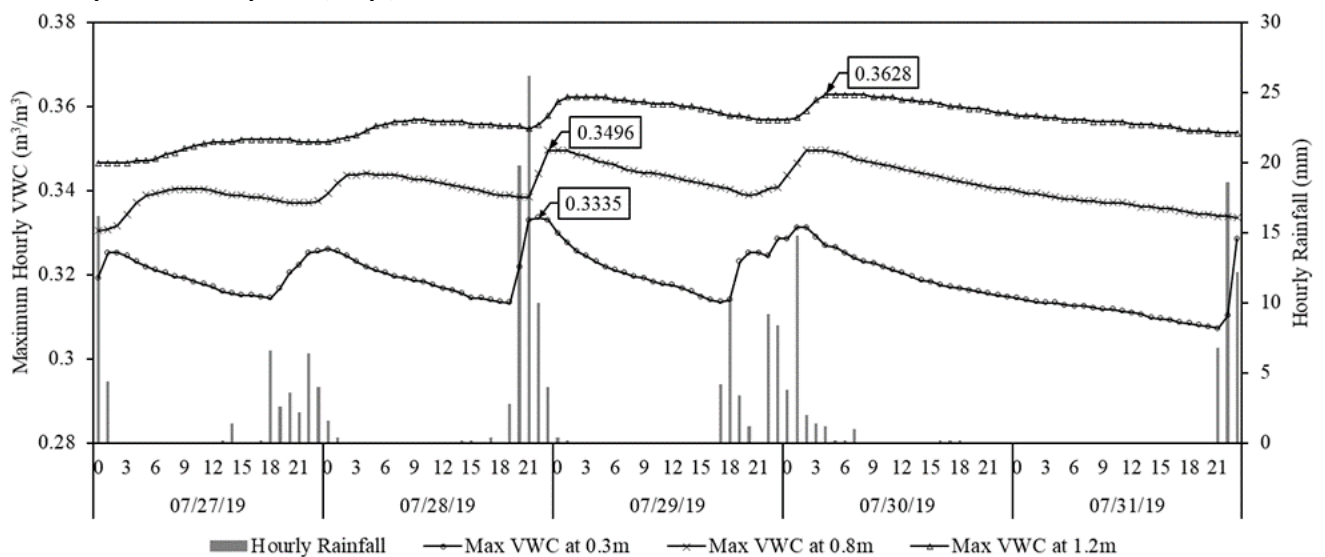
Fig. 8. Maximum hourly VWC (m^3/m^3) and hourly rainfall (mm) between 27 July 2019 and 31 July 2019

Moreover, Fig. 8 highlights the pattern of the increasing response-time of VWC with depth. In general, decrease in the VWC at the upper layer is followed by increase in the VWC at the underlying layer. Such temporal variations of the VWC increments represent the infiltration pattern in the soil. If such conditions prevail throughout the depth of the soil, the decrease in the VWC at 1.2 m on 30 July 2019 after reaching the maximum value shall be followed by a rise in the VWC in the underlying layers. This means that the soil layer below 1.2 m can have a VWC greater than 0.363 m³/m³. Since the porosity of the soil at 1.5 m is 36.40%, the soil at this layer may have reached complete saturation on 30 July 2019.
