Analysis of Tapial structures for modern use and conservation

P.A. Jaquin & C.E. Augarde

School of Engineering, University of Durham, UK

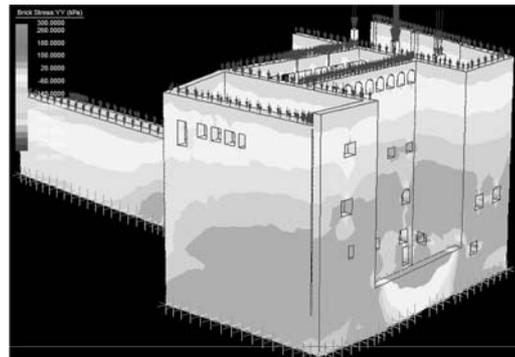
Figure 4. FE model of the building with vertical normal stress contouring.

As an example of the FE modelling, Figure 4 shows the outline of the finite element model used with vertical stresses due to roof loading only and gravity. The stresses range from 0.3 MPa to -0.5 MPa with tension positive. It can be seen that the stresses generally increase down the building, due to the high self-weight of the walls.

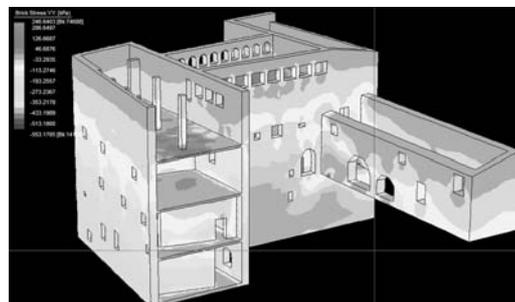
Figure 5. FE model view of the rear of the building.

Figure 5 shows the building from the south, and detailed inspection reveals raised levels of tensile stress between columns of the windows at the top of the building, and also at the floor area around the rear column in room 302. Although the vertical stresses are plotted, the floor is also carrying substantial stresses in the other two directions. The high stresses at this location are due to the floor acting as a transfer beam, as there is no support below. It can be seen by looking at the original plans that this wall is part of a 13th century tower which has been consumed by the building of the 18th century part (that part below room 303). Undoubtedly some of the effects are caused by the idealisations assumed in the modelling, especially the

introduction of the cut line to the model. On a practical level, however, the model demonstrates that this floor should be checked for cracking and deformation, as the whole column load is being transferred through this floor.

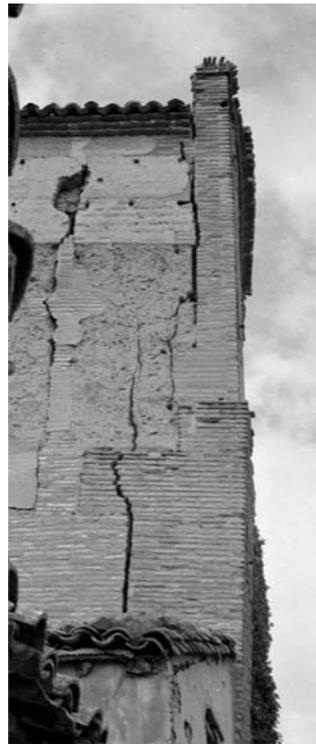
Figure 6. View of major crack in the NE wall.

Figure 6 shows the northeast wall of the building where a major crack is visible. This appears to be the worst crack in the building. Externally, the crack runs between the brick quoins which form the corners of the building, but at around 2/3rds height the main crack stops and another crack extends upwards through the brickwork and into the exposed earth. A further crack is visible to the left, running through the earth, but this is not visible within the building. The wall was built in a number of stages and has also been subjected to numerous repairs and alterations. The base of the wall was built around 1380 and extends the full distance across the front of the building. A second level was built sometime before 1550 and is fronted entirely with brick, although there appears to be a step just to the left of the ivy. A third building phase resulted in brick quoins extending the full height, with a rammed earth wall in between. This final stage actually extended one storey higher than at present and was removed during the building renovation in 1796 (Gerrard 2003).

The bottom of the north wall is leaning forward slightly when compared to the adjacent building in

which was constructed in 1960 which can be assumed to be vertical. It is assumed that the next stage of building commenced onto an already leaning wall, and that the top sections of the wall are indeed vertical. There is however the possibility that the top of the north wall is falling forward, away from the building as it does not appear tied to the other walls at the top. It is assumed that originally the top storey tied the north wall into the structure, but following the removal of the top storey, the north wall is now unsupported.

There is also no connection between the floors and the north wall as the ceiling beams run east-west, tying the east and west walls together, but allowing the north and south walls to act independently. These rooms have been used as granaries for most of their lives, therefore will have been subjected to high loading and unloading cycles, and the floor could easily have failed given the high loading. However the cracking pattern in the floor is not consistent with slab failure given a load on the whole area, but is consistent with the floor being loaded very unevenly.

The top storey was removed in order to prevent major structural collapse (Gerrard 2003). This would indicate that the cracking in the east wall were already present. What is not known is if the cracking has been stopped or dramatically reduced since 1796, is the

crack 'stable'. This can partly be guessed at by looking at the floor pattern in room 237 which reveals that there have been two major failures of the floor, with the tiling pattern changes indicating a repair. Therefore it can be assumed that the floor failed first in the centre of the room and was repaired, although beam failure rather than wall movement may have caused this collapse. Secondly the floor failed again, the crack is still present, and has been repaired by the placing of a wooden beam into the western wall. This repair probably occurred around 1800 although it is difficult to date exactly.

The reason for the initial crack is difficult to pinpoint, but one reason could be settlement of the made ground on which the wall is based. The land is sloping gently down to the north, with a made stone base upon which the rammed earth wall is built. A stream has been running across the north of the site for at least 1000 years, and while this is not very large, it is conceivable that this stream may have caused erosion, flooding or other activity leading to subsidence of the ground immediately under the tower. As the ground is already sloping, it is conceivable that the original builders made the level up in order to build the first level of the wall, which acted as a one storey building, and backs onto solid rock. After a number of years this wall was built up to three storeys, then again built up to 5 storeys. From the change in angle, it can be seen that the leaning forward of the wall occurred before 1380 and following this around 1550 the remainder of the wall was built.

The best method to prevent the cracks propagating is to pull the two surfaces closer together, but this must be

done in such a way that no further harmful stresses are developed. At present there is little published material on the structural stabilisation of rammed earth structures, although much has been published on new build, and there are many specific examples of restoration work. The present solution involves the bolting of steel I beams to the transverse roof timbers, which are then tensioned against H shaped bars fixed against the outside of the building. This solution, while appearing to work, is not ideal, in that the whole overturning force of the north wall is taken on the timber beams, and that there is a large visual impact on the front of the building.

The authors considered a number of solutions. Grouted reinforcement bars could be inserted into the north wall and travel through into the east wall. These bars could either be anchored externally in a similar fashion to the H bars present at the moment, or may be able to provide enough resistance though application of grout.

Problems involved with this technique include the fact that it has never been tried before in rammed earth structures, and tests would have to be carried out in order to ascertain the pullout strength of the reinforcement bar (the tensile capacity of the joint) and the effect of drilling a long hole into rammed earth. However this solution would prevent the load being transferred to the roof beams, and should be considered if there appears to be any failure of the roof bolts.

A tested retrofitting technique is the application of nylon strapping to provide tensile support across the crack. This strapping would have to be bolted into place, and again the effect of bolting structural elements into existing walls has never been thoroughly investigated, but would provide an easy and cheap solution to cracking in rammed earth walls.
