## The slip surface mechanism of delayed failure of the Brumadinho tailings dam in 2019

Fangyuan Zhu<sup>1</sup>, Wangcheng Zhang<sup>1,2</sup> & Alexander M. Puzrin<sup>1</sup>

The 2019 Feijão dam failure in Brumadinho, Brazil, claimed 270 lives and caused enormous environmental damage. A special feature of this failure was that it took place three years after the tailings disposal was terminated, which should have allowed sufficient time for the material to consolidate and increase its strength. Here we propose a basic physical mechanism of a delayed slip surface growth along weak layers of fine tailings within the dam body. Using accurate numerical modelling of all stages of the evolution of the Feijão dam, we show how this growth was preconditioned by dam construction and tailings discharge history and further driven by creep deformation during the post-closing stage, until the slip surfaces reached their critical length, resulting in their unstable propagation and the rapid collapse of the entire dam. Main factors controlling the time of failure have been identified, facilitating future risk assessment for decommissioned tailings dams.

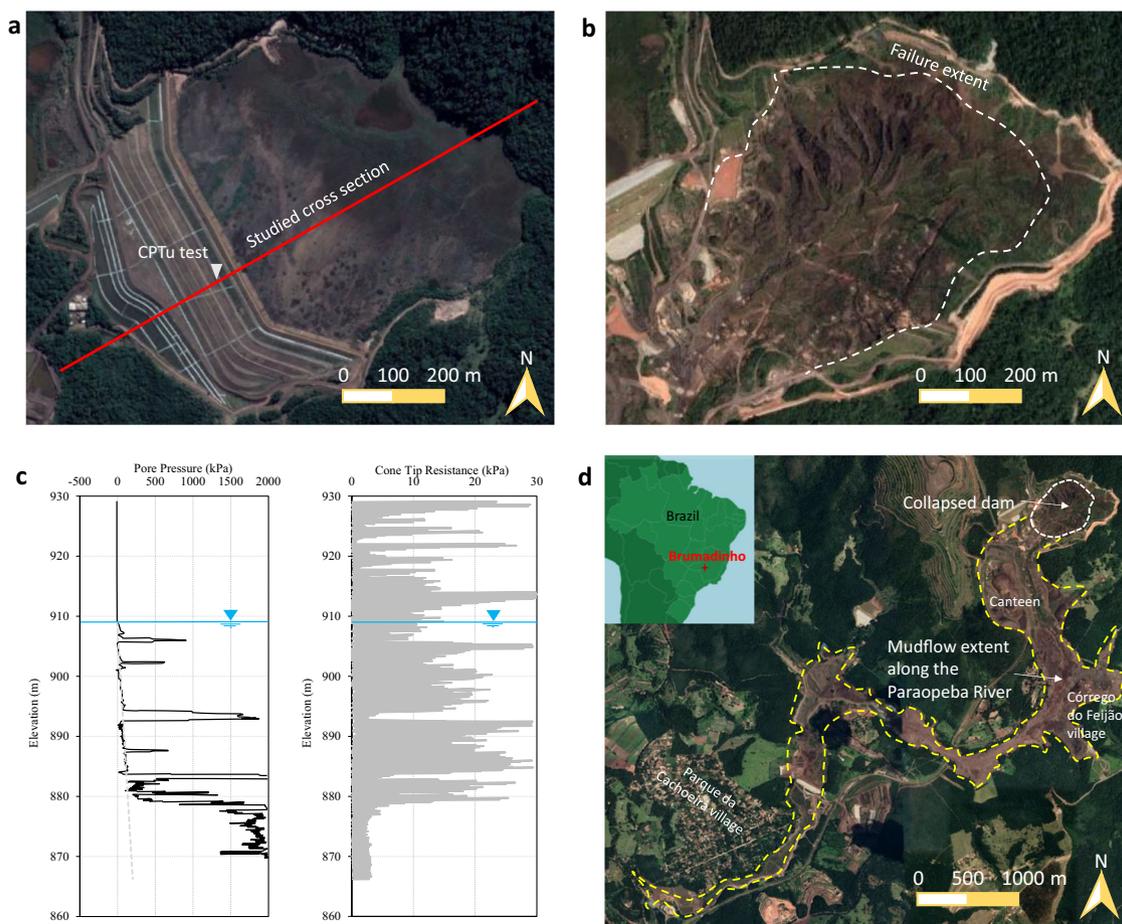
Figure 1 shows the location and extent of the Brumadinho dam disaster. The failure extended across the face of the dam and released 9.7 Mm<sup>3</sup> of stored tailings with the mudflow running through the Paroepaba River<sup>15,16</sup> and demolishing infrastructure that it came across, including a canteen where miners were having lunch. The failure occurred without any notification, despite the fact that the dam had stopped receiving tailings since 2016 and been equipped with state-of-the-art monitoring instrumentation<sup>17</sup>. Geotechnical reports prior to the failure indicated the dam was on a safe side. Despite its scale and impact, as well as the considerable effort invested into its investigation, the cause of the failure remains debated, mainly due to its delayed nature. The expert panel, appointed by Vale after the disaster, suggested that the failure was associated to the internal creep and the loss of suction induced by heavy rainfall at the end of 2018<sup>18</sup>. In contrast, the report of the Federal Police of Brazil concluded the disaster was triggered by vertical perforations in a weak point of the dam structure, which was supported by Arroyo and Gens<sup>19</sup>. The resulting uncertainty may impede avoiding similar tragedies in the future.

**Fig. 1** Satellite images taken before and after the Brumadinho tailings dam failure and geotechnical cone penetration test (CPTu) data prior to failure. **a** Image of the Feijão dam prior to failure, studied cross-section and location of CPTu test. (Source: Google Earth 3D, image dated June 30, 2018) **b** Post-collapse image of the Feijão dam. (Source: Google Earth 3D, image dated July 30, 2022) **c** Profiles of pore pressure and tip resistance from the CPTu test showing the distribution of interlayered fine tailings layers (after<sup>18</sup>). **d** Map showing the dam location and impact area of the tailings mud flow. (Source: Google Earth 3D, image dated July 30, 2022). Note: Historical images of the dam were retrieved using the Google Earth Pro with the specific coordinates of 20°07'12.05" S latitude and 44°07'14.55" W longitude.

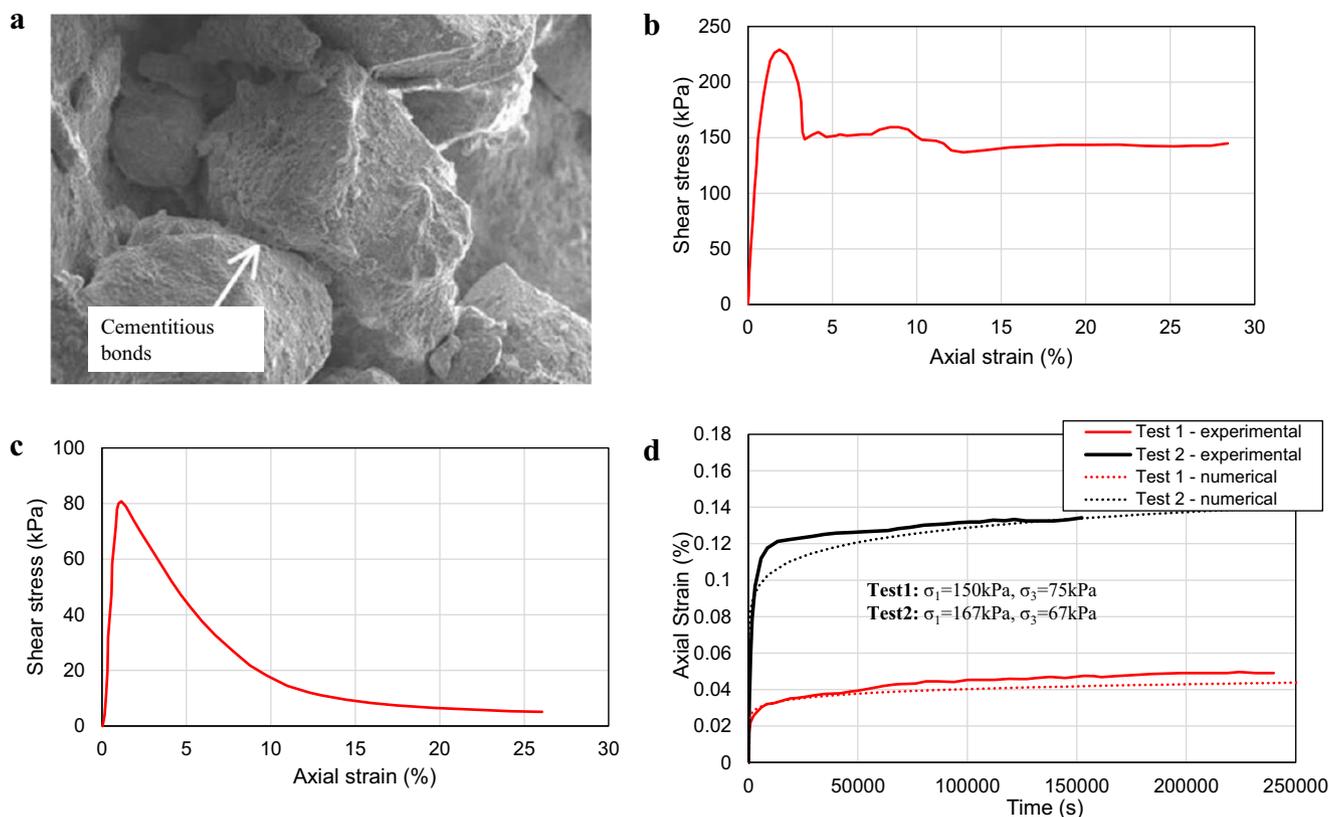
Another important physical phenomenon relevant for understanding the delayed failure of the Feijão dam is creep<sup>23</sup>. Laboratory tests showed that the Brumadinho iron ore tailings tend to deform continuously under constant stresses, with some of the tailings particles changing their positions and corresponding force chains rearranging to accommodate the external loads. As seen in Fig. 2d, the creep rate increases with the applied stress. The presence of fine particles in loose tailings also increases the creep rate. The strains accumulated due to creep are particularly dangerous when combined with the brittle tailings behaviour, because they can cause the growth of slip surfaces at constant loads, resulting in a delayed failure even if a tailings dam is in the postclosing phase without further discharge of tailings. The influence of creep in the failure of the Feijão dam will be evaluated through numerical analyses by incorporating an advanced creep constitutive model.

**Fig. 2 Mechanical behaviour of Brumadinho tailings (after<sup>18</sup>).** **a** Scanning electron microscope of tailings. **b** Stress-strain relationship under a drained triaxial test (confining pressure: 100 kPa). **c** Stress-strain relationship under an undrained triaxial test (confining pressure: 100 kPa). **d** Creep strain under sustained load.

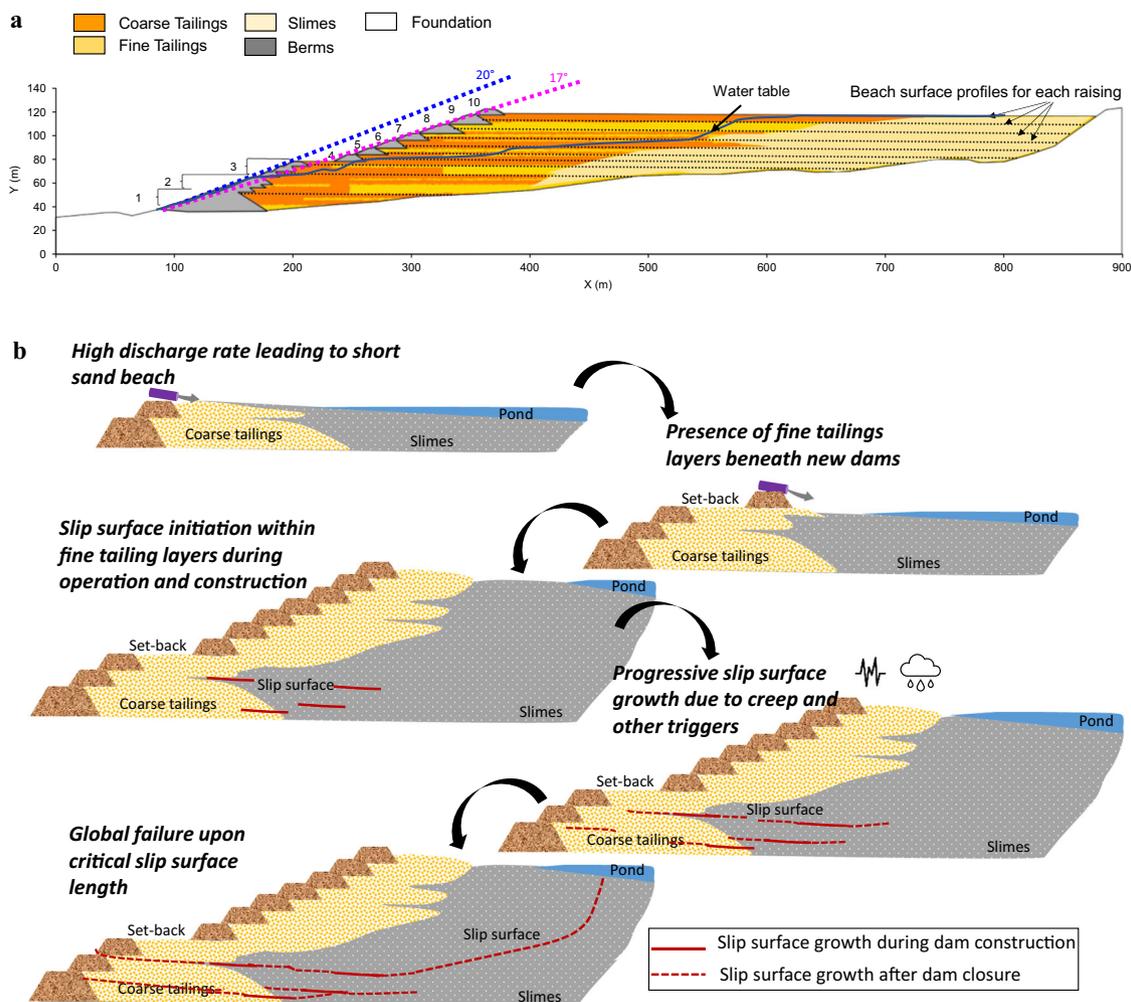
In the Feijão dam case, the fine tailings layers within the coarse sand beach (Fig. 3a) provided the locus for the slip surface. Our working hypothesis, schematically shown in Fig. 3b, is that the initial slip surface has likely initiated within one or several of these fine layers and propagated progressively under the increasing weight of the dam during its construction. The length of the slip surface within the weaker fine layers was not, however, sufficient to cause the catastrophic failure of the dam during and immediately after its construction. Since no more tailings were deposited, the weight of the dam stopped increasing and the slip surface should have stopped growing

**Fig. 3** Slip surface growth mechanism for the Feijão dam failure. **a** Layout of raisings and layering of tailing in the Feijão dam; **b** Initiation and propagation of slip surfaces during the dam construction/operation and after the closure.

We propose a mechanism of a delayed catastrophic failure of the Feijão dam (Fig. 3b), where after the dam closure, the slip surfaces continued growing within the fine tailings layers under the constant external loads, driven purely by the creep deformations. This growth was very slow, due to the slow creep rates, and yet unstable, since no increase in external forces was required. This slow process continued, until the length of the slip surface has reached the critical value, triggering the classical catastrophic slip surface propagation and subsequent dam failure. The proposed mechanism will be validated and discussed in the following sections.

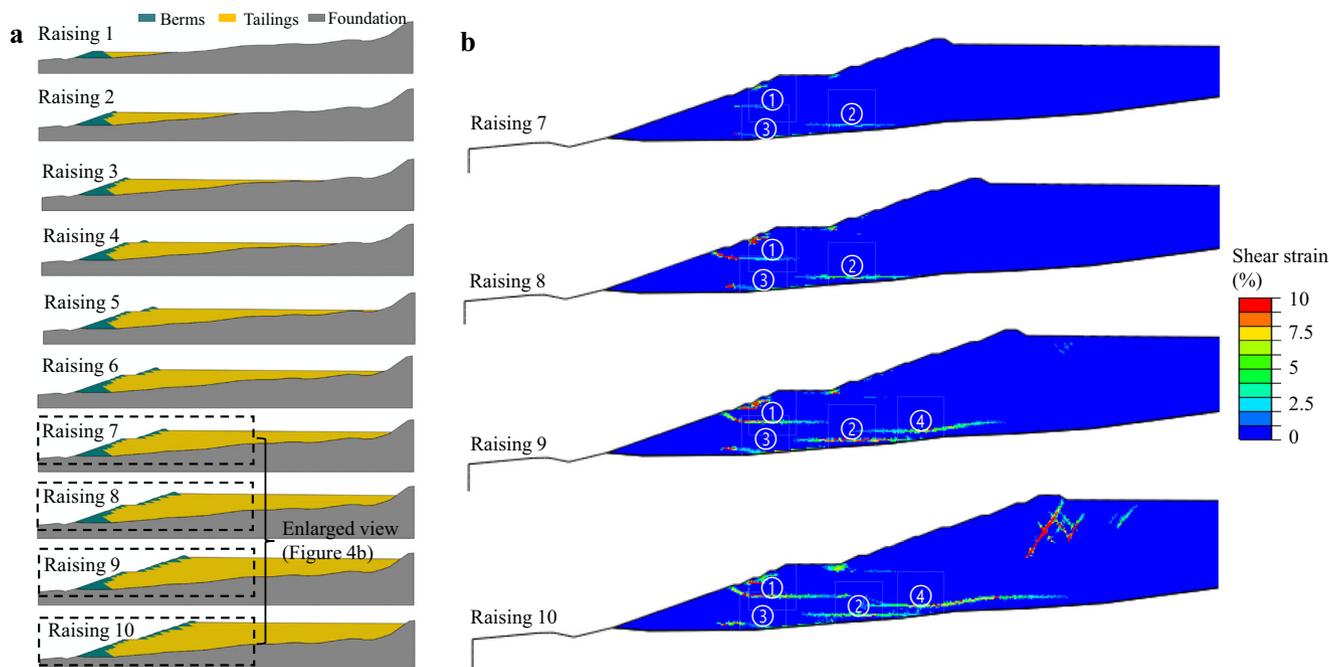
The slope angle of the first three dams was designed to be 20° to horizontal but adjusted to 17° after the fourth raising through construction of a setback (Fig. 4a). According to our numerical modelling, the initial design is not conservative and without the setback the Feijão dam should have collapsed at the sixth raising, with failure initiating from the toe. While the improvement of the centreline saved the dam, it also moved the upper portion of the dam closer to the pond and above fine tailings layers, which offered conditions for progressive growth of slip surfaces inside the Feijão dam (Fig. 4b).

Our rigorous numerical modelling allowed for capturing the stress history during the continuing raising of the dam and discharge of tailings (see Fig. 4b). The localized plastic deformation first becomes evident at the seventh raising, with the initiation of slip surfaces No. 1, 2 and 3. With further elevation of the dam, the plastic regions grow as a result of the continuing discharge of tailings, with slip surface 1 daylighting at the dam surface at the eighth raising and the new slip surface No. 4 nucleating at the ninth raising. Inspection of Fig. 4b shows that the localized failure is mainly concentrated within the regions dominated by fine tailings because of their lower shear strength. Despite the local plastic deformation, the dam remains globally stable after the completion of all ten raisings, which is in alignment with the design and consistent with observations. However, this plastic shearing significantly weakens the tailings at the slip surfaces, pre-conditioning these localized shear zones towards further growth that will eventually cause the Brumadinho disaster.

**Fig. 4 Numerical modelling of the construction and operation stage.** **a** Layouts of dams and tailings for ten raises. **b** Distributions of accumulated total shear strain at raisings 7–10.

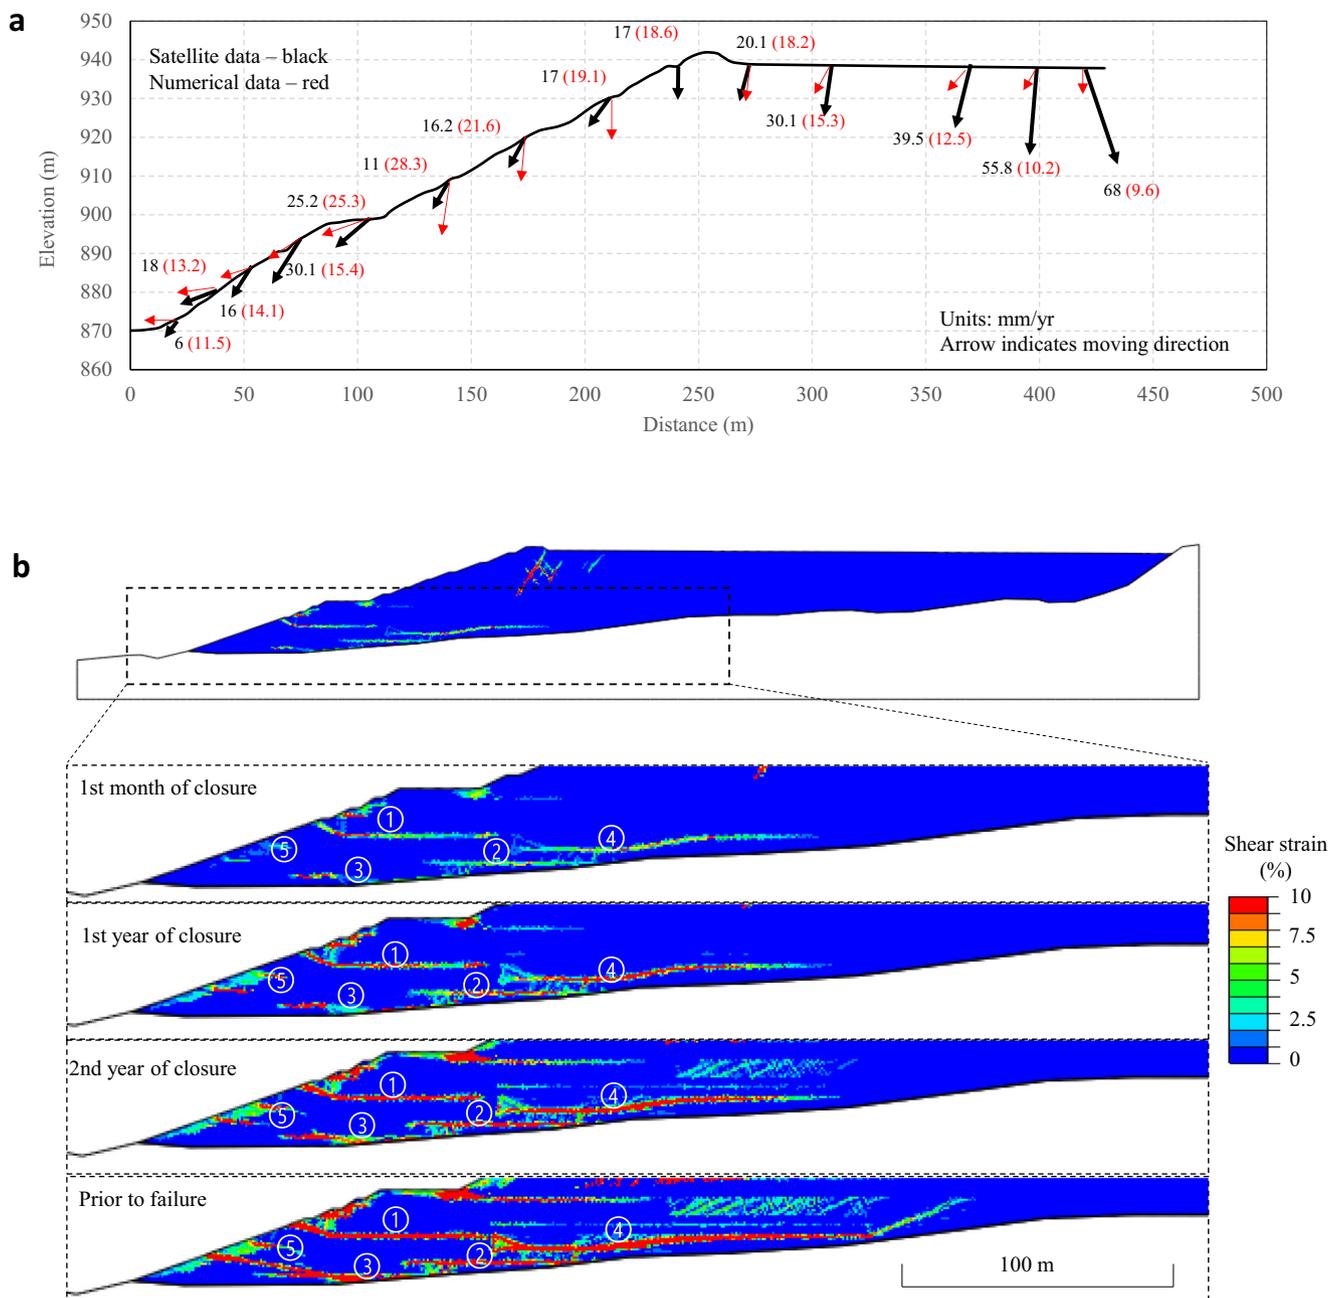
The dam maintained almost the same post-closure effective stress level for two and a half years before the collapse. Nevertheless deformations of the dam continued, driven by creep first at a faster and then at a slower rate. Figure 5a provides measured displacement of the dam surface in the year prior to the failure (2018-2019), available from the satellite images and compares them to the surface displacements predicted

**Fig. 5 Numerical modelling of the post-closure stage. a** Annual displacement in 2018-2019 obtained from numerical modelling compared to the satellite image analysis (after<sup>18</sup>). **b** Creep performance of tailings dam after the closure of the Feijão dam: total shear strain with unfavored undrained discharge history.

From the numerical modelling (Fig. 5b) it can be concluded that the catastrophic slip surface growth commenced when the combined length of the top two surfaces (No. 1 and 4) reached about 250 m. This result can be validated using the analytical criterion for the onset of catastrophic slip surface growth in a cut planar slope proposed by Zhang et al.<sup>36</sup>. The corresponding analysis has been carried out in the Methods section. It follows that for the two slip surfaces No. 1 and 4 located at the average depth of 60 m, the critical length is about 200 m. This explains why their merger and subsequent growth to the combined length of 250 m served as a trigger of their unstable propagation leading to the collapse of the dam. Similar analysis was carried out for the bottom three surfaces (No. 3, 4, and 5 in Fig. 5b) which were also merging at the onset of the failure. The critical length of a slip surface at the depth of these three surfaces (averaged at 70 m) is 210 m, which is larger than their combined length of 140 m prior to failure. This is consistent with the observation that the catastrophic slip surface growth takes place after the merging of the top two surfaces rather than of the three bottom ones.

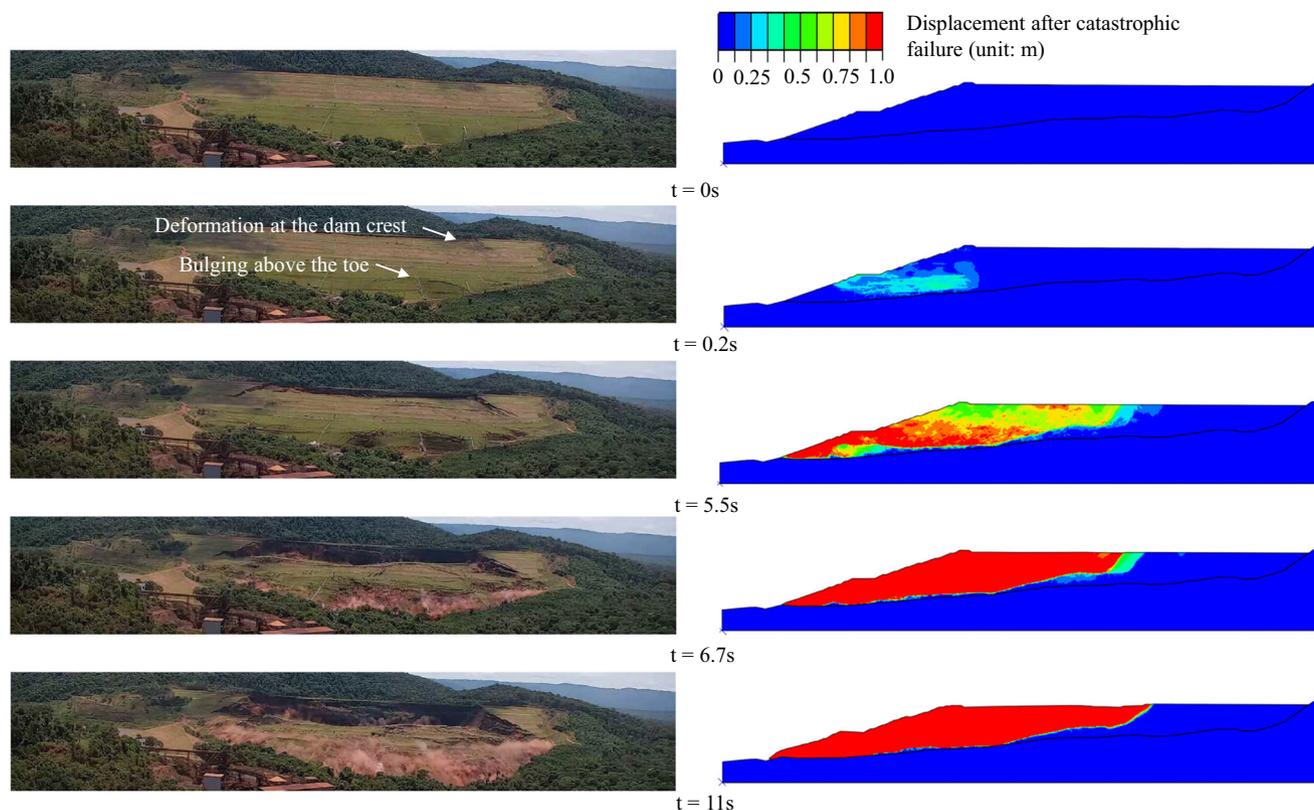
**Catastrophic dam collapse.** Figure 6 shows the simulated dynamic behaviour at the onset of collapse compared to the actual video footage. Within half a second from the onset of its catastrophic propagation, the main slip surface in Fig. 5b daylighted at the dam surface above the starter dam. This is consistent with the high-quality video images of the event where an obvious bulge can be recognised above the starter dam. The consistency of the predicted deformation pattern at the onset of failure with observations confirms that the ‘weak’ fine tailings layer present above the first raising (Fig. 1c), where the slip surface No. 1 had initiated, played a critical role in the formation of the failure mechanism. Within the following five seconds the main slip surface propagates upwards to the bottom of the pond, about 300 m behind the crest of the dam. This causes the sinking of the crest and sets in motion enormous volumes of saturated tailings, shearing and liquefying them. Comparing in Fig. 6 field maps of displacements at 6.7 s and 11 s provides evidence of retrogressive failure, which gradually removes more tailings upslope. The

**Fig. 6 Displacement evolution at the initial stage of the catastrophic failure.** Video snapshots (on the left, after<sup>18</sup>) are printed against the results of numerical modelling (on the right), for the same elapsed times after the dynamic failure initiation.

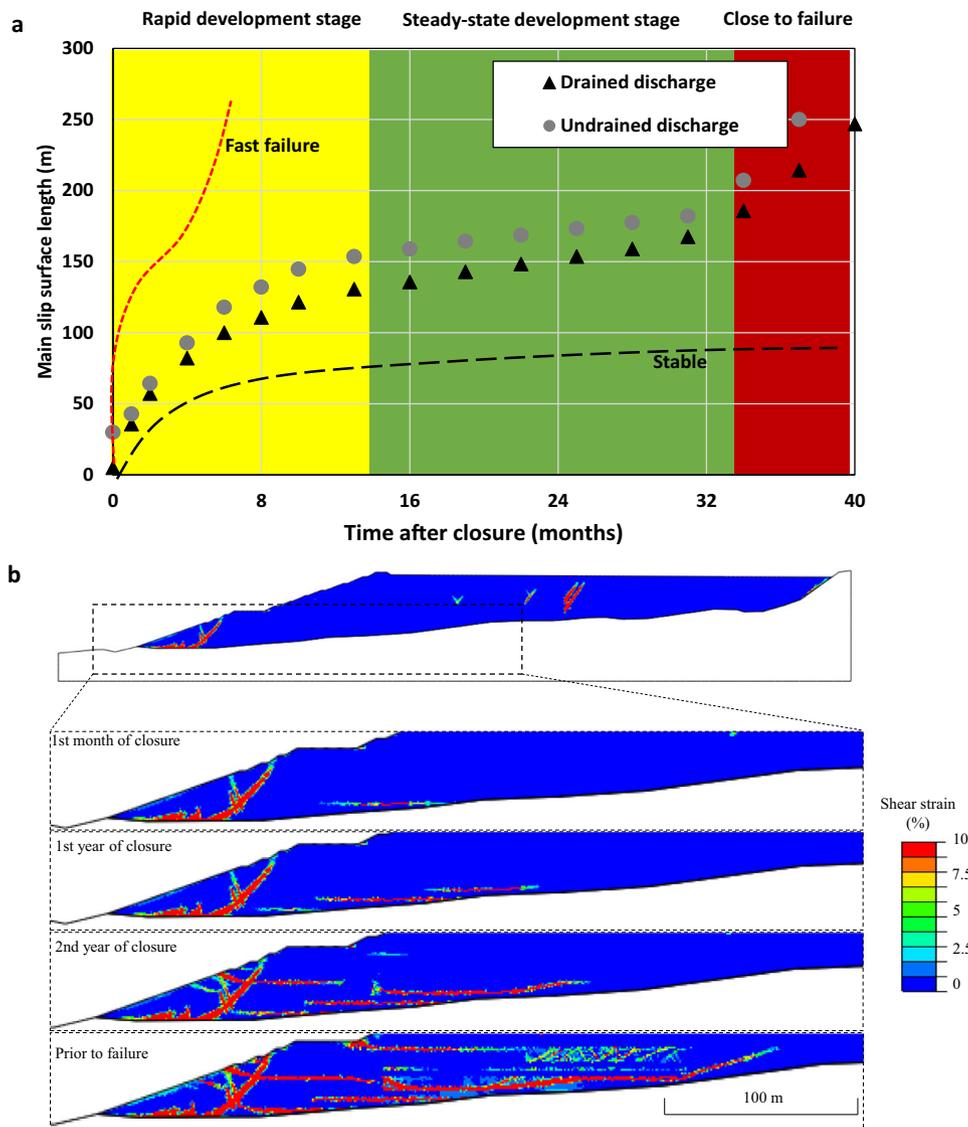
**Time to failure.** Figure 7a presents the growth of the main slip surface after the closure of the dam. During the first year after the closure, the slip surface grows impressive 130 m due to the higher initial creep rate. The creep rate decreases with time and hence the propagation of slip surface decelerates after the first year with the length increased by 50 m over the following two years, corresponding to a stable growth stage. After 32 months and prior to the failure, the slip surface saw a fast propagation due to the merging of the two slip surfaces.

Significantly, the delayed slip surface growth in the weak fine tailings layers is still active during the post-closing stage, but the catastrophic failure takes place later than for undrained discharge as illustrated in Fig. 7a.

**Fig. 7 Time to failure and effects of discharge history.** **a** Growth of the main slip surface. **b** Creep performance of tailings dam after the closure of the Feijão dam with favoured drained discharge history.
