Assessing earthquake effects on archaeological sites: the employment of photogrammetry and 3D model analysis

Paolo Forlin, Riccardo Valente, Miklós Kázmér

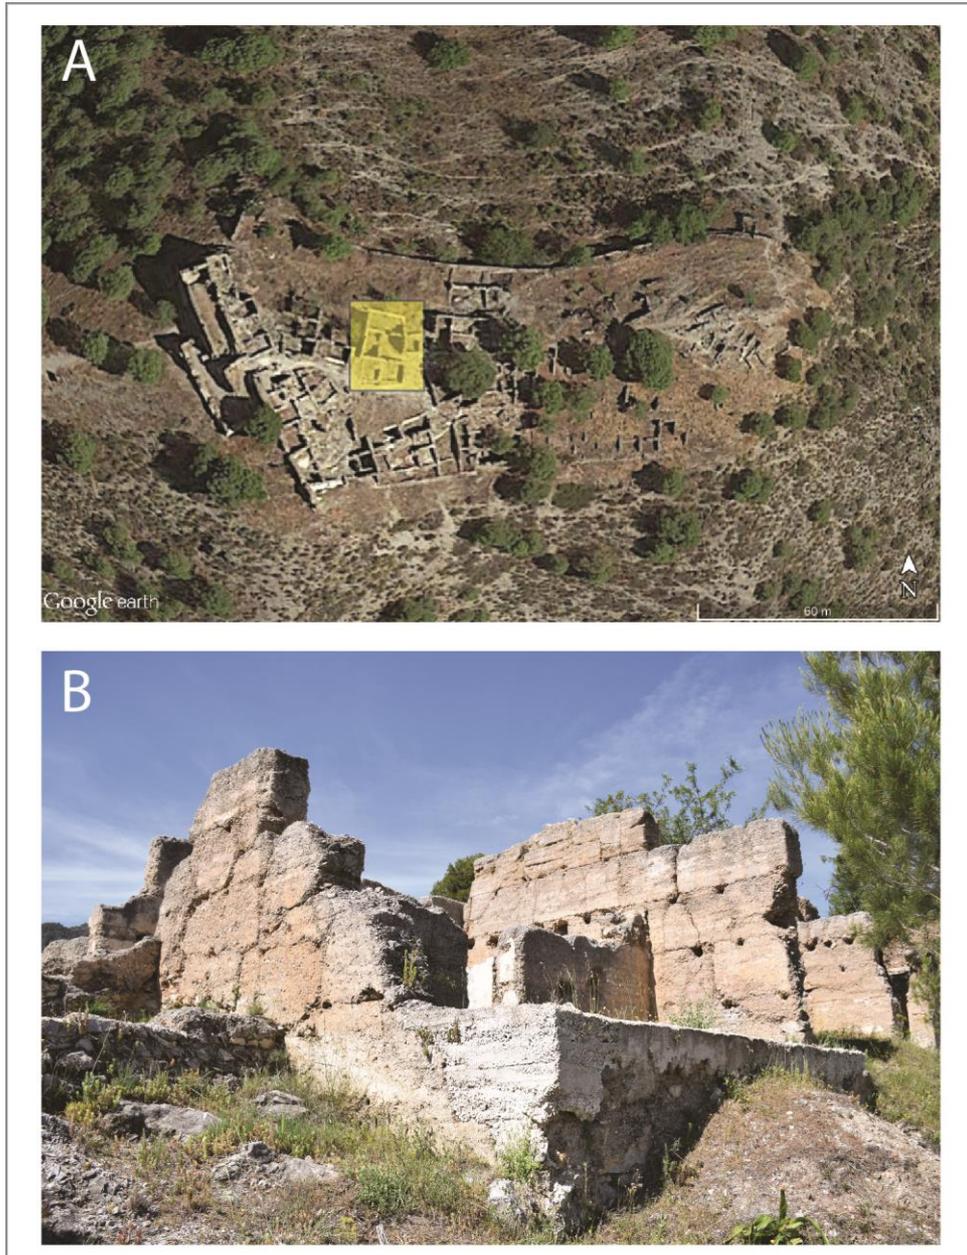
Fig. 2. El Castillejo, Guájar Faragüit (Granada, Spain). Aerial photo (© Google Earth) and general view of Building 4 from north-east.

Today, at least twelve buildings across the site are in a partially standing condition. Excavations undertaken by the University of Granada from the 1980s until 2001 demonstrate that the site was occupied from the beginning of the 11th century to the mid-14th century (García Porras, A, 2001; Bertrand et al., 1990; Malpica et al., 1985; Malpica et al., 1986; Malpica and Cressier 1989). The buildings conform to a repeated plan of several rooms organized around a central patio with at least two floors. Standing walls were built in rammed earth, known locally as *tapial*, with foundations of stone masonry. The reason behind the abandonment of the village remains controversial (one possibility is that its desertion was caused by the Black Death; Malpica and Cressier 1989), but, at some point during its occupation, possibly during the 13th - early 14th century, El Castillejo experienced a destructive earthquake. Seismic damage occurred across the site with a focus in the eastern area, which was almost completely destroyed and, unlike the rest of the site, never subsequently resettled. The western area survived the seismic event with minor damage, with clear EAEs recognisable in the surviving standing structures. Furthermore, in this area, a number of buildings and the circuit wall display evidence of the post event repairs through a later phase of *tapial*, of lower quality than the earlier phases, and the reemployment of *spolia* and material from the earlier period. The present study focuses on Building 4, a 5-storey dwelling measuring about 10m x 11m (**fig. 2B**).

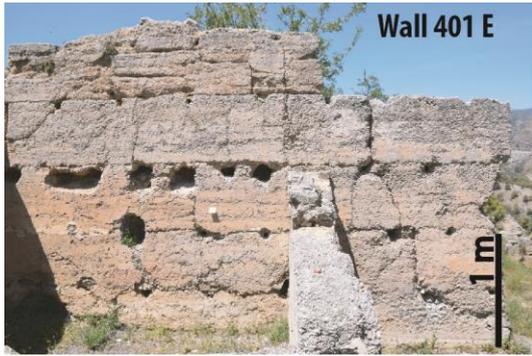
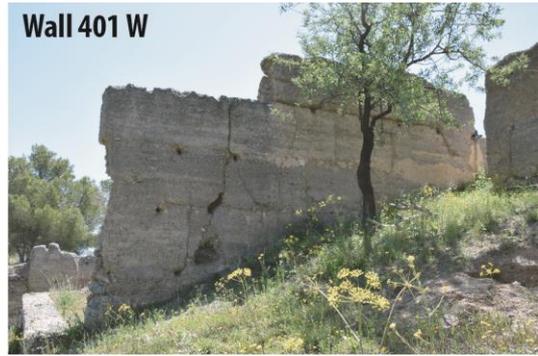
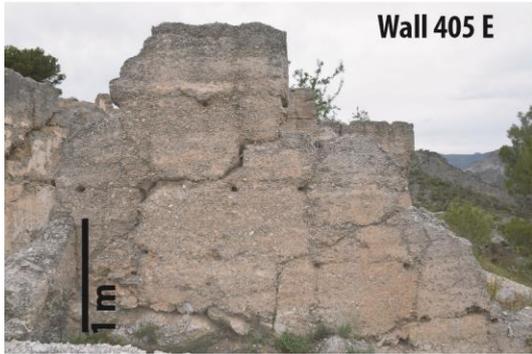
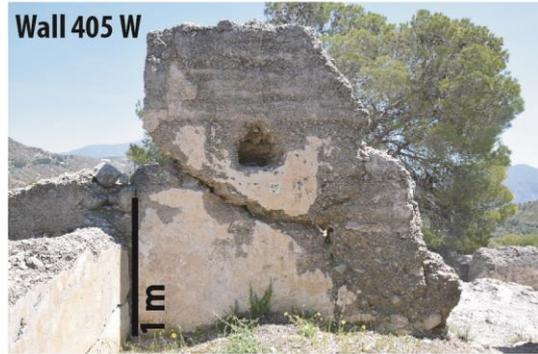
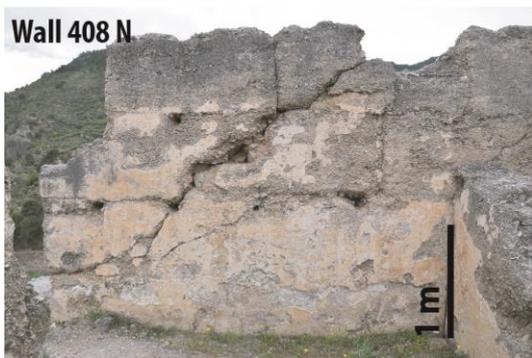
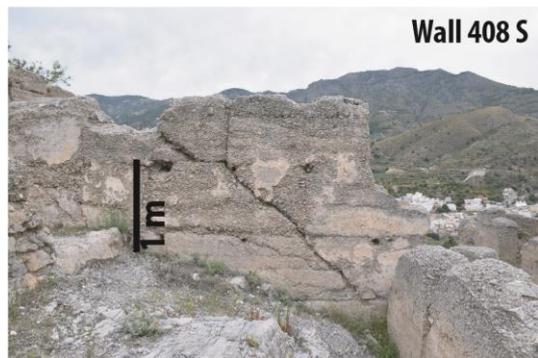
Seismic damage consists of a variety of penetrative fractures such as horizontal, vertical and shear cracks with some evidence of the shifting of rammed earth blocks (**fig. 3**).

Fig. 3. El Castillejo. Seismic damage visible on the standing structures of Building 4.

Wall 408, the southern wall of Building 4, contains a huge penetrative, shear crack crossing the entire height of the structure. It can be observed as an individual feature on the external wall (408-south), but it is associated with minor (shear and vertical) cracks on the internal wall face (408-north). The western wall of the building (405) shows other, huge shear cracks associated –as in the case with 408- with vertical, sub-vertical and sub-horizontal fractures. Wall 401, the structure's western wall, preserves evidence of seismic damage represented by a composite network of vertical, sub-vertical and horizontal fractures. The upper *tapial* block is displaced and rotated, a point which can be clearly observed from the external profile of the wall. As already mentioned, at some point the building's northern wall (404) entirely collapsed, and no EAEs are recognisable on the *in situ* foundations.

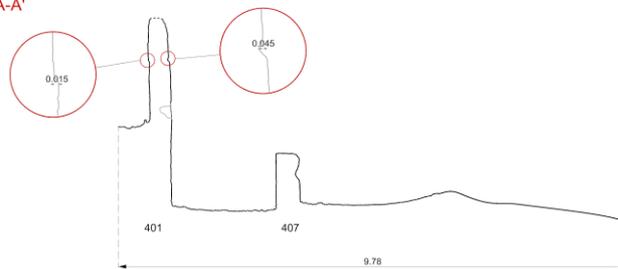
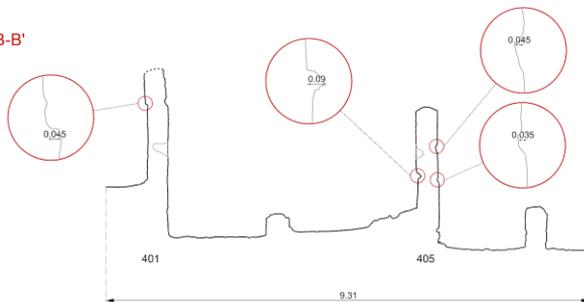
El Castillojo - Vertical Sections E/W

The vertical sections accurately reproduce the walls' profiles, exhibiting detailed seismic damage. For example, section AA' shows the profiles of cracks and a post hole on the upper part of wall 401 with another crack at the base of wall 407. Section BB', along with another two post holes, permits the clear identification of the outward displacement of the upper rammed earth block of wall 401 and a pattern of shear crack profiles in wall 405. [Section AA', wall 401: west side, 1.5 cm; east side, 4.5 cm. Section BB', wall 401: west side, 4.5 cm (displacement). Section BB', wall 405: west side, 9 cm; east side: 4.5 and 3.5 cm.]

Fig. 8. El Castillejo, Building 4. East-west oriented sections of the obtained mesh. Seismic damage is shown and emphasised by red circles. Block displacement and the depth of the penetrative fractures from the corresponding face are expressed in millimetres.

Given the height of the surviving masonry and the mechanical characteristics of the construction techniques (rammed earth), several intersecting sections were set in order to assess the different types of damage. Two parallel vertical sections oriented from east to west (A-A' and B-B': **fig. 8**) were extracted from the mesh, as well as an additional pair of parallel sections oriented from north to south (C-C' and D-D'; **fig. 9**), intercepting the majority of the standing wall of the structure. A final horizontal section was set 2.1m from the ground.

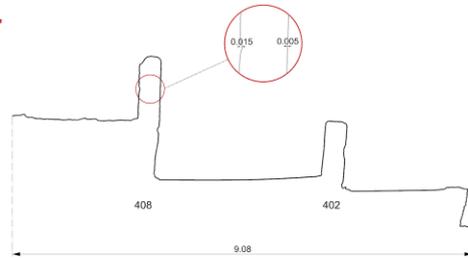
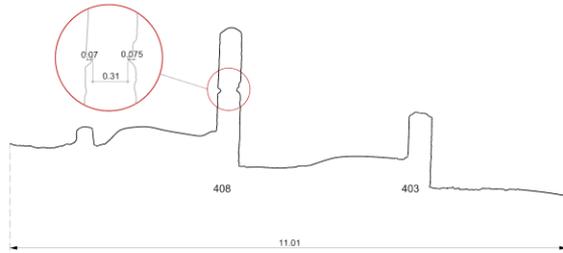
El Castillejo - Vertical Sections N/S

The north-south oriented sections CC' and DD' highlight the pattern of penetrative cracks in wall 408 as well as some very shallow damage in residual walls 402 and 403. [Section CC', wall 408: south side, 1.5 cm; north side, 0.5 cm. Section DD', wall 408: south side, 7 cm; north side, 7.5 cm.]

Fig. 9. El Castillejo, Building 4. North-south oriented sections of the obtained mesh. Seismic damage is shown and emphasised by red circles. The depth of the penetrative fractures from the corresponding face are expressed in millimetres.

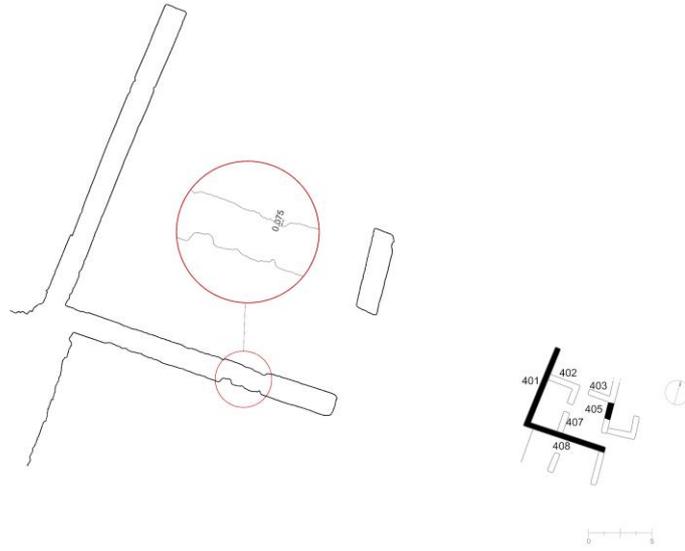
El Castillejo Horizontal Section

Penetrative cracks are also visible in the profiles extracted from the horizontal sections (**fig. 10**) This is the case with walls 401 and 408, in which the many irregularities visible along the walls' profiles correspond with the observed seismic cracks [Horizontal section, wall 408: north side, 7.5 cm]. Such profiles permit accurate measurements of the cracks within the standing structures to be taken.

Fig. 10. El Castillejo, Building 4. Horizontal section of the obtained mesh. Seismic damage is shown and emphasised by red circles. The depth of the penetrative fractures from the corresponding face are expressed in millimetres.

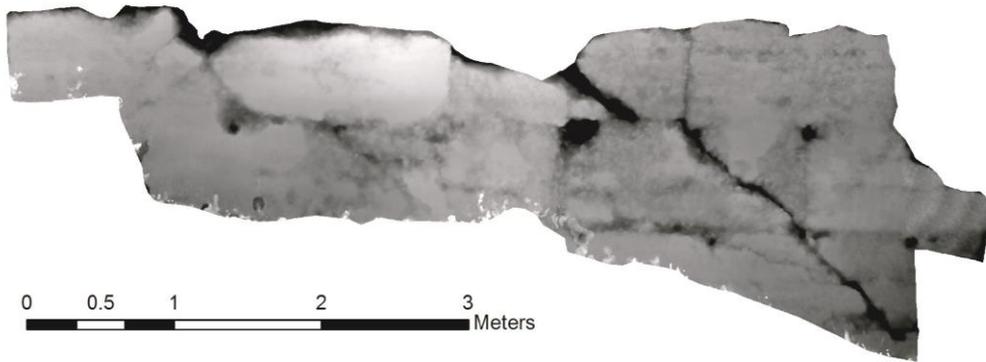
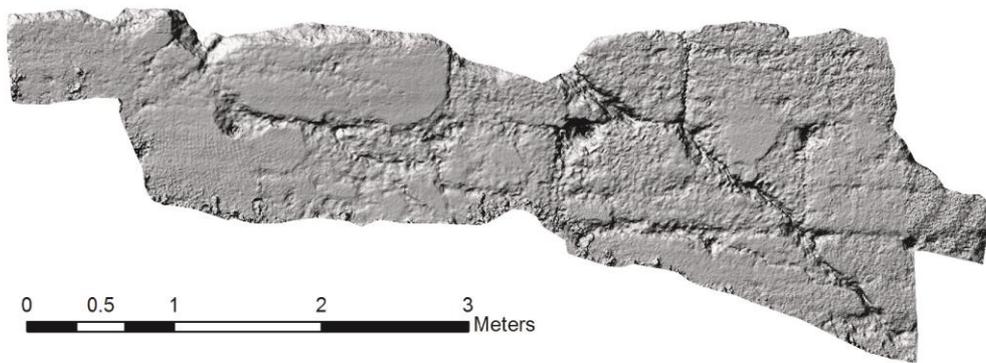
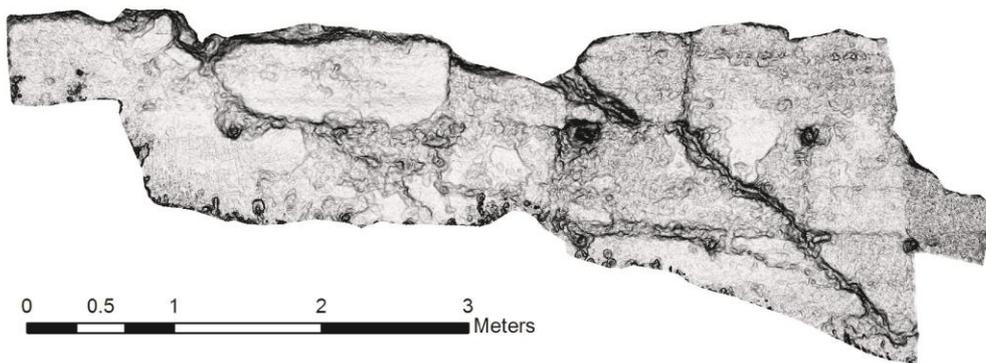
The understanding of the seismic damage pattern and its visualisation can also benefit from the extracted Digital Elevation Model (DEM). **Fig. 11** and **12** show the DEM of the southern face of wall 408 visualised in hillshade and slope mode.

Fig. 11. El Castillejo, Building 4, Wall 408 (south side). The extracted DEM (A) allows to appreciate the penetrative fractures when visualised in hillshade (B) and slope (C) mode.

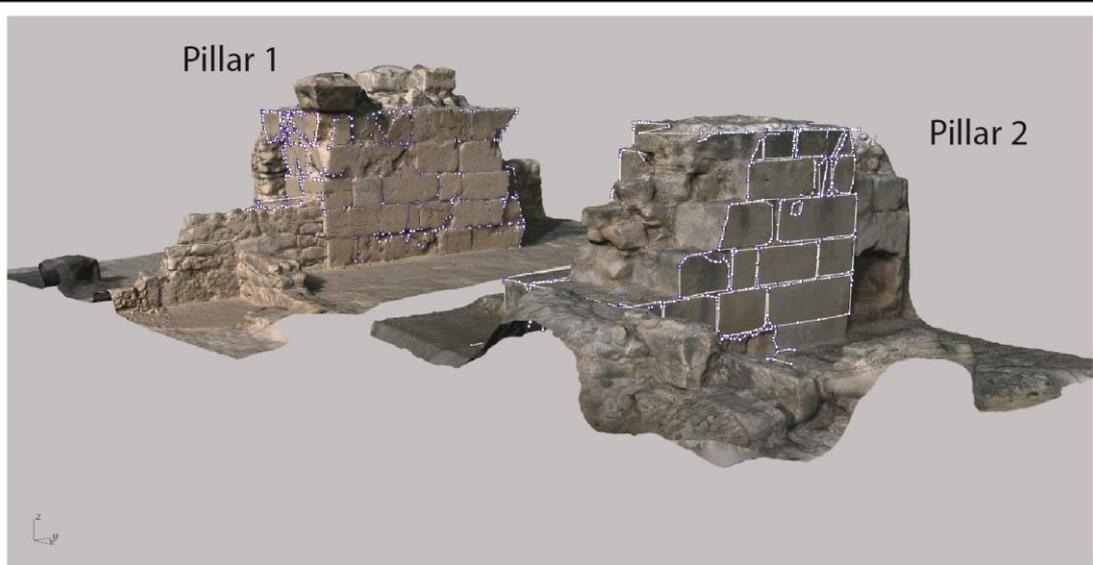
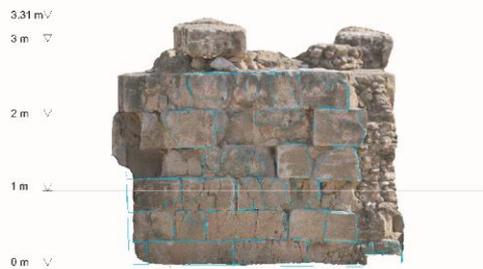
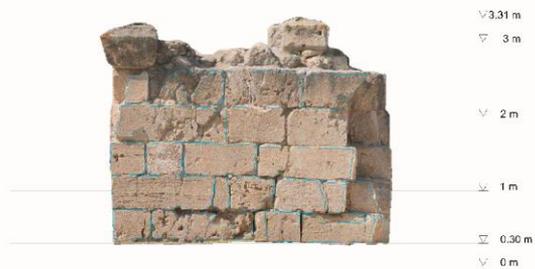
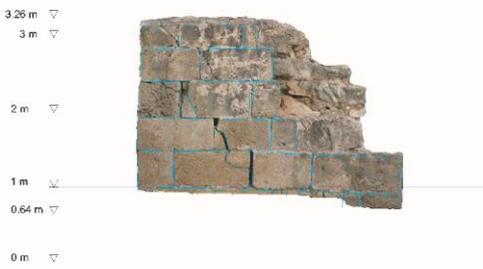
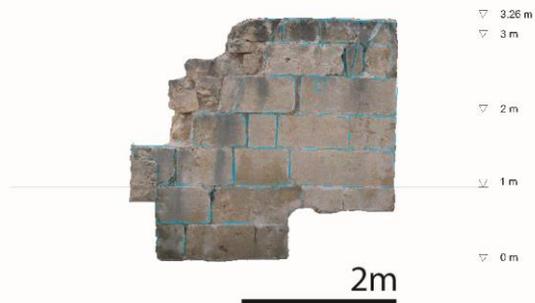
The 3D reconstructions of pillar 1 and 2 from the Crusader castle at Saranda Kolones exhibit an impressive correspondence with the stone-by-stone instrumental survey gently provided by ‘The Saranta Kolones Excavations Project’. Vector contours plotted during that survey were then superimposed on the 3D photogrammetric reconstructions of the two pillars, confirming the accuracy of both outputs (**Fig. 13**). The overall error estimated by the software is 0.013 m for pillar 1 and 0.007 m for pillar 2.

Fig. 13. Saranda Kolones. Superimposition of the vector contours plotted by the 'Saranda Kolones Excavations Project' on the 3D photogrammetric reconstructions of the two pillars.

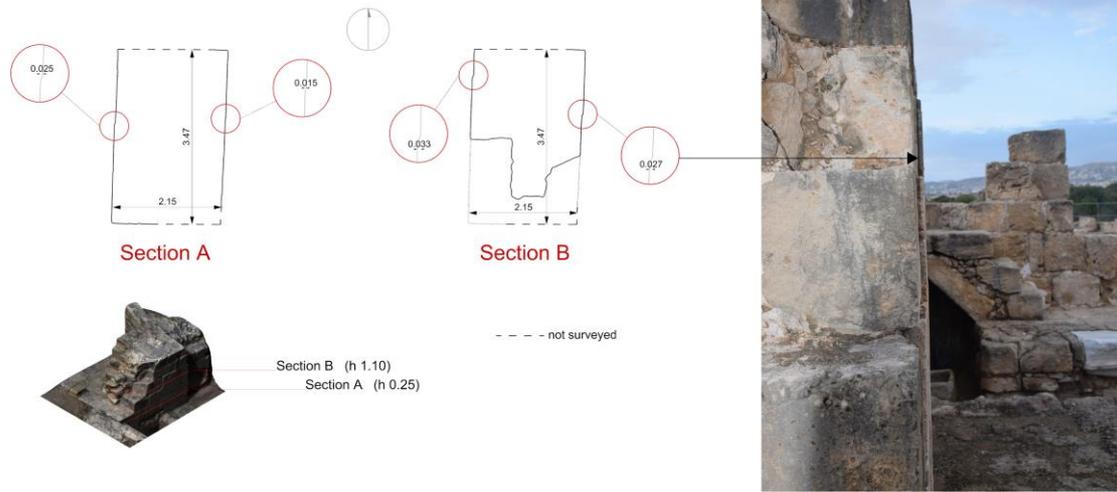
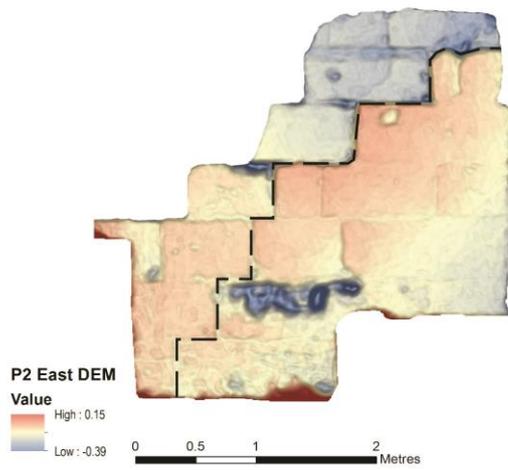
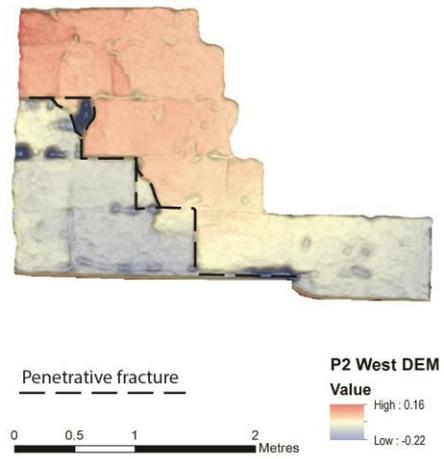
Saranda Kolones - Pilaster 2

Fig. 16. Saranda Kolones, pillar 2. Sections A2 and B2 showing centimetre-scale displacement of masonry blocks on both sides of the structure. The picture on the right records the out-of-plane shifting along the eastern side of the pillar.
