Manuscript Number: CULHER-D-15-00283R2

Title: Science, value and material decay in the conservation of historic environments

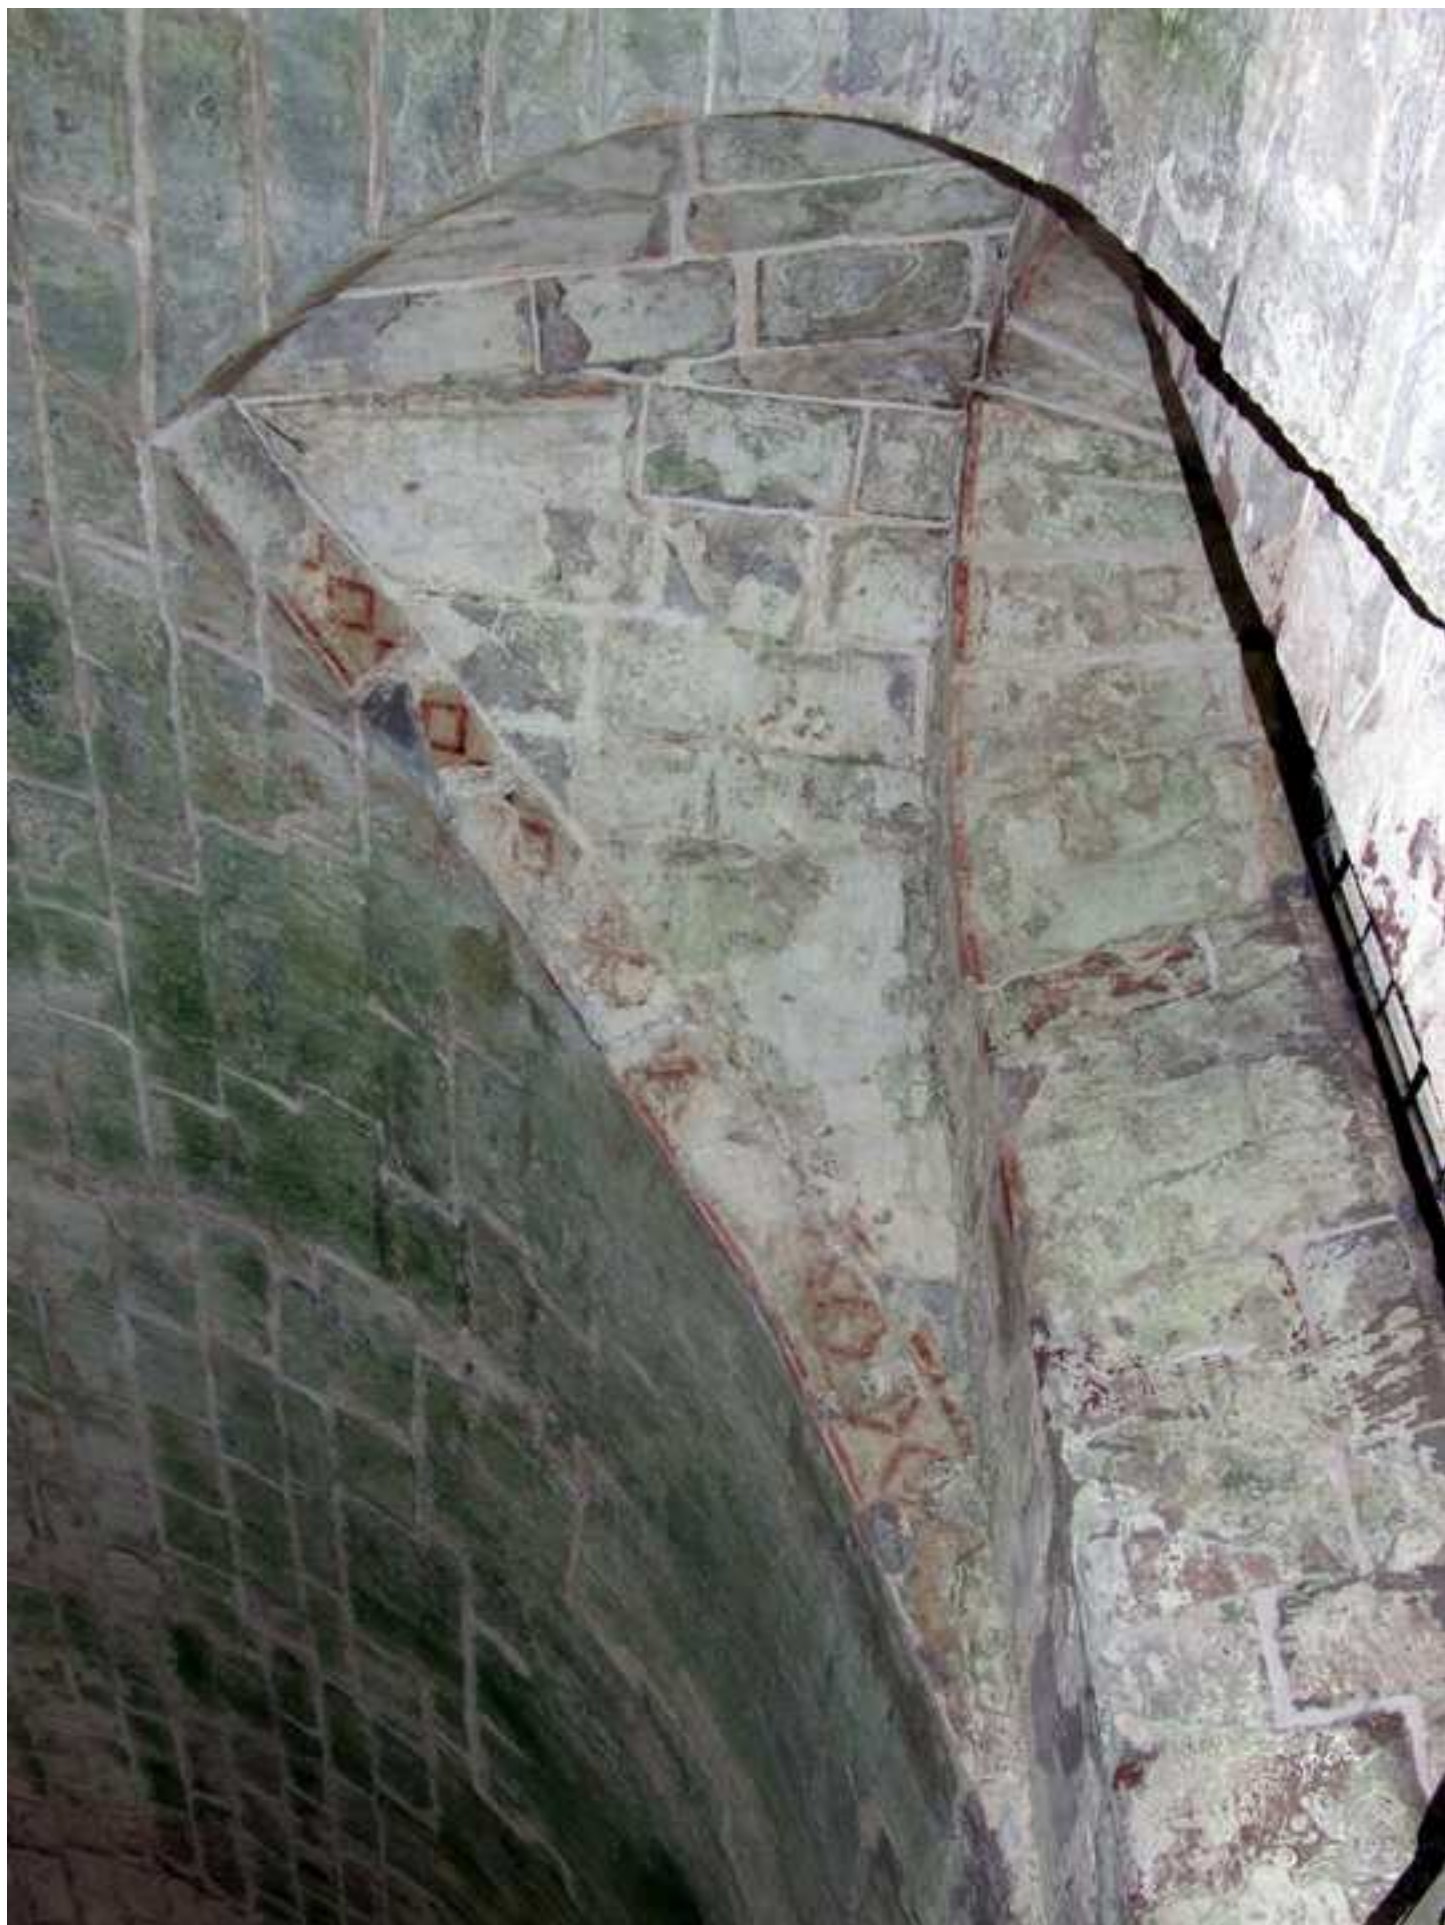
Figure 2. Part of the medieval painted ceiling in the Chapter House at Dryburgh Abbey, Scottish Borders, showing details around the east facing window. The surviving decoration is very faint. The image also clearly illustrates the greening of the stonework caused by the biological colonisation, that is the subject of periodic cleaning. The debate about the control of this surface alteration, through direct environmental control measures or cleaning, is a key conservation issue at the site. (Photograph: Maureen Young, Historic Environment Scotland).

7
8 The partially subterranean Chapter House is one of the few surviving roofed parts
9
10 of the Abbey, although it has a doorless entrance and unglazed windows. This
11
12 structure has national significance because it contains the largest area of medieval
13
14 polychromatic wall decoration in Scotland, painted with tempera onto lime plaster
15
16 (Fig 2). However, it has been at risk for some time from water ingress from above
17
18 and high air humidity. Interventions to date have included re-roofing and
19
20 waterproofing, as well as the construction of a French drain to ameliorate rising
21
22 damp. The decorations and the internal walls suffer nonetheless from colonisation
23
24 by algae and lichens. The ceiling and walls are currently cleaned using a weak
25
26 chemical biocidal treatment. This intervention is regarded by HS as an acceptable
27
28 temporary measure to control the biocolonisation, which returns requiring

40 More recent scientific research and intervention has focused on preventative
41
42 conservation. Data-loggers have been used to monitor the RH (>90%) and the
43
44 movement of condensing air. Based on this data, the introduction of a door and
45
46 window glazing, has been proposed, allowing active control of humidity to
47
48 discourage biological growths. To explore the possible effects of environmental
49
50 modification, HS conducted an experimental trial during 2012-13 in a small room
51
52 adjoining the Chapter House. The trial demonstrated that relative humidity (RH)
53
54 could successfully be controlled through this method, but painting conservators,
55
56
57
58
59
60
61
62
63
64
65

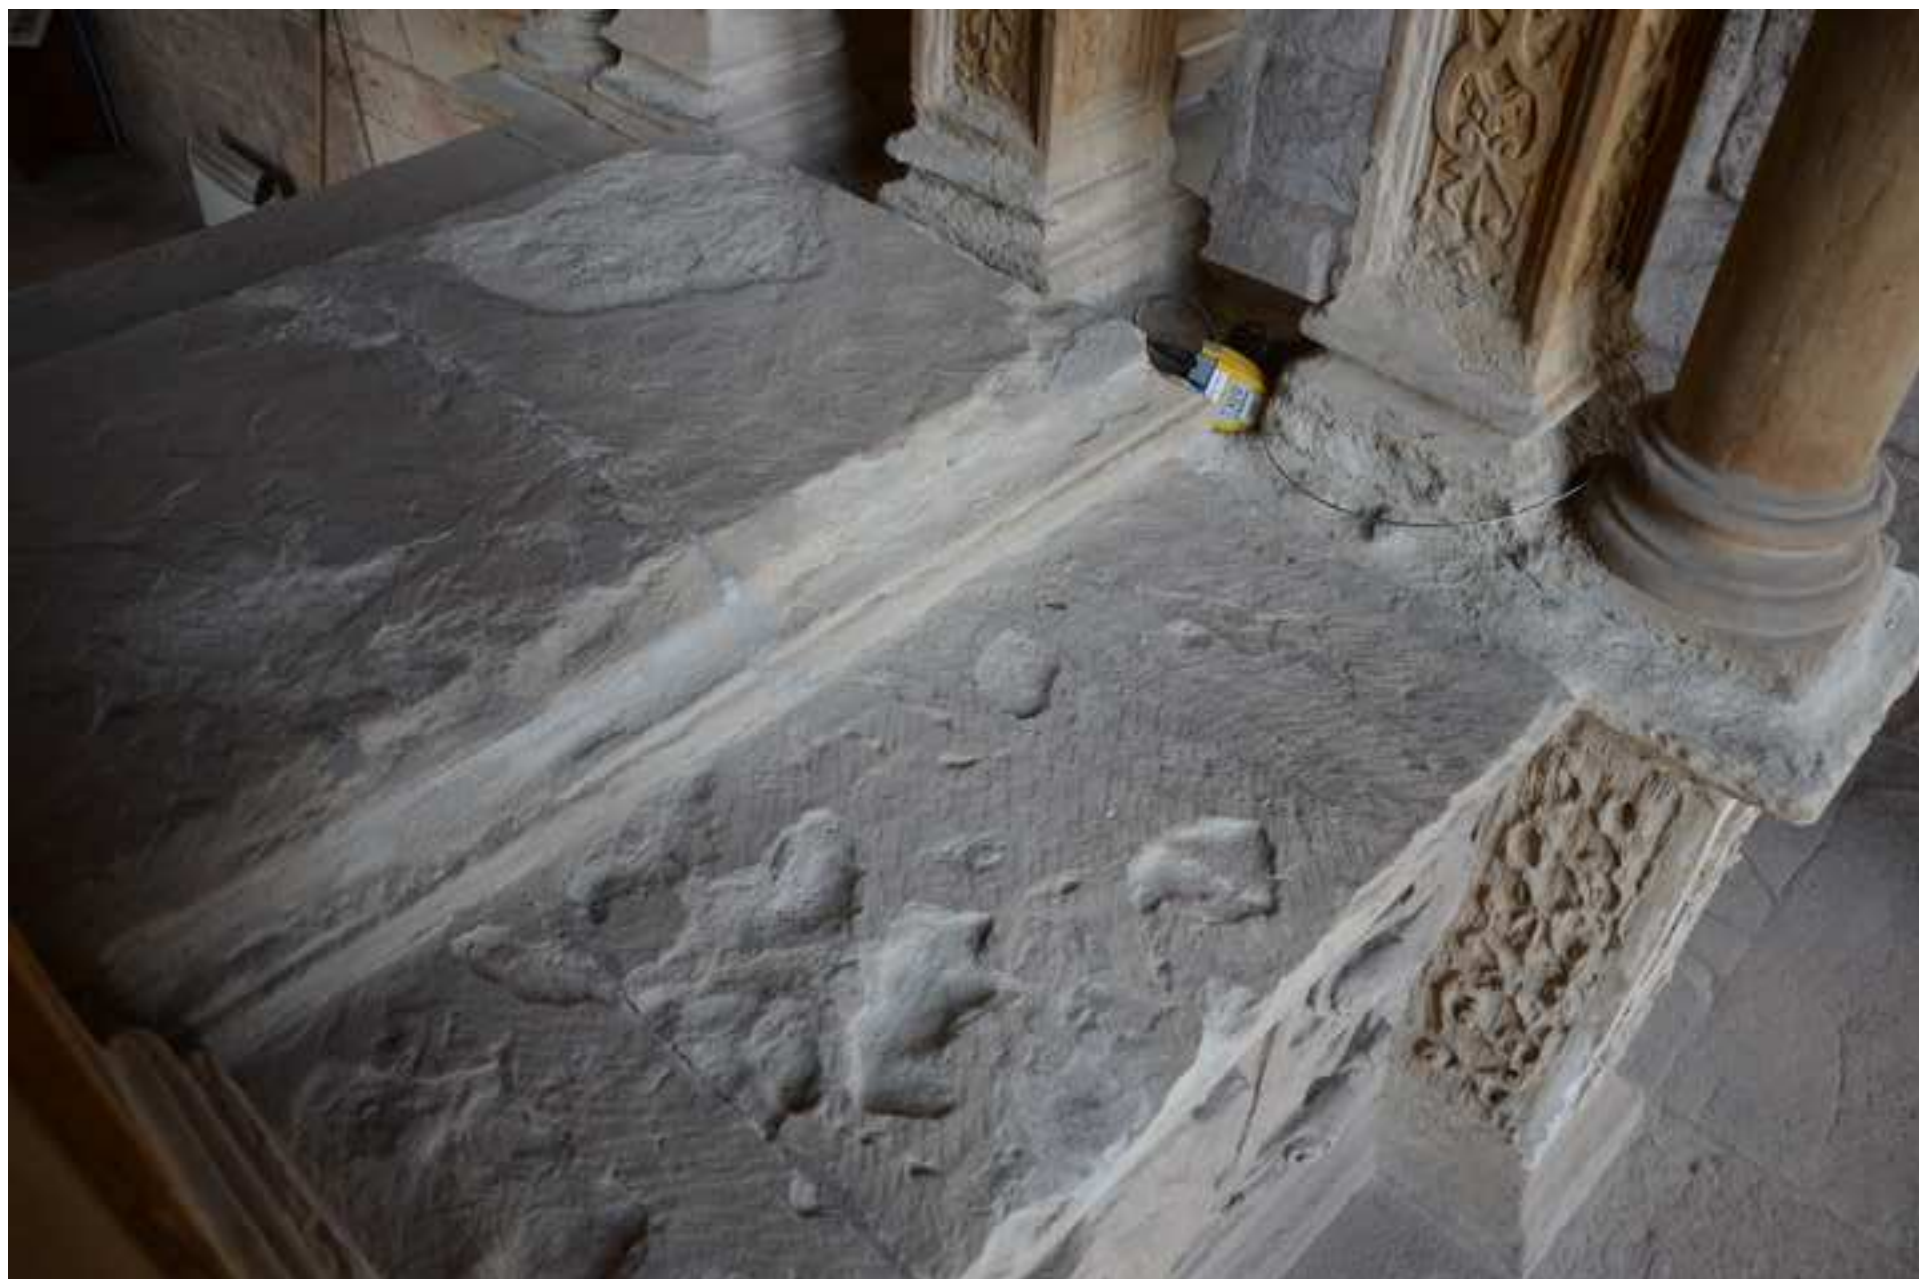
Figure 5. Decay on the top of the tomb at the Skelmorlie Aisle, Largs. Here the dense fine grained sandstone is suffering from cratering and powdering. At the centre top right of the image an environmental logging device can be seen attached to the structure, recording conditions of Temperature and Relative Humidity near to where damage is occurring. (Photograph: Maureen Young, Historic Environment Scotland).

41 The ceiling paintings are in a good state of preservation. The tomb canopy is
42
43 faring less well. Although the upper stonework is crisp, the lower parts appear
44
45 badly decayed. Granular disintegration and exfoliation (Fig 5) has been evident
46
47 since the mid 20th century, manifesting as craters, flaking and powdering on the
48
49 surface. Indeed, records show that in 1940 powdered surfaces were treated with
50
51 Magnesium Fluorosilicate with little evident success. In places, a thin crust has
52
53 formed, with disintegration continuing beneath. So far, the decay has been
54
55
56
57
58
59
60
61
62
63
64
65

1
2 attributed to high moisture levels and possible salt contamination. There are also
3
4 damp patches and salt efflorescence on the walls of the Aisle, which are
5
6 constructed from course ashlar. The south wall is a particular concern, because it
7
8 originally consisted of an internal wall with a pointed arch that was blocked and
9
10 rendered (‘harled’ in Scotland) externally after the rest of the church was
11
12 demolished.
13
14
15

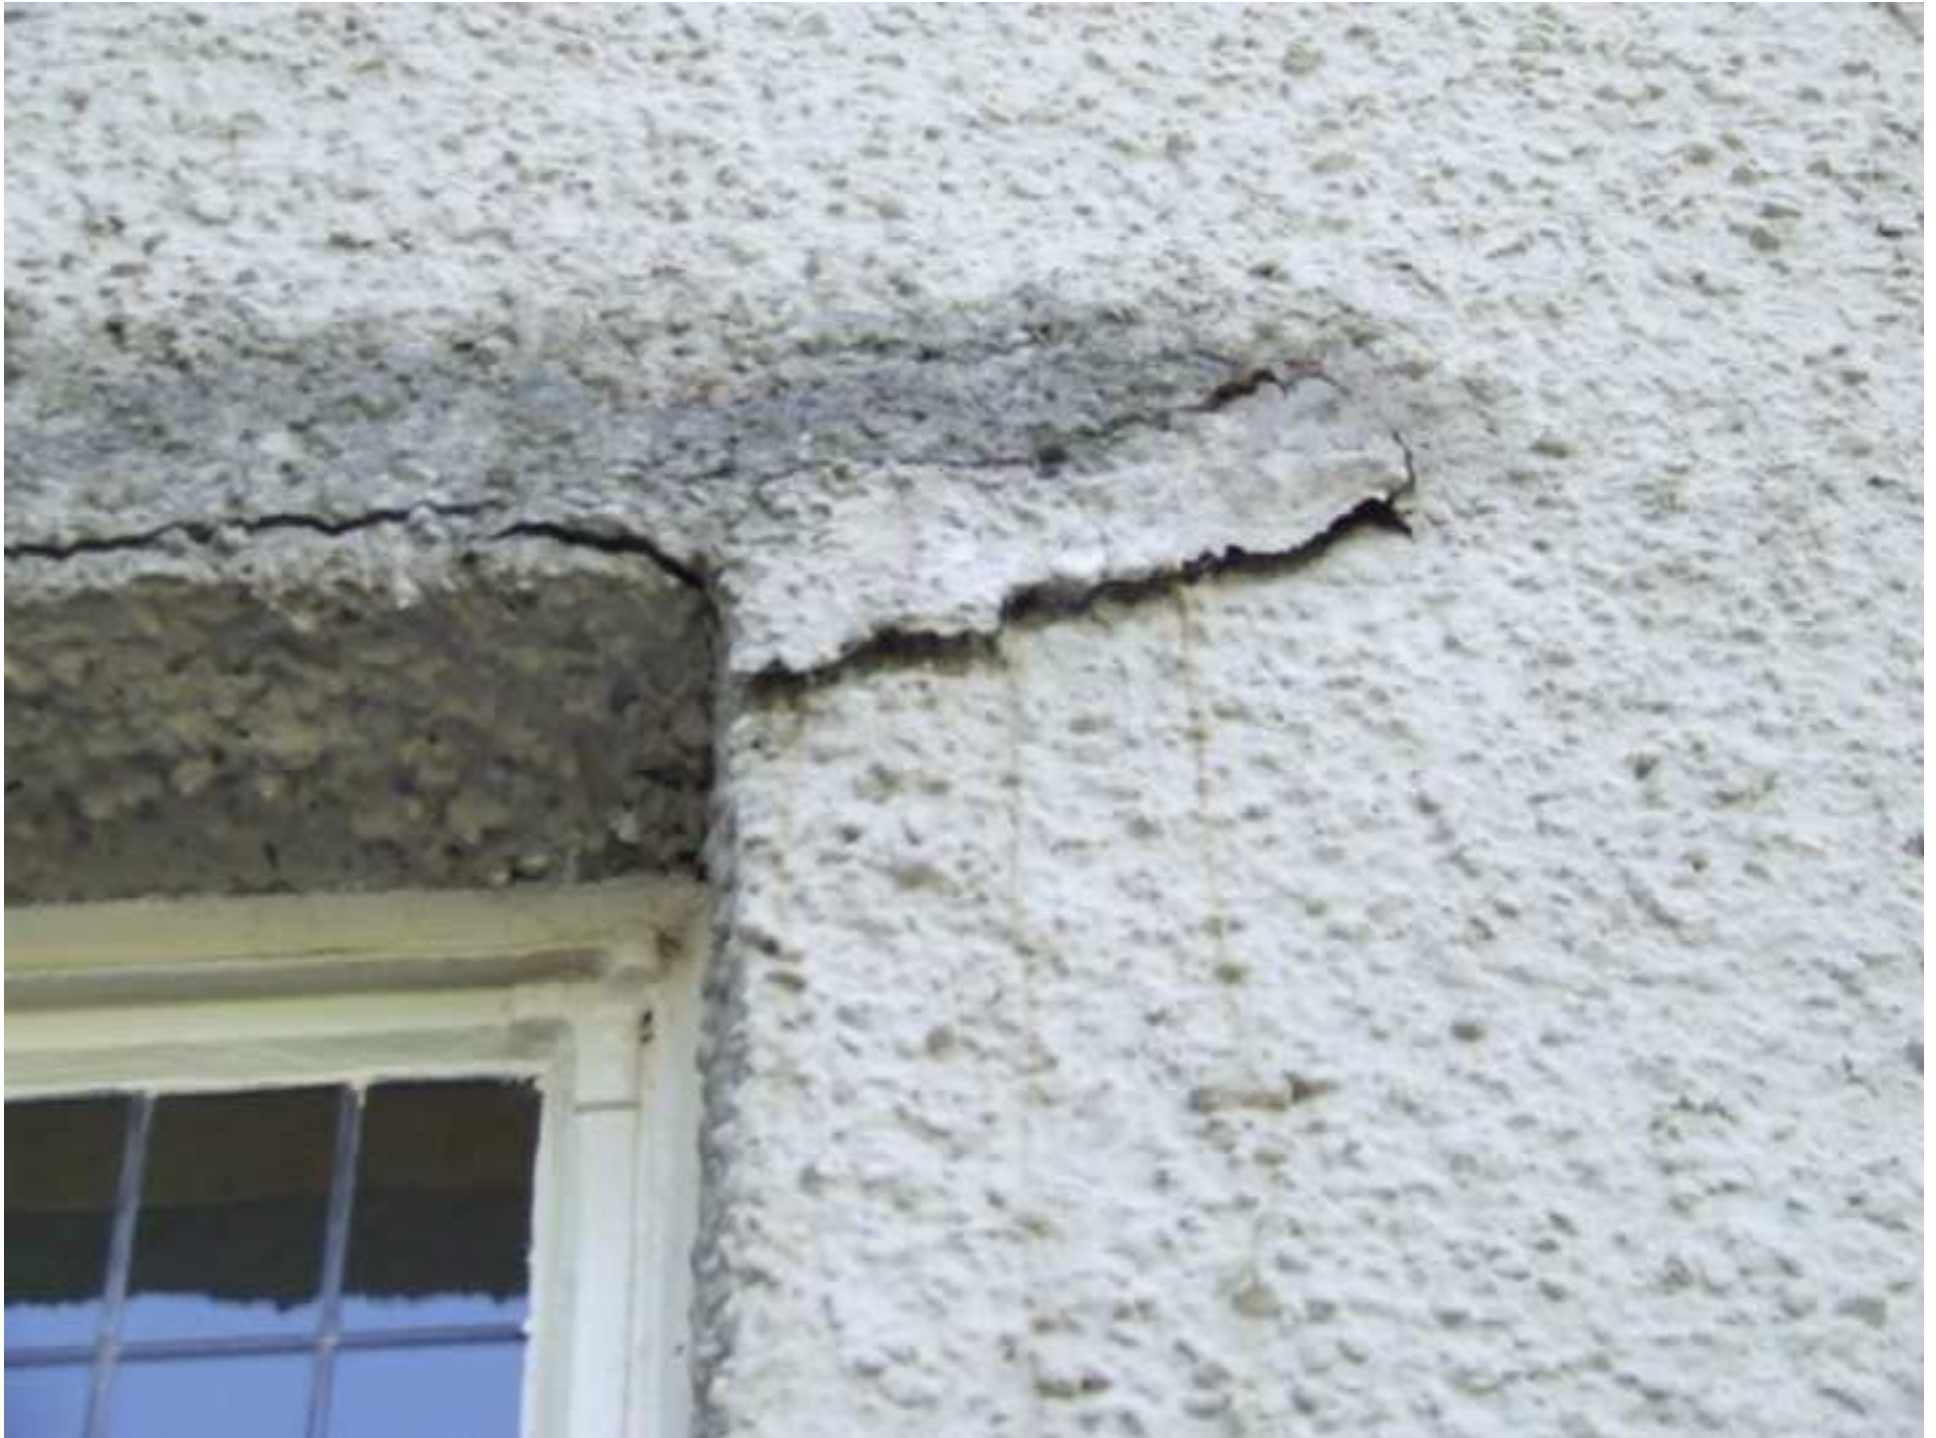
Figure 7: Example of the cracking in the Portland Cement render of the Hill House, Helensburgh. Cracking such as this allows water ingress that threatens the

1
2 and window cills. However, the inflexibility of the PC based render, compared
3
4 with a lime-based alternative, has resulted in extensive cracking (Fig. 7). PC's low
5
6 water permeability and high capillary retention traps any water ingress that occurs
7
8 through the cracks causing further deterioration of the render, exacerbated by
9
10 freeze-thaw action. In places, moisture has penetrated the whole wall, putting the
11
12 Mackintosh-Macdonald interior at risk by increasing RH and condensation,
13
14 resulting in mould growth. There have also been outbreaks of dry rot. Recent
15
16 scientific investigations have focused on investigating the condition of the fabric
17
18 of the building using materials analysis (petrographic thin sections and XRD) and
19
20 thermography, alongside traditional engineering and condition surveying. The
21
22 internal environment is being monitored with Hanwell recorders documenting
