Title: Sediment erosion dynamics of a gullied debris slide: a medium-term record

Article Type: Research Paper

First Author: Richard Johnson

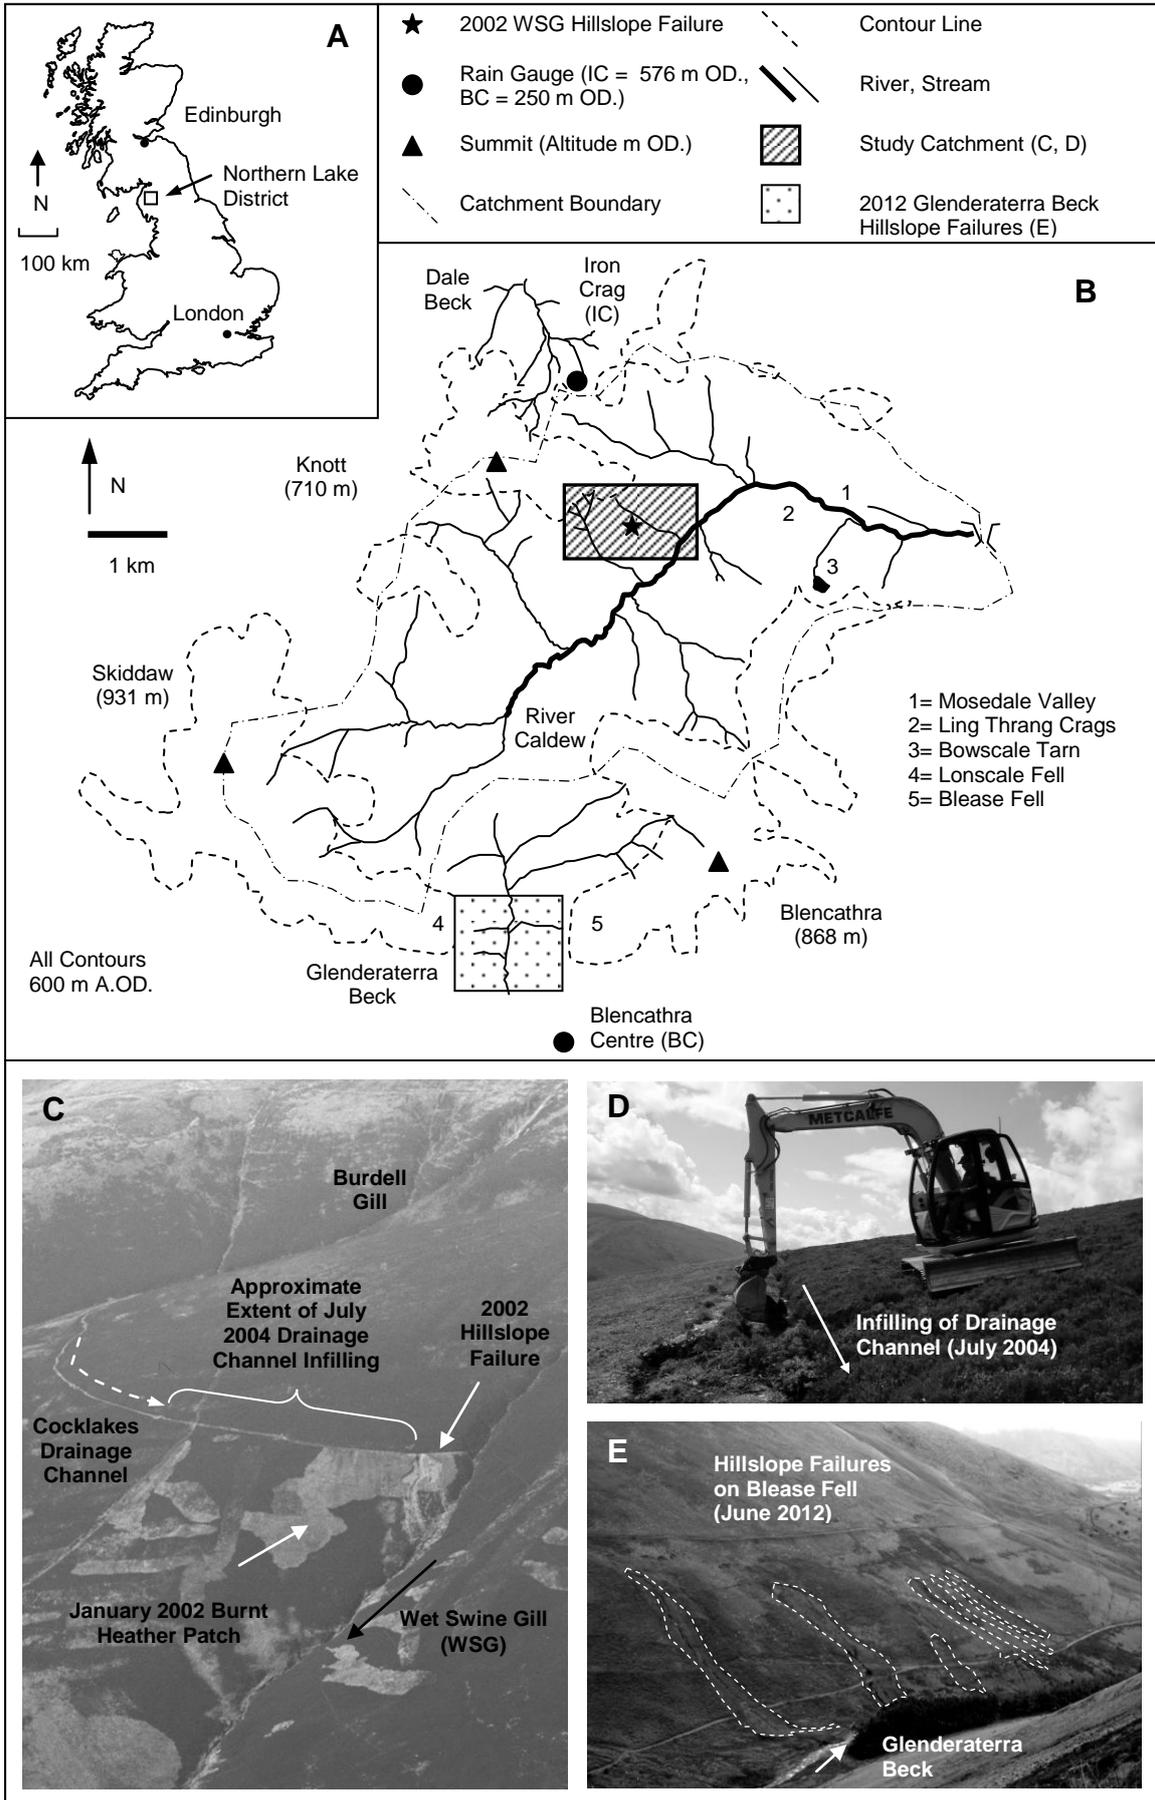
Fig 1

Figure 1 The location of the Wet Swine Gill hillslope failure. (A) Northern Lake District in Northern England, (B) Upper River Caldew Catchment, (C) Oblique aerial view of the Wet Swine Gill catchment looking east to west (Photograph April 2005), (D) Infilling of the drainage channel near the hillslope failure (Photograph July 2004), (E) Hillslope failures on Blease Fell (Photograph, July 2012).

13 The overlying soils in the catchment are a mosaic of raw oligo-fibrous peat and
14 lithomorphic humic rankers (Soil Survey of England and Wales, 1983).
15 Vegetation is heather (*Calluna vulgaris*) and bilberry (*Vaccinium myrtillus*)
16 dominated moorland heath with broadleaved woodland in adjacent streams
17 (LDNPA, 1997) and bracken (*Pteridium aquilinum*) at lower elevations. The
18 heather moorland habitat is managed using controlled burning, especially in the
19 Cocklakes area (LDNPA, 2001, 2002; Ratcliffe, 2002) (Figure 1 C).

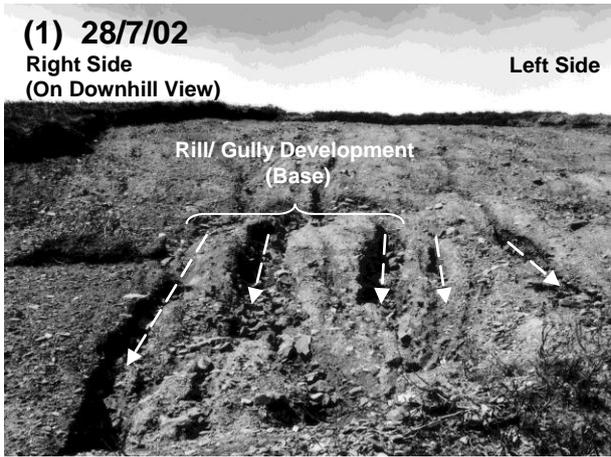
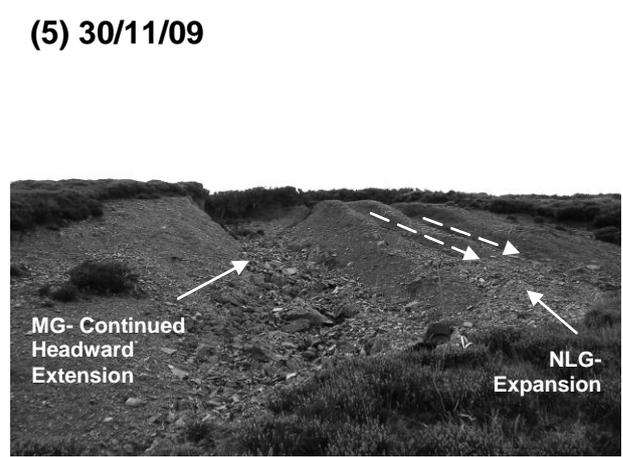
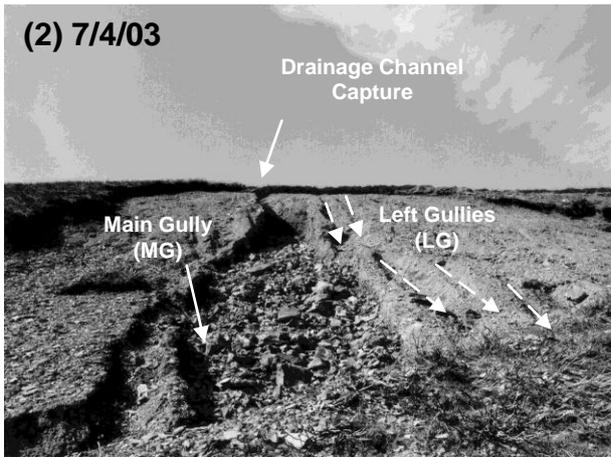
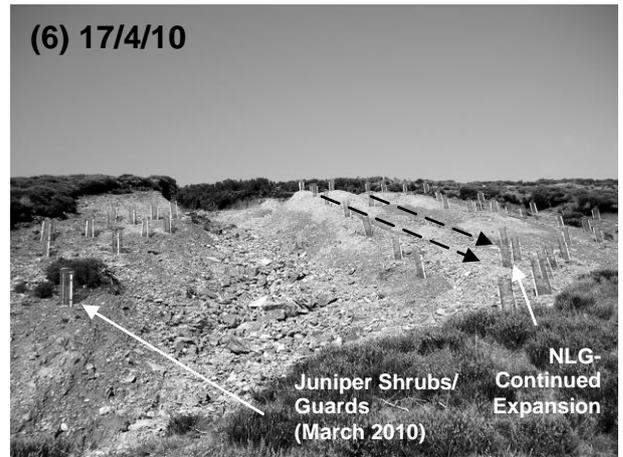
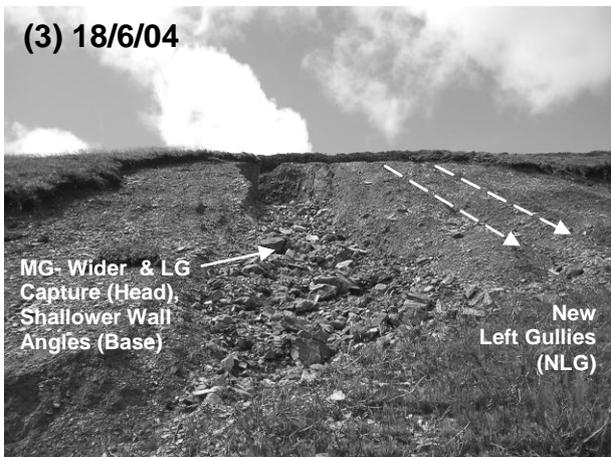
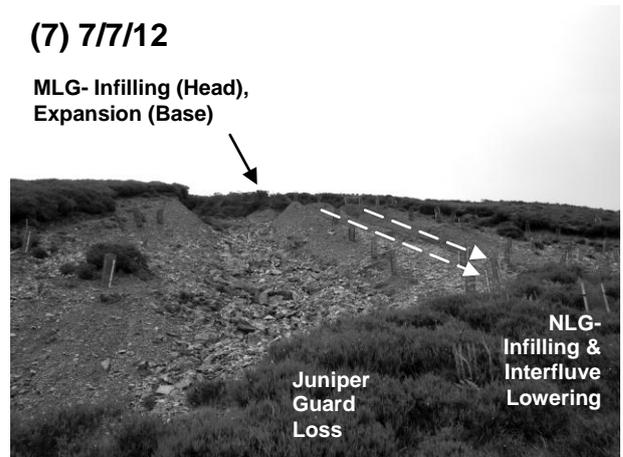
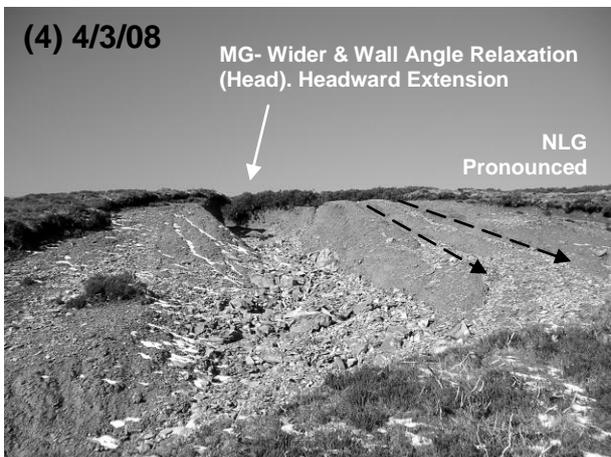
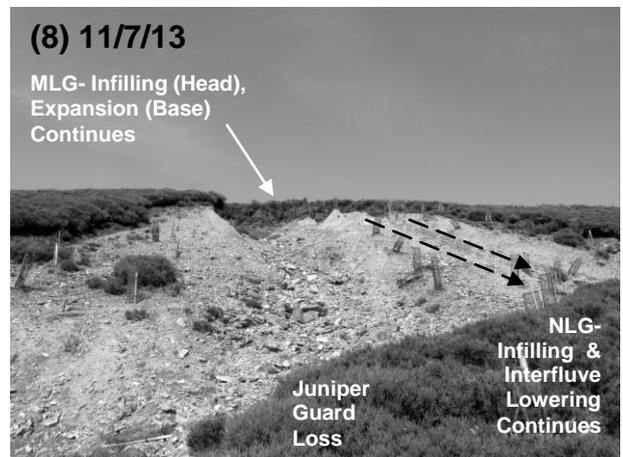
Fig 3

19 Post-failure activity beyond the main gully was initially less marked, but became
20 more prominent by 2008. The 'left gullies' (Figure 3) can be grouped into two
21 sets, firstly shallow forms which existed prior to June 2004 and were captured
22 by the widening of the main gully and; secondly, two gullies which developed
23 nearer the scar edge ('new left gullies' in Figure 3), fed by runoff from the upper
24 hillslope. By March 2008 these gullies transferred sediment beyond the scar

1 perimeter, with coarse sediment eventually coupling with Wet Swine Gill (first
2 observed in July 2012). Furthermore, ongoing interfluvial lowering between them
3 (Figures 3 and 4), may in time result in the capture of gully L1 by gully L2.
4 These may also eventually merge with the main gully, triggering a new phase of
5 activity.

1 communication). Figure 3 (photos 7 & 8) shows subsequent widespread loss/
2 tilting of the plastic nursery guards installed around the Juniper shrubs. By 30
3 July 2014, 39% of nursery guards had failed and only 30% of the planted
4 shrubs were established. Furthermore, following February 2014, under a 2013
5 Higher Level Stewardship Agreement, the Caldbeck Commoners Association,
6 LDNPA and Natural England, have planted 500 native trees on hillslopes
7 adjacent to the Wet Swine Gill stream, with 64 immediately downslope of the
8 scar (Barron, 2014, personal communication; Planning Inspectorate, 2014).
9 Additional works are planned for later in 2014, including a temporary fence
10 enclosure (consented for 15 years) around the failure scar (Barron, 2014,
11 personal communication); this is part of a wider initiative in the Caldbeck Fells
12 to reduce sediment transfer and improve water quality (Planning Inspectorate,

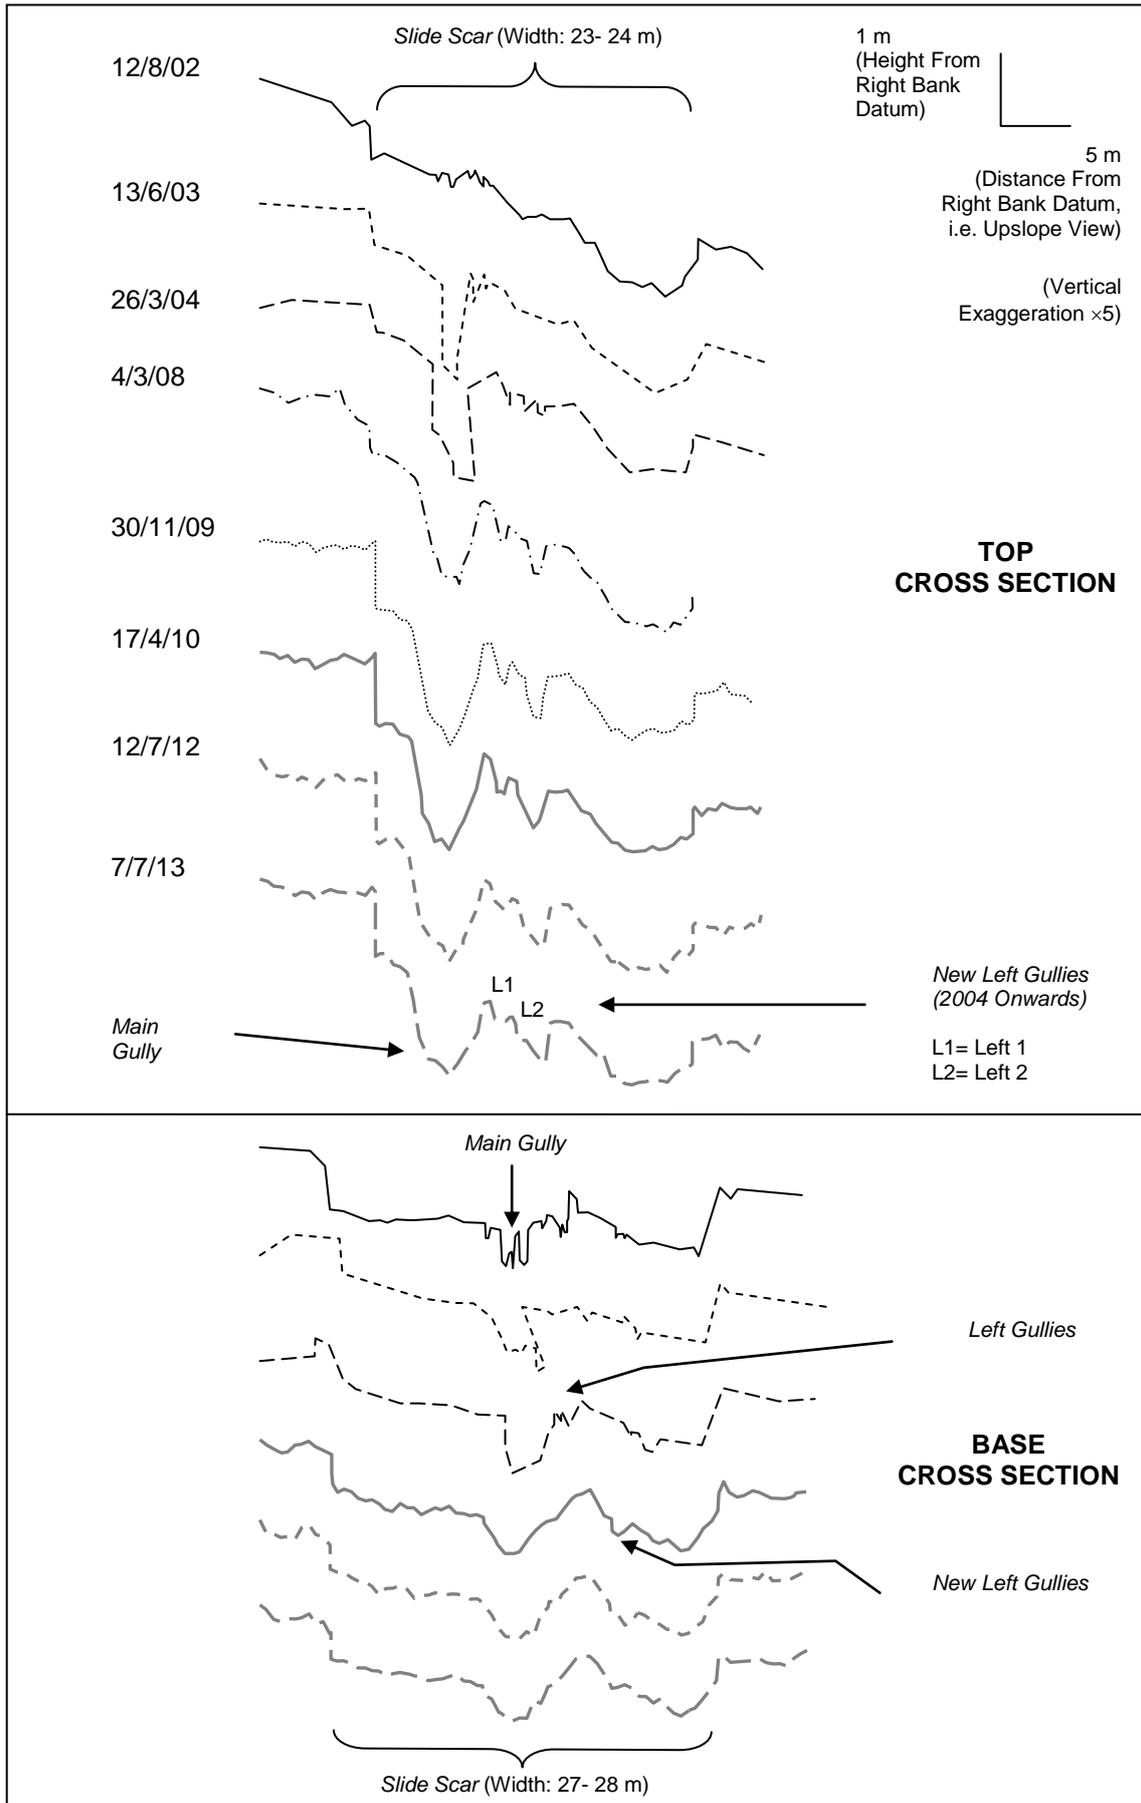
Fig 4

22 Figure 4 shows the evolution of the scar surface at the top and base of the
23 slope. This demonstrates that scar width has remained relatively stable since
24 the hillslope failure, with significant change being focused on the scar surface.

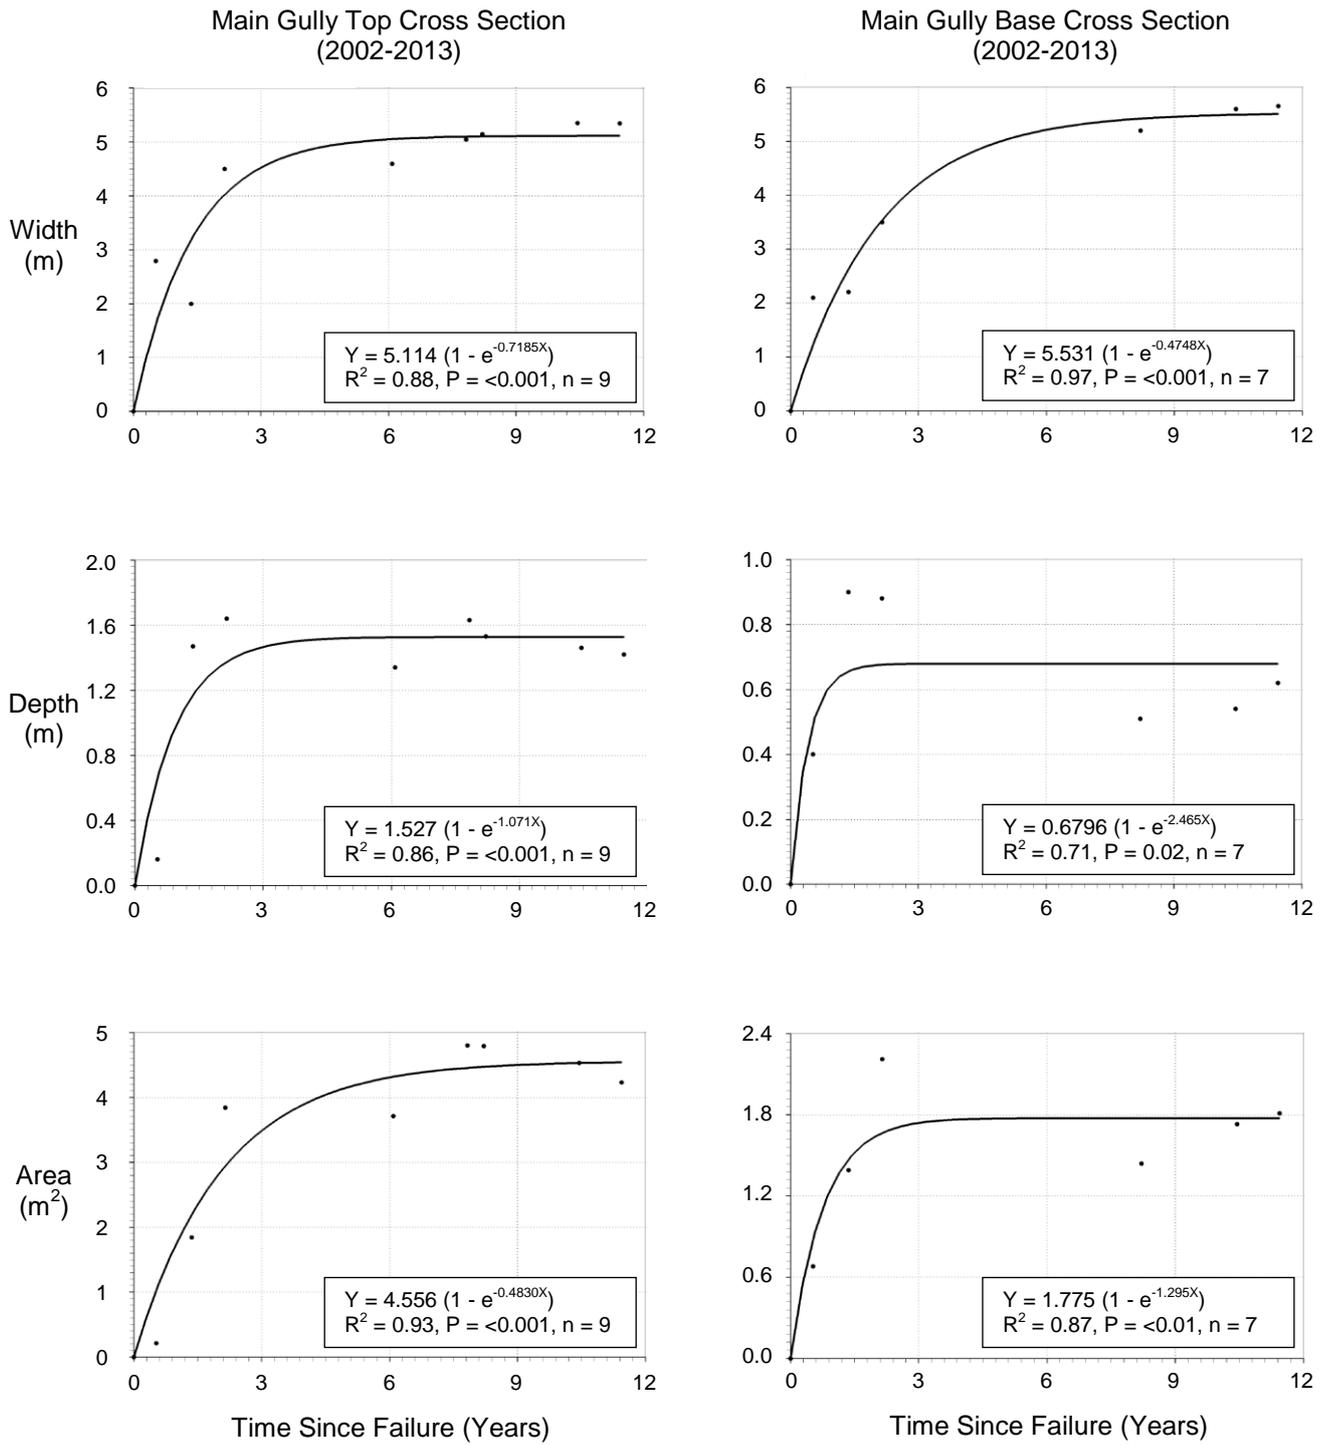
Fig 9

18 Figure 9, shows the fit of non-linear regression functions to the field data. An
19 exponential curve of the form $y=a(1-\exp^{-bx})$, demonstrates a condition
20 approximating negative exponential growth in main gully cross sectional width,
21 depth and area relative to time since debris slide failure. At Wet Swine Gill all
22 regression relations are strong and significant ($R^2= 0.71$ to 0.97 and $P= <0.05$ in
23 all cases). The weakest relationship occurs for the base cross section depth

Figure 9 Main gully morphometric evolution as a function of time since debris slide failure, at medium-term cross section locations (February 2002 to July 2013).

1 rates of change dominated by width expansion and gully wall angle decline.
2 This sequence was shown to exhibit strong and statistically significant
3 conformity to a negative exponential growth model (Figure 9). These
4 characteristics are summarised in a conceptual model of landslide scar
5 evolution, which integrates existing conceptual descriptions of gully growth and
6 capture (Figure 10). The transferability of this revised model requires further
7 testing, based upon quantification of post-failure slide scar and gully dynamics
8 in environments contrasting those existing in the UK uplands, and over varying
9 timescales. Nevertheless, it follows, that continuing to develop scientific
10 understanding of post-failure sediment supply from headwater hillslopes and
11 channels, like Wet Swine Gill, will beneficially impact society; by helping to
12 improve hazard and risk awareness for ecological and economic assets, to

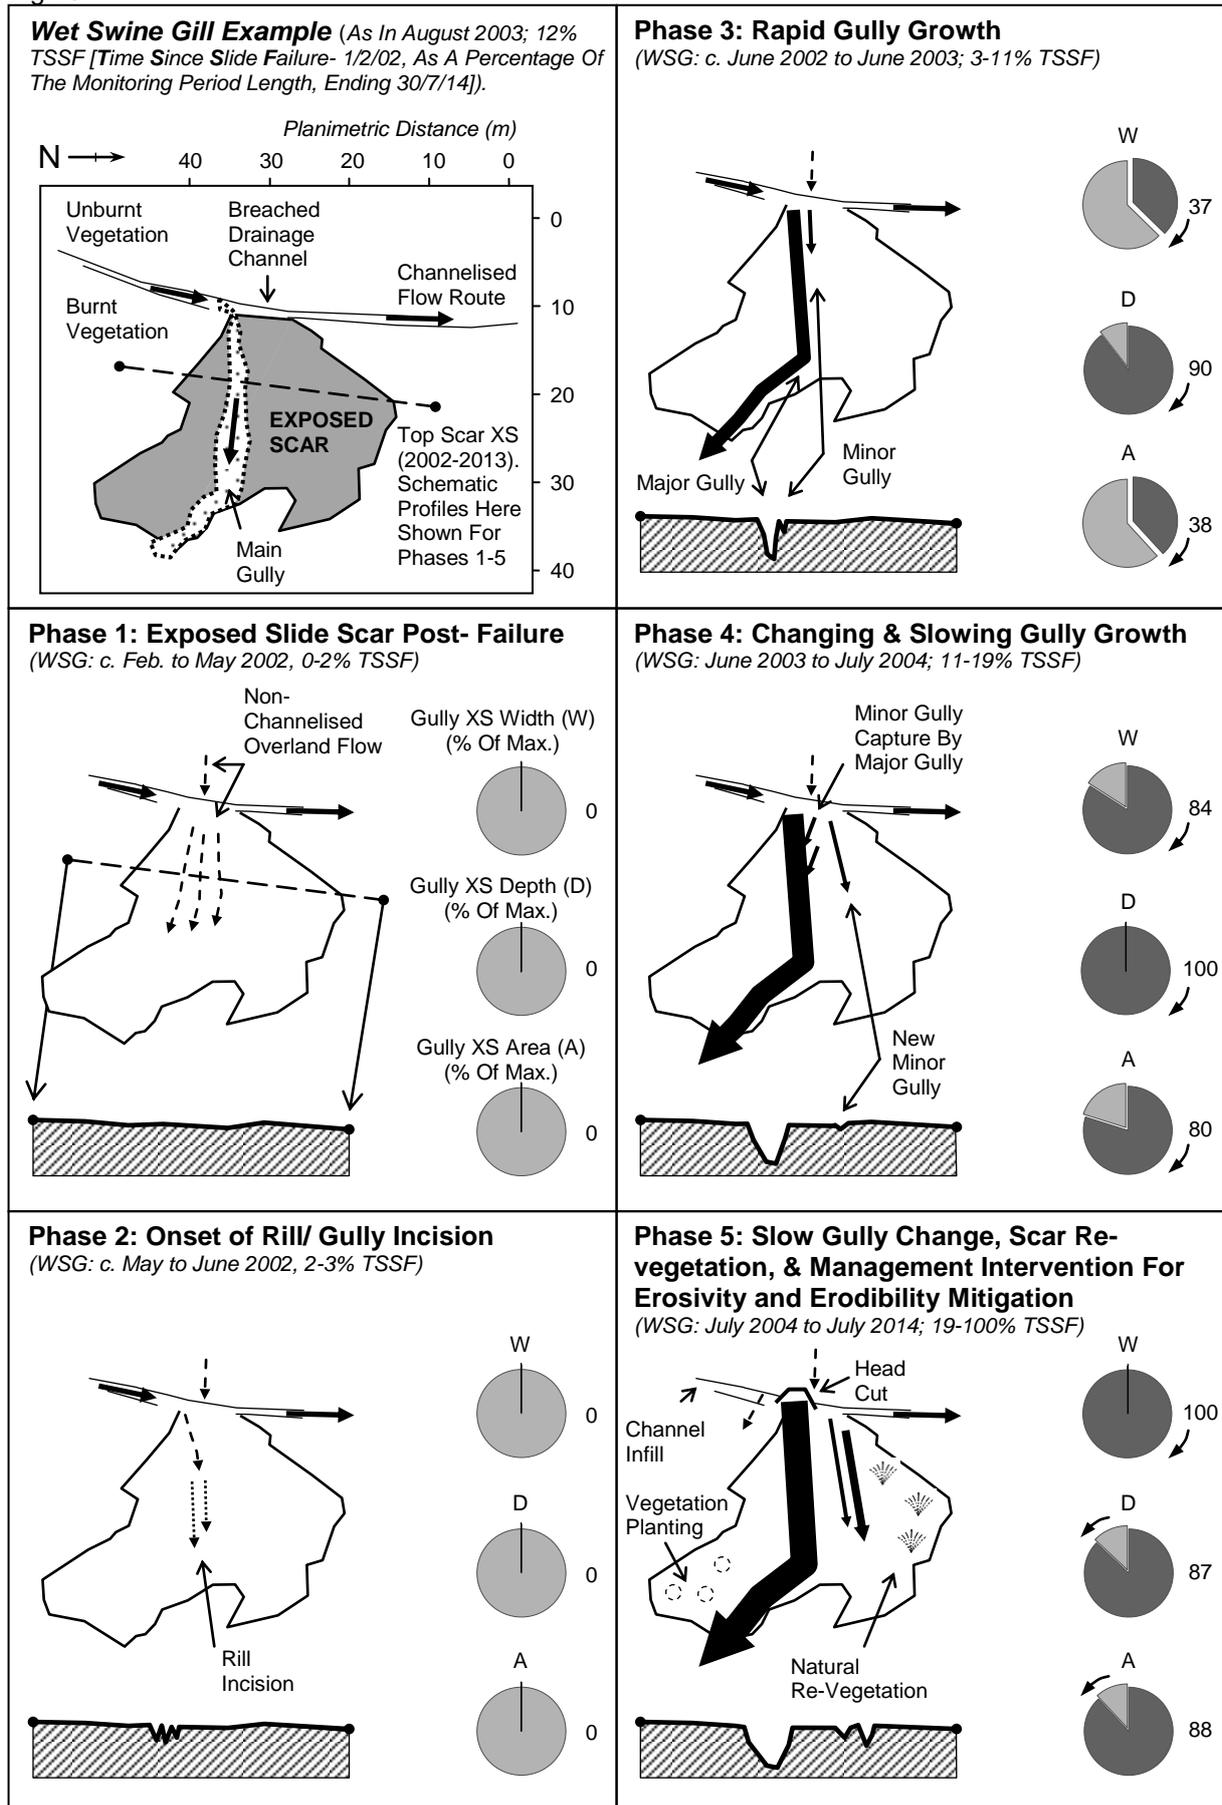
Fig 10

23 Figure 10 is a conceptual model for the post-failure development of a slide scar.

1 This model recognises five main phases, comprising: (1) post-failure scar
2 exposure; (2) onset of rilling/ gully; (3) rapid gully growth; (4) changing and
3 slowing gully growth; and (5) slowing gully change and scar re-vegetation.
4 These phases outline key process activity, landform features and management
5 interventions; each expressed with an indication of their relative longevity (being
6 the time since slide failure [TSSF]) and the relative proportion and direction
7 (clockwise= increasing to measured maximum; anti-clockwise= decreasing from
8 measured maximum) of cross sectional change (here based on main gully top
9 cross section dimensions at the end of each phase, except phase 5 which uses
10 2013 data [last measurement]). As established previously, these phases at Wet
11 Swine Gill broadly conform to existing conceptual gully evolution models (i.e.
12 Betts et al., 2003; Burkard and Kostaschuk, 1997; Harvey, 1992; Ireland et al.,

Figure 10 Conceptual model of post-failure slide scar and gully development based upon the Wet Swine Gill case study.
