## Preliminary assessment of series of landslides and related damage by heavy rainfall in Himachal Pradesh, India during July 2023 --Manuscript Draft--

5 **Preliminary assessment of series of landslides and related damage by heavy**  
6 **rainfall in Himachal Pradesh, India during July 2023**

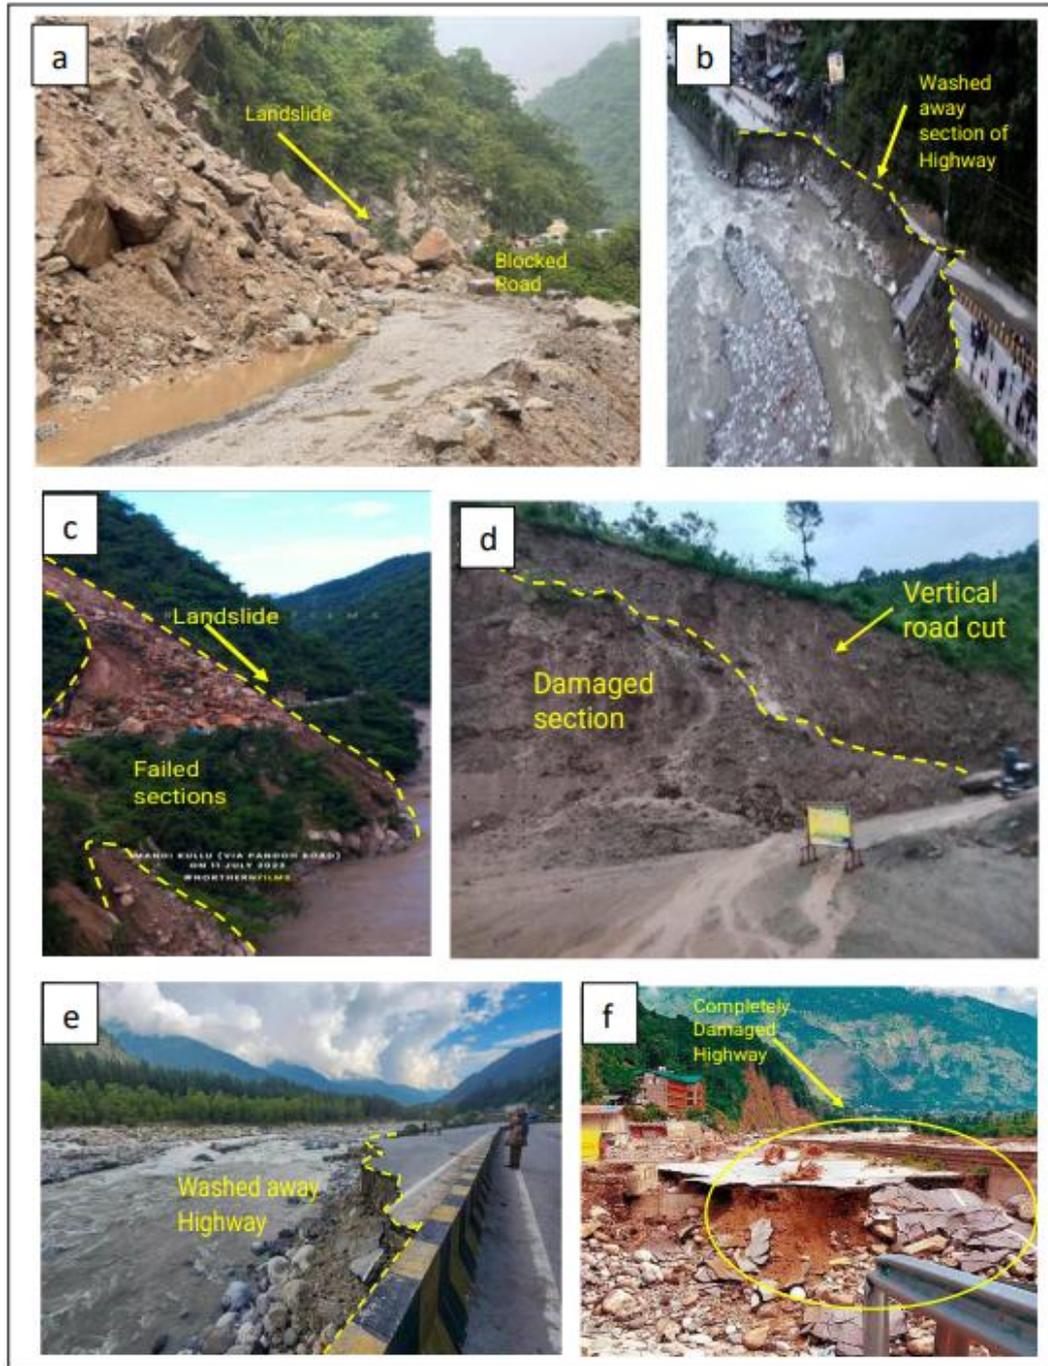
239 Fig. 3 Damages to the Chandigarh-Manali National Highway. **a** Blocked road due to landslide (The  
240 Tribune 2023a), **b** Washed away section of the highway (The Tribune 2023b), **c** Blocked highway due

241 to major landslide (Hindustan Times 2023a), **d** Failure of vertical cut slope (AN1 2023), **e** Washed  
 242 away highway section (The Hindu), **f** Completely damaged highway (The Tribune 2023c)

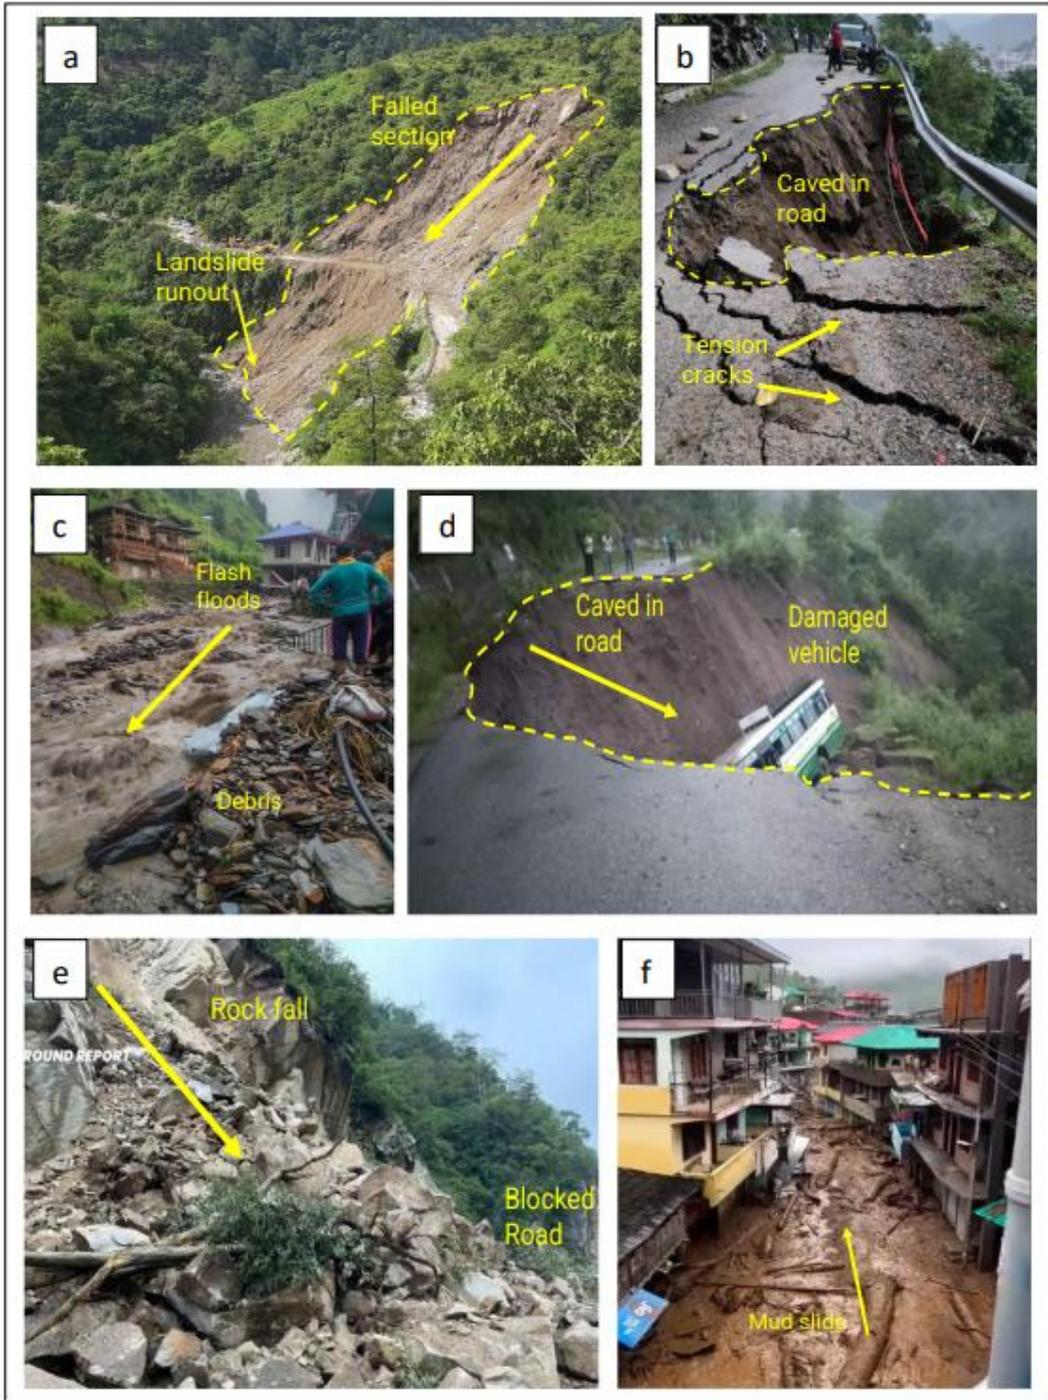
259 Fig. 4 Damages in the Mandi district. **a** failed section of the slope (Field assessment), **b** Caved in road  
 49  
 260 leading to formation of tension cracks (Field assessment), **c** Flash floods (Hindustan Times 2023b), **d**  
 51  
 261 Caved in road resulting in accidents (The Tribune 2023d), **e** Rock fall (Ground Report 2023), **f**  
 53  
 262 Mudslide (India Today 2023a)

247 Figure 4 highlights the extensive damage incurred to roads and building infrastructure in the  
 248 Mandi district, including rockslides on the national highway and landslides downslope of major  
 249 district roads (Figures 4a-e). These incidents led to numerous road accidents. A mudslide in

1 250 Thunag market of Mandi damaged 30 shops and 15 houses, with another 70 shops being  
2 affected (Figure 4f).  
3

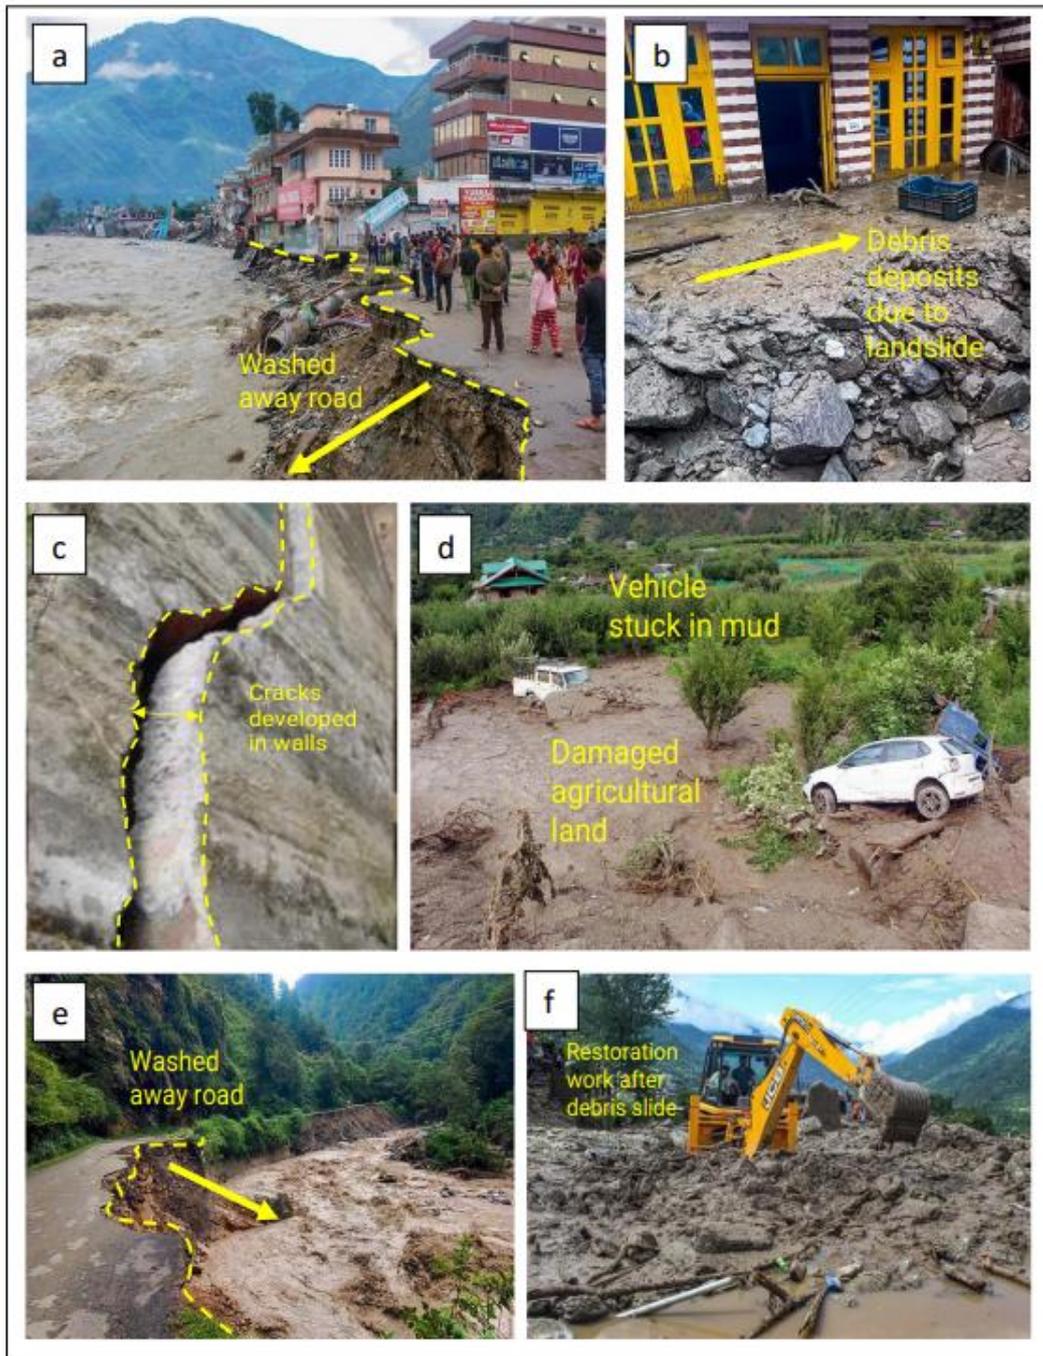
Fig. 5 Damages in the Kullu district. **a** Washed away road section (India Today 2023b), **b** Debris deposition in front of houses (Outlook 2023), **c** Cracks in houses (ETV Bharat 2023), **d** Damaged agricultural land and vehicles due to mud slide (The Tribune 2023e), **e** Washed away road section (The New Indian Express 2023), **f** Restoration work after a debris slide (Outlook 2023)

4 252 Figure 5 displays photographs of damages within the Kullu district. These include washed-out  
5 portion of roads, debris deposition in front of houses, cracks in the houses, washing away of  
6  
7 253 parked vehicles and the ongoing restoration works. In Kullu's Sainj area around 40 shops and  
8  
9 254 30 houses were washed away in debris flow ([The Indian Express 2023a](#); [The Indian Express](#)  
10  
11 255 [2023c](#)). Several houses have developed cracks posing a serious threat to inhabitants.  
12  
13  
14  
15 256  
16

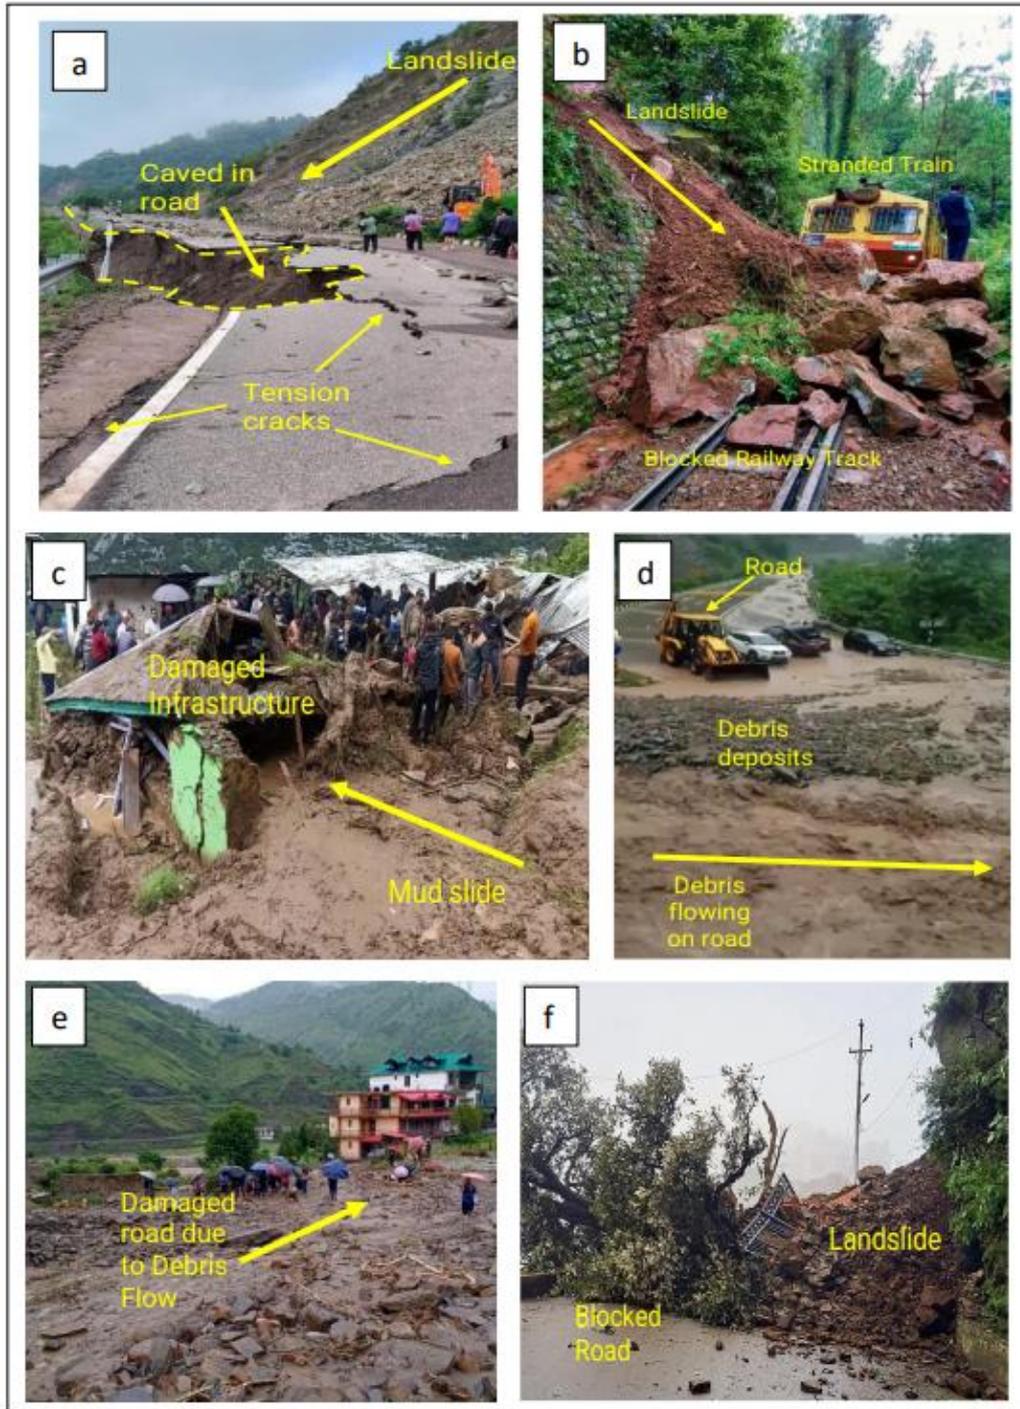
271  
 272 Fig. 6 Damages in the Shimla district. **a** Landslide and caved in road on Kalka-Shimla NH-5 leading  
 273 to formation of tension cracks (Bhaskar 2023), **b** Blocked railway track due to landslide (The Tribune  
 274 2023f), **c** Damage to infrastructure due to mud slide (The Quint 2023), **d** Debris flow and deposition  
 275 on road (Punjab Kesri 2023), **e** Damaged Road due to debris flow (India TV 2023), **f** Blocked Road  
 276 due to landslide (The Tribune 2023g)

Figure 6 displays photographs of damages incurred within the Shimla district indicating the similar damage patterns experienced by Mandi and Kullu districts.
