A Field Study on the Stability of Road Cut Slopes in Nepal

Abstract

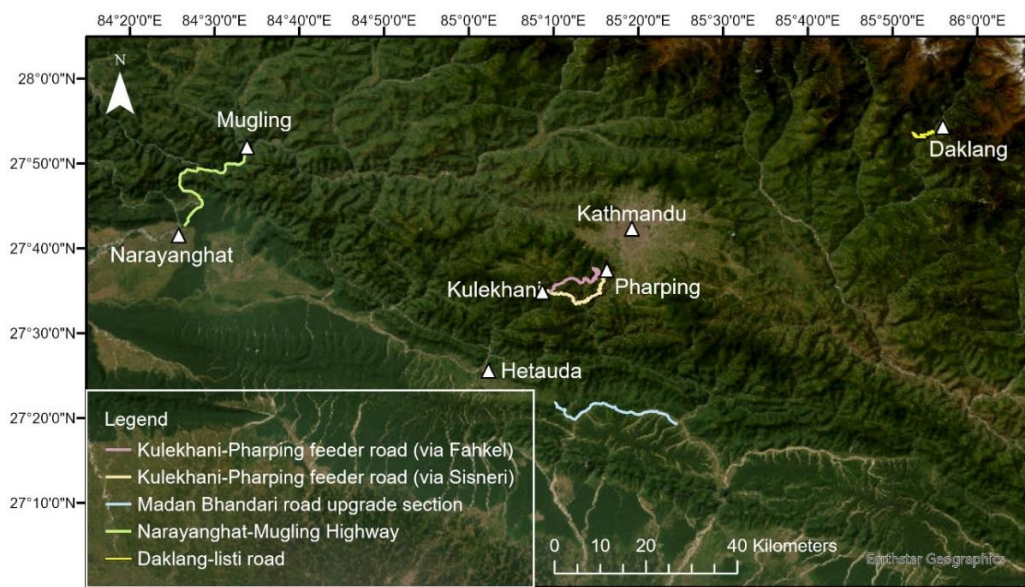
Figure 1: Map displaying location of roads surveyed in study.

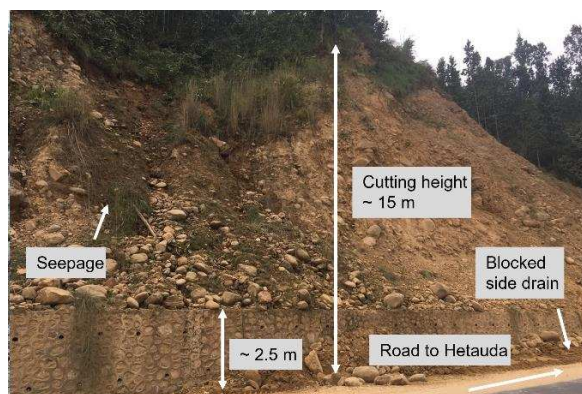
Mortared masonry walls were also present along each of the roads visited. They are another low-cost measure as they can be built with locally sourced material. Mortared masonry walls cannot withstand variable foundation settlement. During the field visits, it was observed that the masonry walls were constructed at a very similar geometry, despite the differences in slope geomaterial and geometry. Weep holes were present in most walls, spaced 0.5 m apart in both directions. However, they were often blocked. DoR (2007) state that cement masonry walls can be 1 to 8 m in height, with a base width of 0.25 times the height and a top width of 0.5 m. They state that mortared masonry walls up to 3 m in height can be designed by rule of thumb. Figure 4 shows an image of a mortared masonry wall at a cutting visited along the Madan Bhandari Road built to the common geometry observed. At this site, the collapse of loose debris had blocked the roadside drainage. Many of the weep holes within the wall were blocked. Seepage could also be observed on the surface of the cutting.

Figure 4: Example of an ineffective mortared masonry wall on the Madan Bhandari Road.

The field study revealed that mortared masonry walls and concrete walls were not built to standard geometry, despite differences in cutting height and material. They were often found to have failed through overturning or collapse. Gabion walls were found to be bulging and/or overturning. DoR (2007) states that retaining walls can be built by rule of thumb if they are <3 m and does not give any advice on designing the size of the wall according to the height of the cutting.

Another finding of this field study is that there is a general lack of maintenance in road slope stabilisation measures; roadside drainage and weep holes were often blocked, resulting in a build up of seepage in the cutting slopes. Multiple walls were also cracked.
