Preliminary Results of Post-Disaster Archaeological Investigations at the Kasthamandap and within Hanuman Dhoka, Kathmandu Valley UNESCO World Heritage Property (Nepal)

Coningham, R.A.E.¹, Acharya, K.P.², Davis, C.E.¹, Kunwar, R.B.³, Simpson, I.A.⁴, Schmidt, A.¹ and Tremblay, J.C.¹,

¹Department of Archaeology, Durham University, DH1 3LE, UK

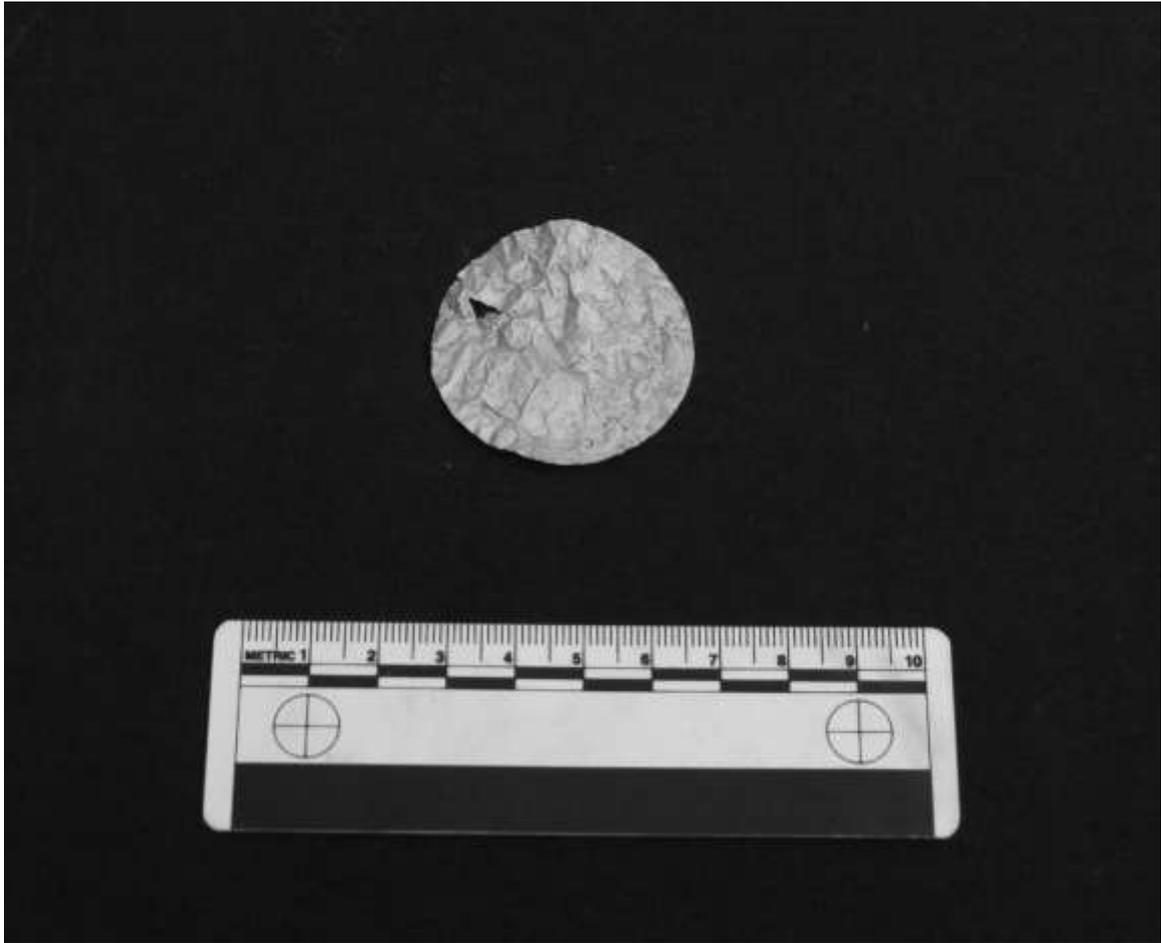
The saddlestone measured 0.50 metres square with a raised central square of 0.37 metres. The mortise socket for the wooden pillar's tenon tongue had been cut into the centre of this raised area and measured 0.14 by 0.14 by 0.14 by 0.135 metres and 0.06 metres deep. The presence of a roughly square copper alloy residue on the raised square portion of the saddlestone suggests that original wooden pillar was separated from its saddlestone by a copper alloy plate, perhaps acting as a damp proof course (Figure 14). Indeed, we identified one of the original central timber pillars from the Kasthamandap within the Durbar Square and found that it measured 6.2 metres long and 0.39 square. At the upper end of the pillar, it was equipped a 0.13 metre deep mortise socket and at the base of the pillar with a 0.07 metre long tenon tongue measuring 0.12 by 0.11 metres. This indicates that wooden tenon and stone mortise joint was designed to leave a small gap between the two, again perhaps a way of preventing moisture from leading to the rotting of the base of the timber pillar.

Figure 14: Copper corrosion visible on saddlestone.

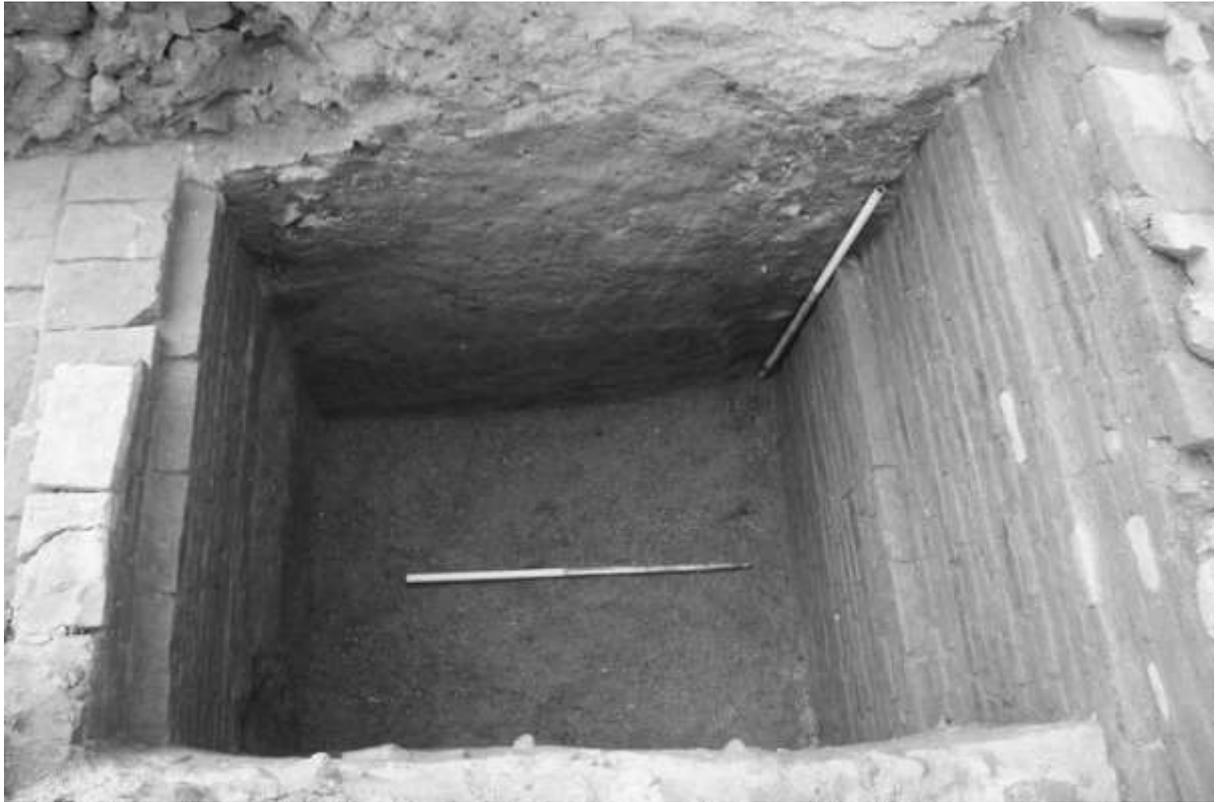
At the base of the cross-walls, brick pier and large foundation wall we identified evidence of pre-monument construction human activity. Below the homogenous fill material that was deposited within the cross-walls and foundation, was a smooth clay that might represent the natural. This ran underneath the cross-wall east-west cross-wall within the larger area of the trench. Very clearly, a rounded feature also cut into this material, to the east of the trench. Cut into the sterile clay, this feature contained inclusions of charcoal and ceramics. It was not fully excavated as water was reached at this depth and waterlogging also caused concerns of undermining the cross-wall and damaging the architectural integrity of the Kasthamandap foundations. This feature indicated that there was cultural activity at the site prior to the construction of the brick walls at the site (Figure 16)

Figure 16: Rounded feature visible below eas-west cross-wall within large foundations of Kasthamandap, looking west.

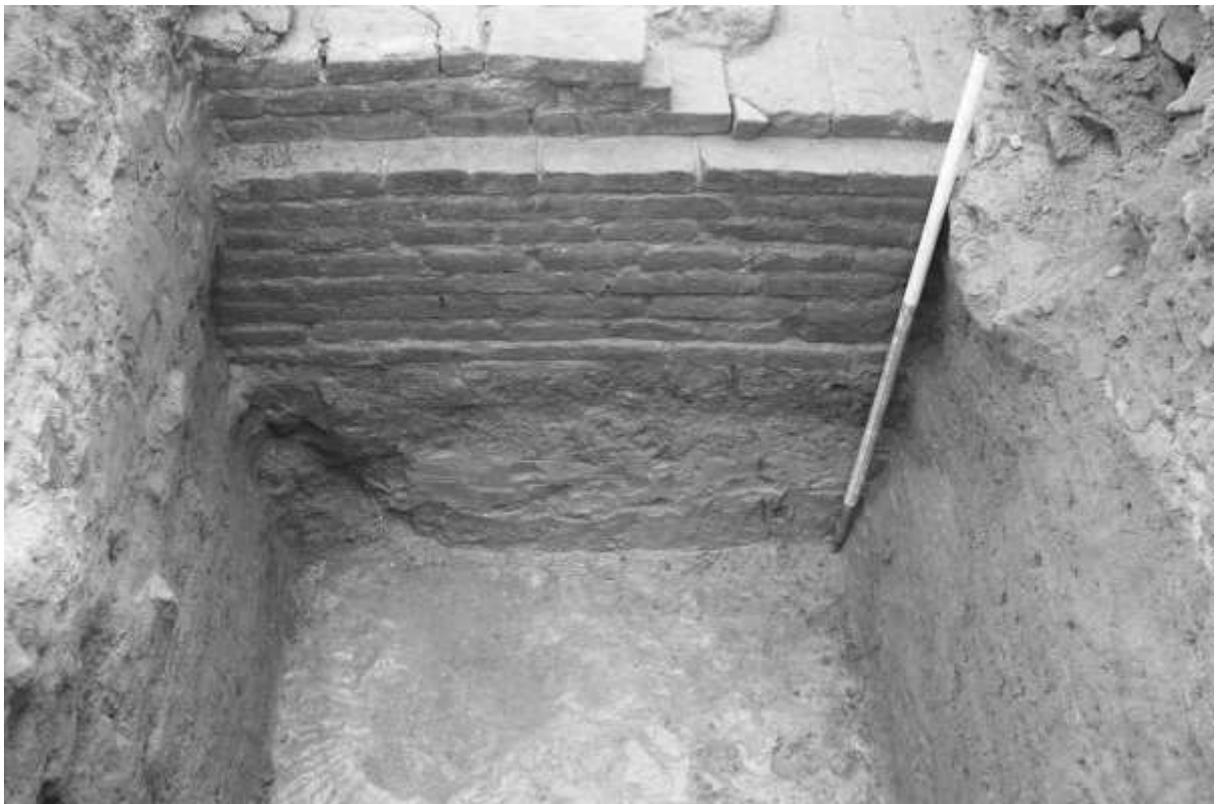
Figure 17: Earlier deposits in the east-facing section, cut by both the foundation wall (north) and exterior wall (south).

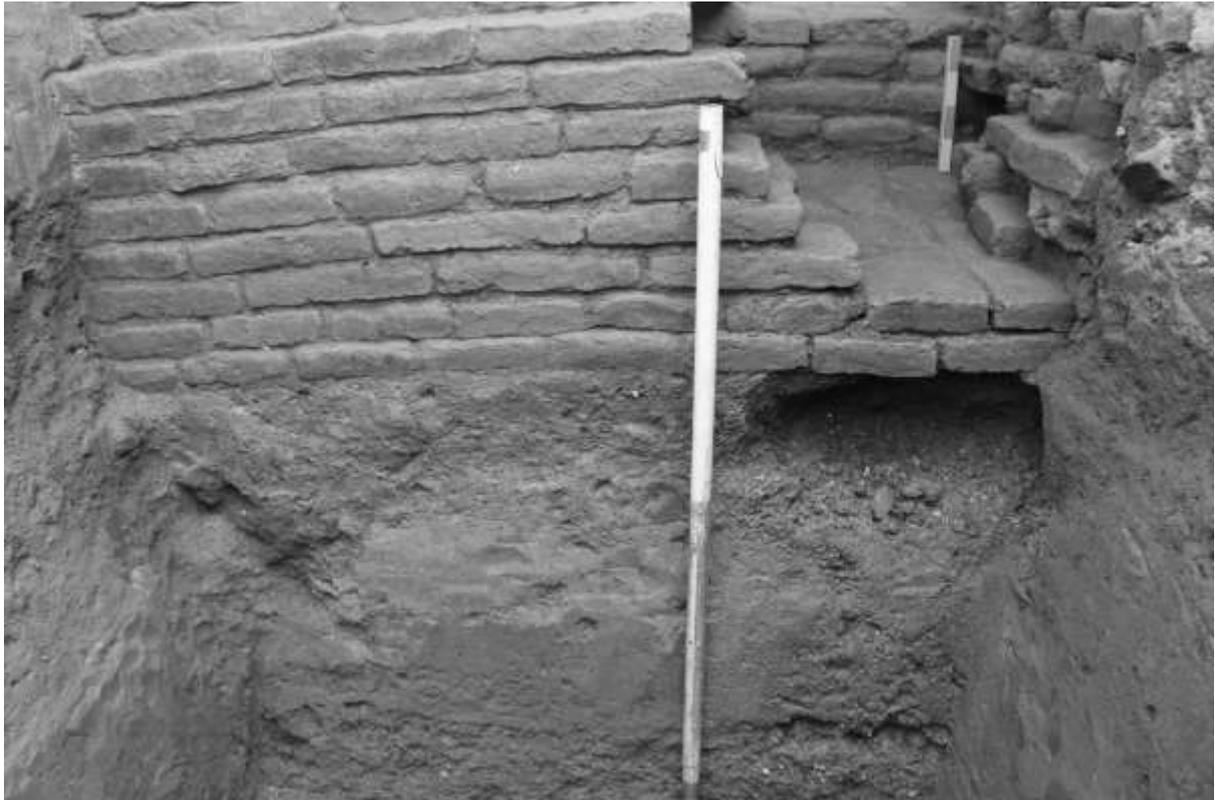
Figure 18: Brick wall to the south of the foundations of the Kasthamandap, looking south.

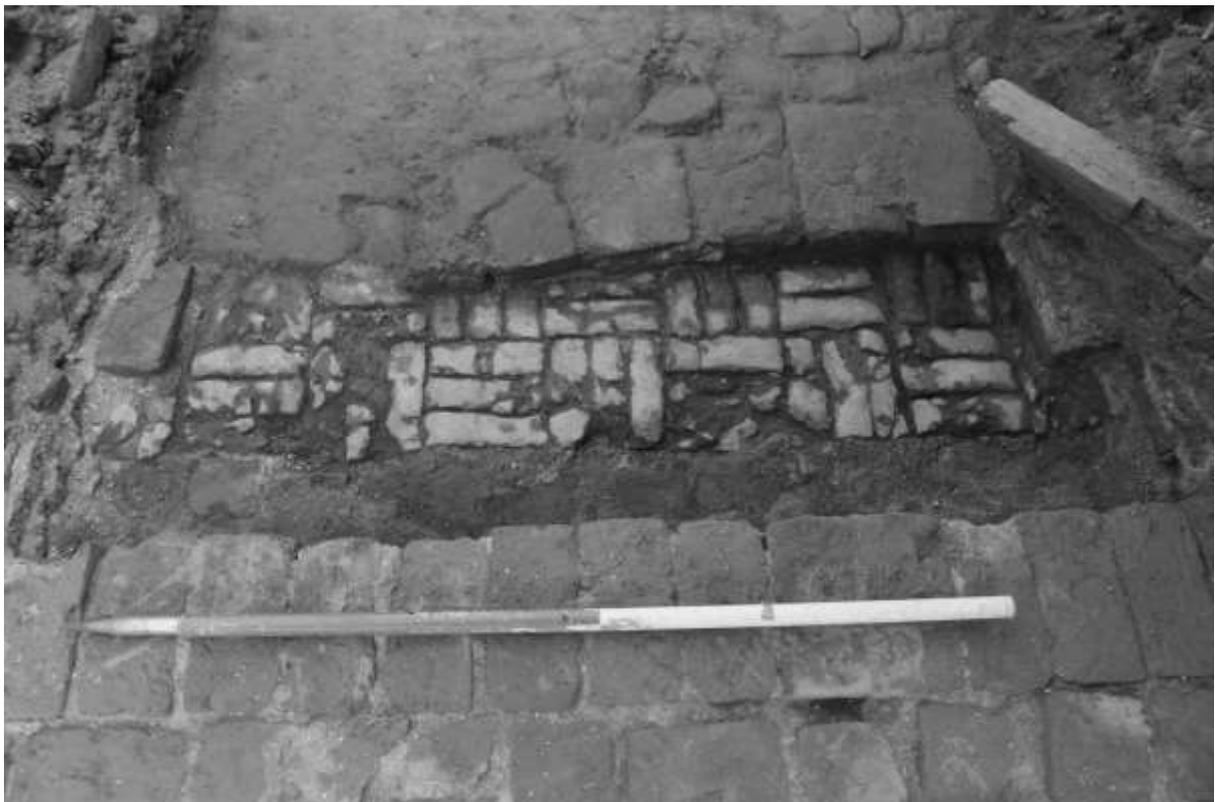
Figure 19: Exterior wall cut through to show an other phase of walling further to the south.

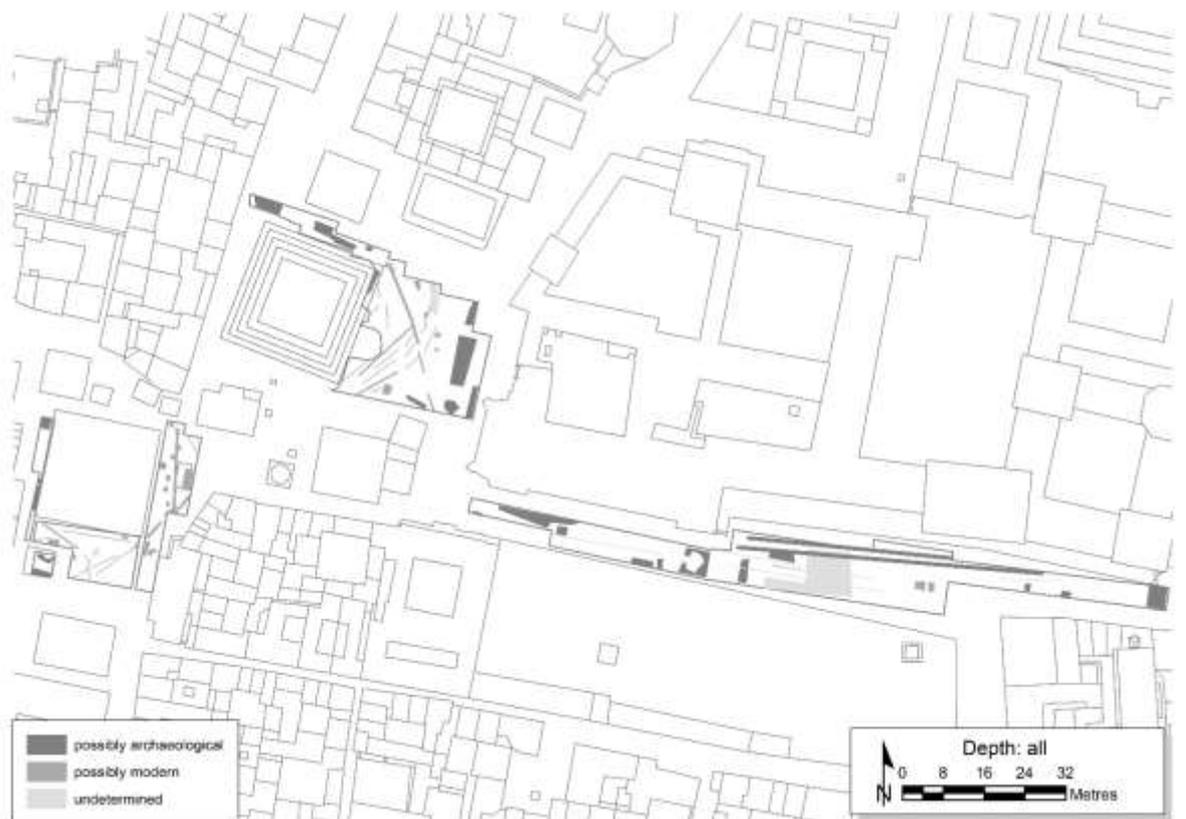
(GPR): (a) around the Kasthamandap; (b) east of the Maju Dega Temple, up to the palace; and (c) south of the palace complex (Figures 21 and 22). The GPR results next to the Temple and Kasthamandap are dominated by linear anomalies that are all interpreted as modern utilities, either for freshwater, sewer or electric cables. Unlike in Bhaktapur (Coningham et al. 2016a), the anomalies show as strong reflections (black) and it is hence assumed that the pipes themselves are imaged. All extended anomalies next to these linear features are also interpreted to be of modern origin, probably forming the interconnection of structures for the utilities. Some of these coincide with metal man-holes or grills that were noted during the Total Station survey. In the southern part of the Maju Dega area, several of these linear anomalies appear interrupted for no apparent reason.

Figure 21: GPR survey results across Hanuman Dhoka's Durbar Square at a 1 metre depth.

The damage caused by the earthquakes will require reconstruction and also the repair and laying of amenities in Hanuman Dhoka and whilst we do not recommend the suspension of the laying services and reconstruction we do advocate the mobilisation of rescue archaeology teams to undertake rescue excavations in advance of interventions (Coningham et al. 2016c). The Archaeological Risk Map for Hanuman Dhoka will provide information for site managers and stakeholders as to the risks posed to subsurface heritage and help guide future development (Figure 25). Indeed, from our observations and investigations, we feel there needs to be a heightened awareness that the cultural heritage of Hanuman Dhoka is not restricted to its standing remains and architectural treasures but that it should extend also to the foundations of these monuments and to preceding phases of cultural development, which are found below the current ground level. The Archaeological Risk Maps and our interventions should facilitate the development of this awareness and protect subsurface heritage whilst not being of detriment to reconstruction.
