A collaborative engineering and archaeology project to investigate decay in historic rammed earth structures: the case of the medieval preceptory in Ambel

This study assesses the structural vulnerability of part of a later medieval earthen building at Ambel (near Zaragoza, Spain), once a preceptory or monastic house belonging to the Military Orders. An inspection of its morphology and materials coupled with the results of an extensive campaign of static monitoring reveals marked structural inhomogeneities, the product of more than a thousand years of construction, failure and repair from the 10th century to the present day. Building materials are inappropriately juxtaposed, there are discontinuities between construction phases and fundamental concerns remain over the long-term stability of the structure. The current condition of the structure is mainly influenced by structural discontinuities introduced at the time of construction, the unintended consequences of repair and modification and the material decay that has affected the base of the rammed earth walls. The overall findings of the static monitoring show that there is no related damage, variations in crack widths are relate

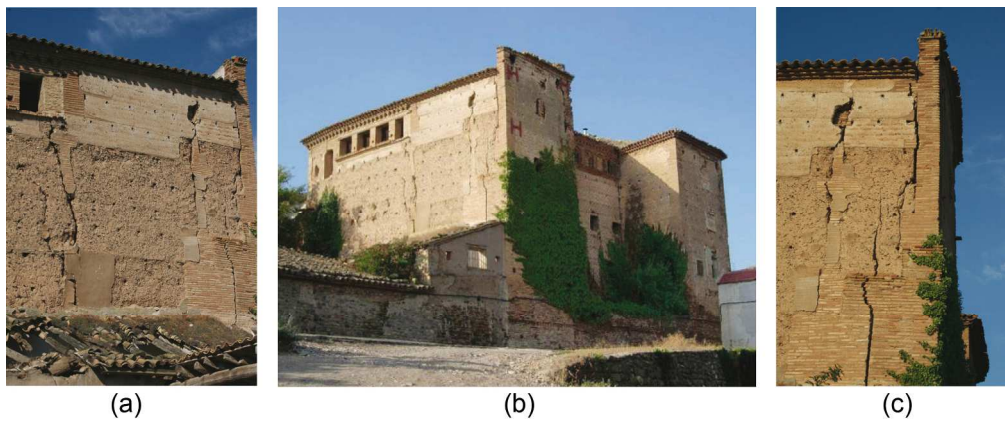
Figure 3. Ambel preceptory: (a), (b), (c) side view of north-eastern granary, looking west.

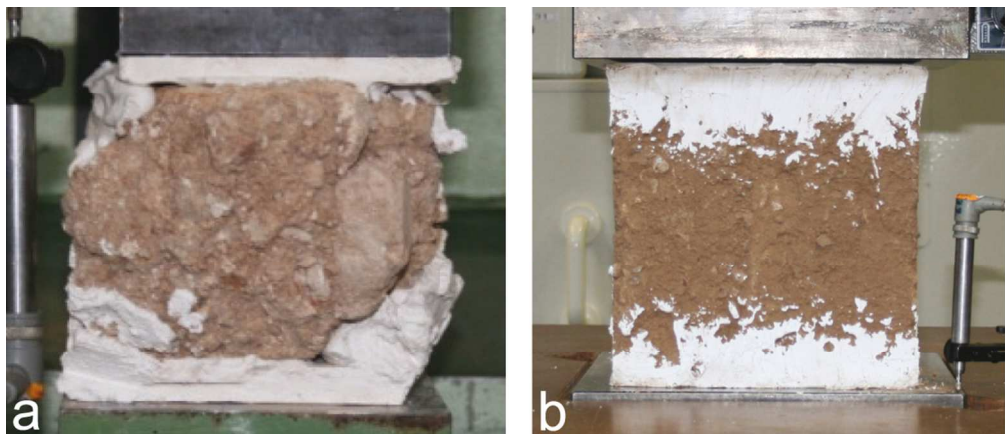
To compare the results between samples of different sizes a reduction coefficient was adopted. Converted to a cubic sample 20 cm × 20 cm × 20 cm, which is the typical size of the samples tested for rammed earth, the compressive strength has to be reduced by a factor of 0.87 (ASTM C42 2013) with a final result of 0.67 MPa. The use of a coefficient of reduction is due to the different lateral confinement pressure applied on the cube during the test. This leads to the smaller cubes (10 cm × 10 cm × 10 cm) having a higher compressive strength than larger ones (20 cm × 20 cm × 20 cm). Once the samples were removed they were remixed after testing by forming regular cubes (10 cm × 10 cm × 10 cm) to eliminate negative influences on test results caused by sample extraction and irregular sample shape (Figure 11). This assumes that cohesion results mainly from clay minerals, which could be reactivated.

Figure 11. Compressive strength test carried out on sample material from R. 307 (12th–13th century): (a) extracted sample during test, (b) local soil sample.

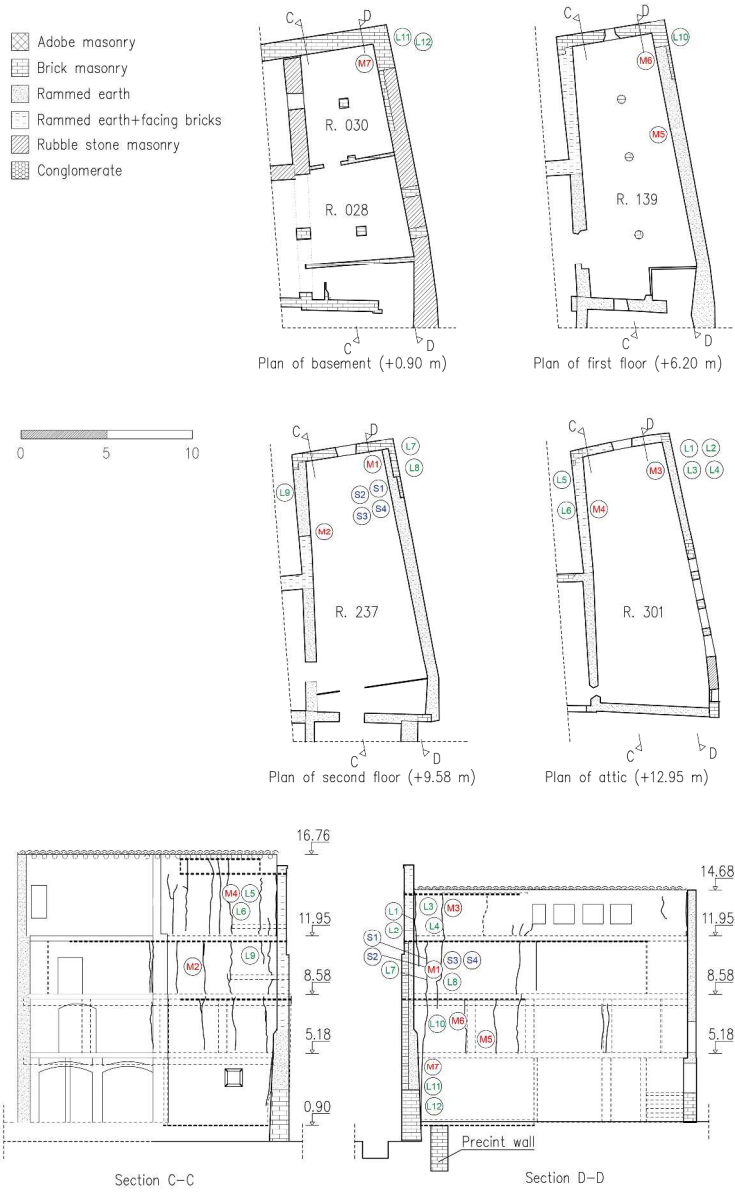
Figure 13. Location of sensors.

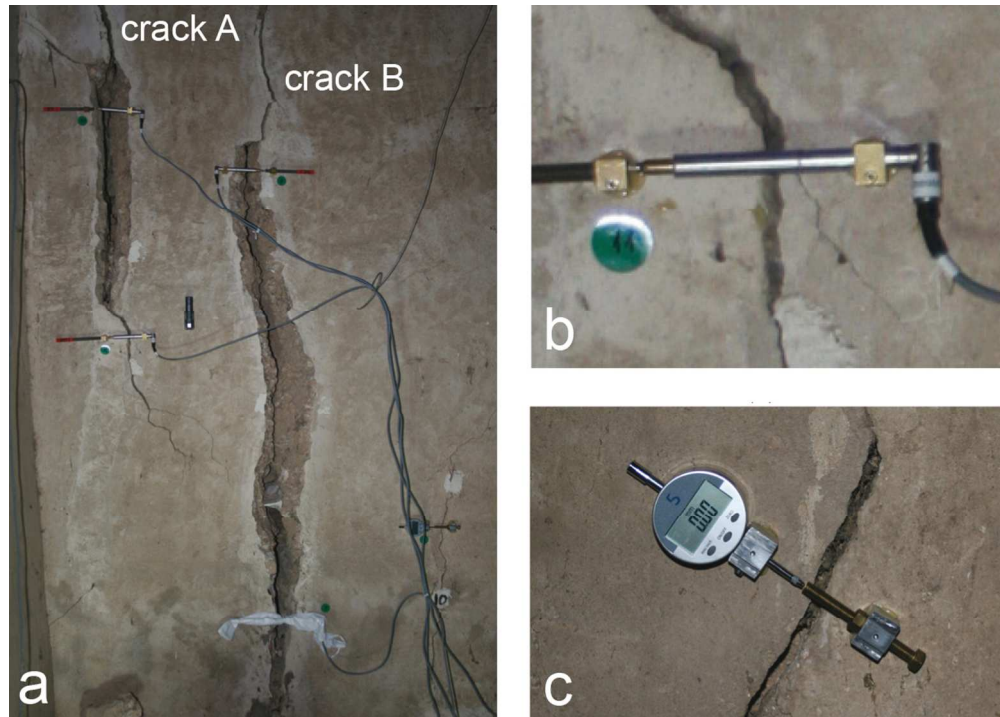
49 As part of the present study a more detailed inspection was undertaken around the east wall, here a major
50 crack was found to run right through wall. For this reason, four linear differential variable transformers
51 (LVDTs), indicated as S1–S4 shown in Figure 14a,b, were installed on the interior of the façade for a short-
52 term monitoring. Other visible cracks on the east and west walls were monitored through medium-term
53
54
55
56
57
58
59
60

1
2
3 monitoring (M1–M7) using seven digital crack meters (Figure 14c). The thermo-hygrometer was placed
4 close by near the central courtyard. Details on the location of sensors are provided in Table 3.
5
6
7

Figure 14. LVDTs used in short-term monitoring (a,b); digital crack meters used medium-term monitoring (c).
