Field monitoring of soil-moisture to understand the hydrological response of a road-cut slope

Samprada Pradhan^{1*}, David G. Toll¹, Nick J. Rosser¹, and Matthew J. Brain¹

¹ Institute of Hazard, Risk and Resilience, Durham University, UK.

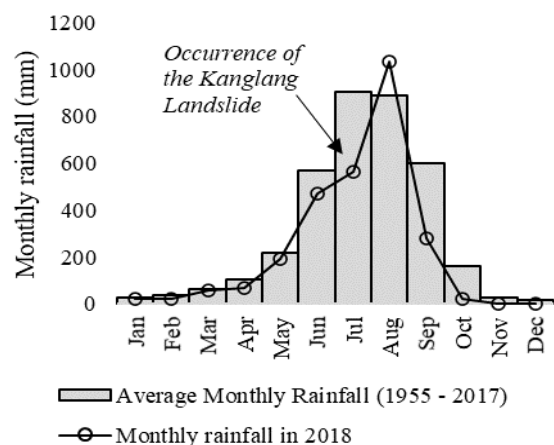
Fig. 4. Monthly rainfall in 2018 in comparison to the 63-year average measured at Gumthang rainfall station Source: [8]

The Kanglang Landslide occurred along Daklang-Listi road in July 2018, when the rainfall was not exceptionally high. This observation led to the understanding that steepening of the slopes due to slope-cutting for road construction can promote landsliding even during non-exceptional rainfall events. Geotechnical investigation was carried out at Kanglang landslide in March 2019, which showed that the soil near the surface existed in an unsaturated state during dry periods. Monitoring of the VWC and rainfall during March-August 2019 revealed that progressive infiltration during longer-duration rainfall and consecutive wet days can cause saturation of the soils and loss of matric suction at shallow depths. Since the slope cuttings along Daklang-Listi road were carried out during the dry season (October-December), the additional shear strength imparted by matric suction in the unsaturated soils may have allowed the cut-slope at Kanglang landslide to remain stable after cutting. On the onset of 2018 monsoon, rainfall infiltration may have caused loss of suction, leading to the failure. Hence, slope-cutting for road construction, relying on the unsaturated strength of the surficial soil can be the major cause of frequent shallow landslides occurring along the hillslopes of Nepal.

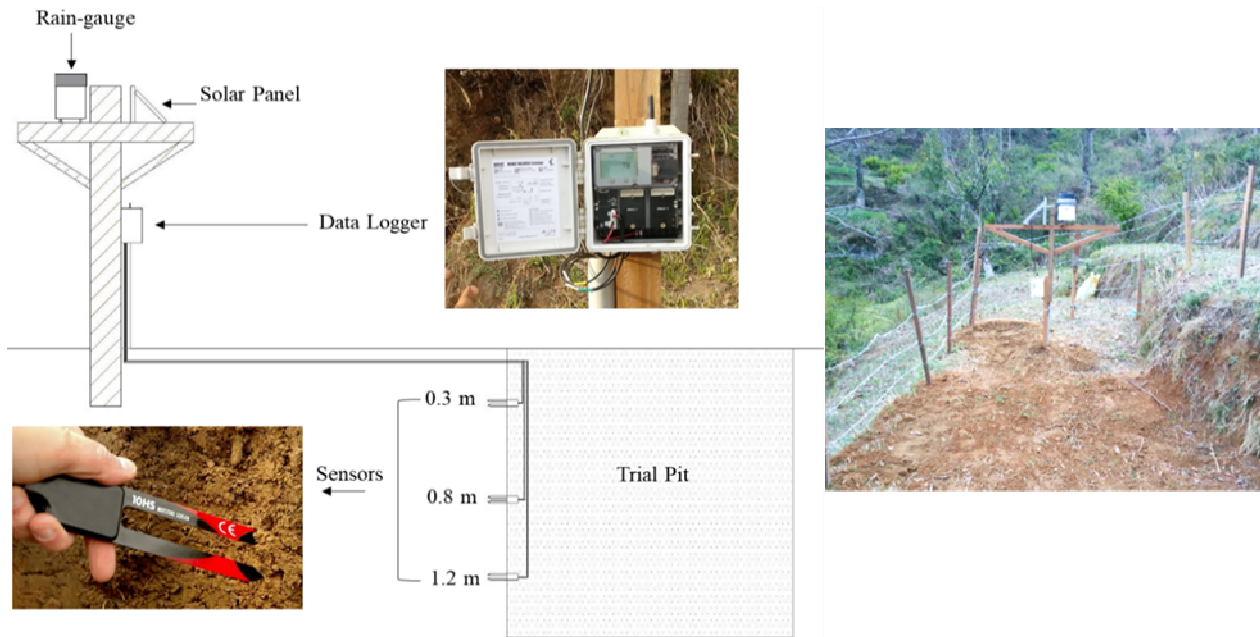
The 10HS soil moisture sensors use a capacitance-based technique to measure the VWC. The concept is to use the sensor probes as the capacitor electrodes and the soil surrounding these electrodes as the dielectric medium to measure the total dielectric permittivity of the medium i.e. soil, which is then converted into the VWC using standard calibration equations (with ±3% accuracy) [22]. In the field, the 10HS sensors were installed horizontally at 0.3 m, 0.8 m, and 1.2 m depths from the ground surface on the undisturbed vertical sides of the trial pit (Section 4). In this way, a natural flow of water was assured and the possibility of preferential flow paths was avoided. A dummy metallic sensor of the same thickness and length was pushed into the pit wall prior to installing the sensors so as to prevent any damage to the sensor prongs. After installation of the sensors, the trial pit was carefully backfilled with the excavated materials in small layers, so as achieve the approximate density of the surrounding soils. The cables above the trench were placed inside a PVC pipe to prevent any damage due to the external factors. The rain-gauge and the data-logger were mounted on a wooden frame next to the trial pit as shown in Fig. 5.

Fig. 5 (a) HOBO RX3000 data logger, (b) 10HS soil moisture smart sensor, (c) Field–monitoring set-up

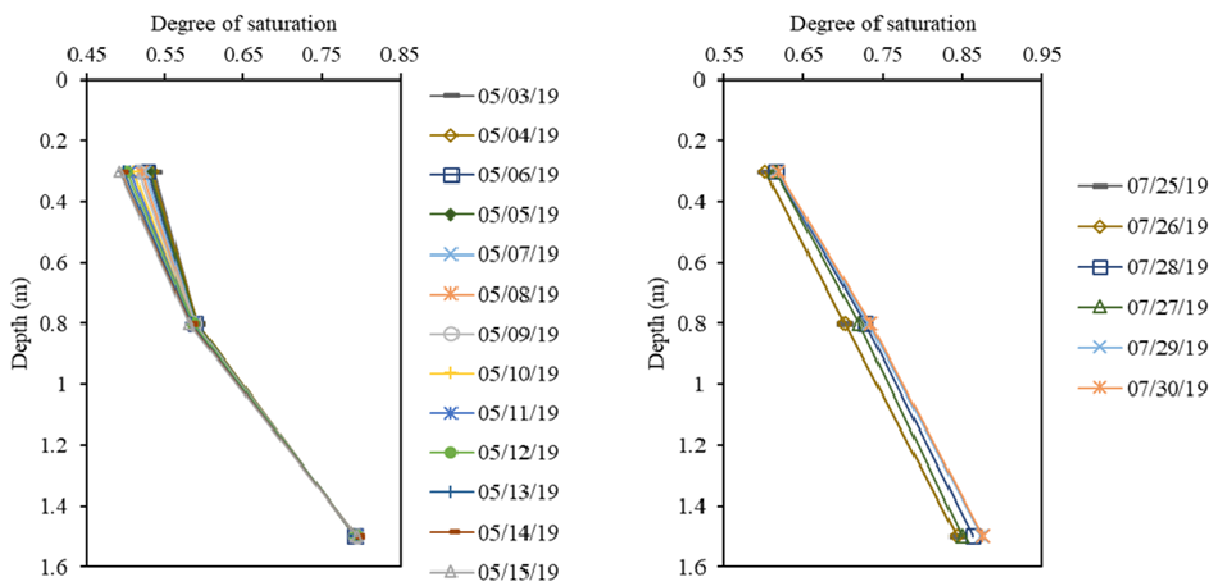
between 28 and 30 July 2019 (Fig. 8). The highest VWC at 0.3 m and 0.8 m occurred during a prolonged, heavy rainfall (64 mm in 12 hours) on 28 July 2019. Similarly, the rainfall on 30 July 2019 that increased the VWC at 1.2 m to maximum was a low-intensity, long-duration rainfall (42 mm in 10 hours). This behaviour shows that the heavy rainfall events, lasting for a relatively longer duration are capable of increasing the VWC at greater depths from the surface. During the continuous wet period between 25 and 30 July 2019, the degree of saturation increased by ~3% or more at all measured depths (Fig. 7(b)). In contrast to the observations during the dry period (Fig. 7(a)), rainfall infiltration caused a notable rise in the degree of saturation down to 1.2 m. Such progressive wetting by rainfall infiltration can cause reduction of matric suction and consequent loss of shear strength.

Fig. 7 (a) Variations in the degree of saturation from 3 May 2019 to 15 May 2019 (13 days), (b) Variations in the degree of saturation from 25 July 2019 to 30 July 2019 (6 days)

Moreover, Fig. 8 highlights the pattern of the increasing response-time of VWC with depth. In general, decrease in the VWC at the upper layer is followed by increase in the VWC at the underlying layer. Such temporal variations of the VWC increments represent the infiltration pattern in the soil. If such conditions prevail throughout the depth of the soil, the decrease in the VWC at 1.2 m on 30 July 2019 after reaching the maximum value shall be followed by a rise in the VWC in the underlying layers. This means that the soil layer below 1.2 m can have a VWC greater than 0.363 m³/m³. Since the porosity of the soil at 1.5 m is 36.40%, the soil at this layer may have reached complete saturation on 30 July 2019.
