Analysis of Tapial structures for modern use and conservation

P.A. Jaquin & C.E. Augarde

School of Engineering, University of Durham, UK

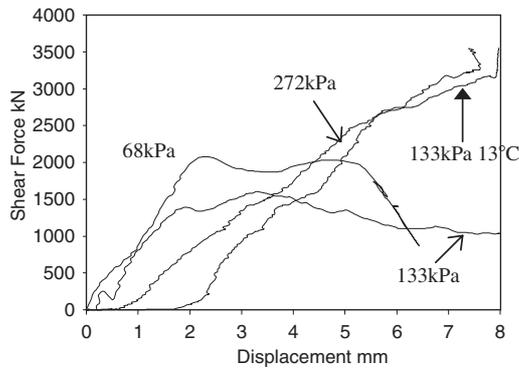
Figure 3. Shear box test results for rammed earth samples.

The results are inconclusive as the plots of shear stress against displacement in Figure 3 shows. Three tests were carried out on samples thought to date from the 19th century and one on a 13th century sample. In the latter samples, a lower peak shear strength is reached in the sample subjected to a higher normal stress, contrary to expectations for standard frictional

materials. For example, predicted angles of friction for the first two samples are 83° and 72° indicating bonding to be significant. The 19th century sample at the highest normal stress, however, does not show a peak strength within the range of testing carried out. The 13th century sample also fails to show a peak strength.
