# The dry tank: Development and disuse of water management infrastructure in the Anuradhapura hinterland, Sri Lanka

We identify and offer new explanations of change in water management infrastructure in the semi-arid urban hinterland of Anuradhapura, Sri Lanka between ca. 400 BC and AD 1800. Field stratigraphies and micromorphological analyses demonstrate that a complex water storage infrastructure was superimposed over time on intermittently occupied and cultivated naturally wetter areas, with some attempts in drier locations. Our chronological framework, based on optically stimulated luminescence (OSL) measurement, indicates that this infrastructure commenced sometime between 400 and 200 BC, continued after Anuradhapura reached its maximum extent, and largely went into disuse between AD 1100 and 1200. While the water management infrastructure was eventually abandoned, it was succeeded by small-scale subsistence cultivation as the primary activity on the landscape. Our findings have broader resonance with current debates on the timing of introduced ‘cultural packages’ together with their social and environmental impacts, production and symbolism in construction activities, persis

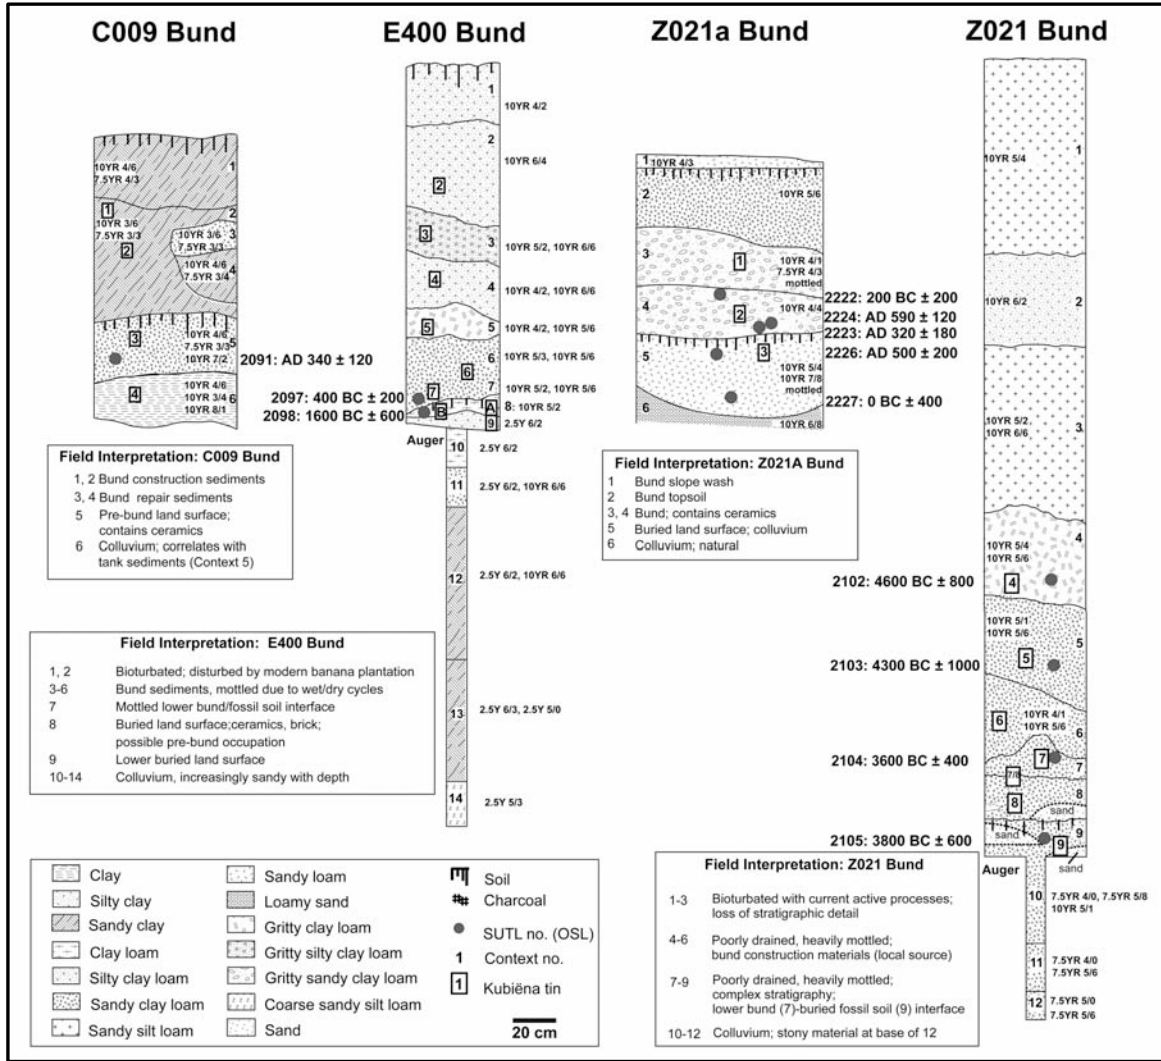
**Figure 4. Stratigraphy, bund and pre-bund surfaces.** Field description, field interpretation and sample locations.

Field stratigraphies and field-based interpretations are given in Figures 3, 4, and 5. Land surfaces and underlying Quaternary deposits, construction phases, and tank and channel infills are evident, and provide the foundation for geo-chronological and micromorphological investigation.

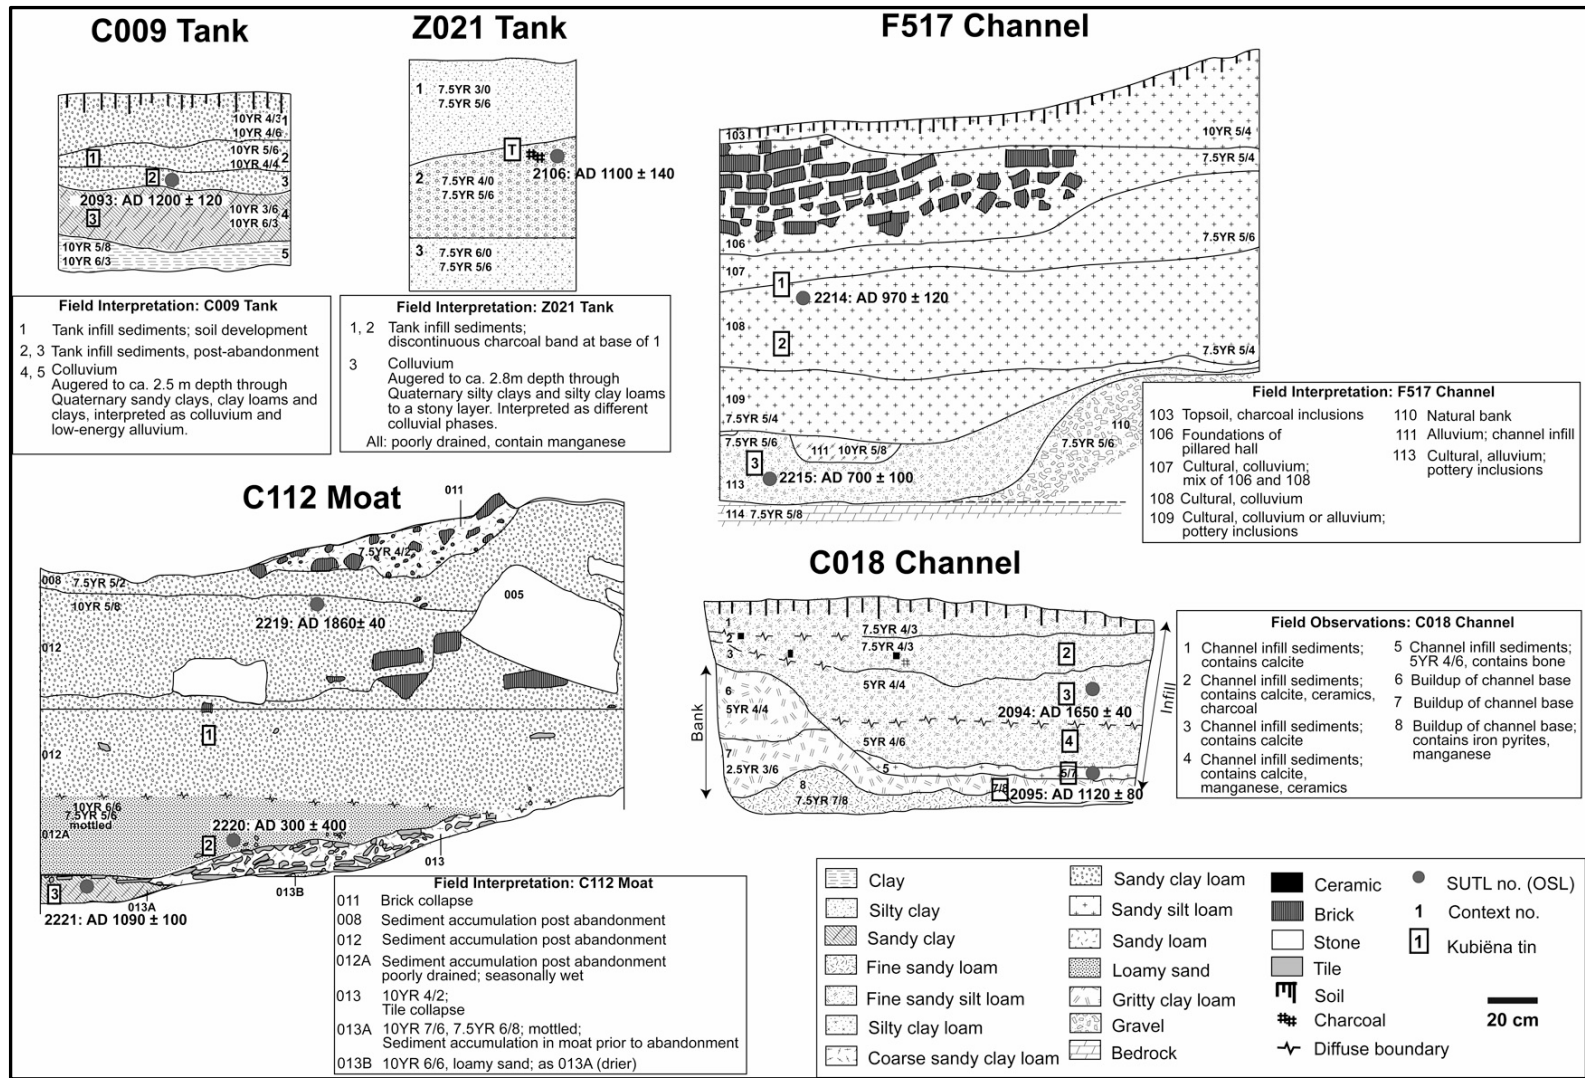
Figure 5. Stratigraphy, infill sediments. Field description, field interpretation and sample locations.

**C018.** Micromorphological sample C018-7/8 (channel base; Figure 5) is divided into three sections, the lower two of which record channel construction. The massive microstructure at the base of this sample indicates compaction and layering of re-deposited sediments with undifferentiated and striated b-fabric and an increased abundance of incorporated organic material. These characteristics are consistent with those of the cultivated control soils, and the sediments are interpreted as relict *chena* soils that were re-deposited or disturbed during channel construction; the elevated total P values for Unit 8 support this interpretation (Table 5). The middle of the sample (C018-7/8B) is primarily composed of gravel-sized quartz aggregates that are not abundant in any other sediment sampled within the entire study area, and were likely imported into the site specifically to line the channel. This layer probably functioned to protect the channel from erosion during transportation of water and is consistent with the protective stone linings on the bund of a large tank observed by Myrdahl (1990) in her work in the Sigiriya region, ca. 50 miles to the southeast. Efforts to compact the channel base thus reducing infiltration are also evident; our double ring field infiltration experiments suggest a mean channel infiltration rate of 2.43cm/cm<sup>2</sup>/day, against 5.93cm/cm<sup>2</sup>/day for the surrounding RBE. The characteristics of the upper section of this sample (C018-7/8A) are consistent with the rest of the infill sediments (i.e. C018-5/7, 4-2; Figure 5). Most anorthic sediment lenses and soil fragments in the C018 infill thin sections have similar lithologies and frequently incorporate organic

Micromorphological samples C018-3 and 2 (infill sediments; Figure 5) demonstrate an intensification of cultivation activities around the channel and within the infill sediments themselves. This evidence includes fragments of charred material resembling burnt husks of cereal grains (probably rice, see Reedy, 2008), elevated frequencies of integrated anorthic soil fragments containing increased abundances of coarse charred and fine organic material (Figure 8D), and U-shaped or parallel-oriented compaction features, interpreted as tool marks; these observations are supported by elevated total P levels (Table 5). Thin section C018-2 demonstrates elevated abundances of cultural indicators relative to C018-3 and undifferentiated b-fabric consistent with the *chena* control soils, suggesting channel cultivation intensified following deposition of Unit 2. Cuneiform bulliform (Madella, et al., 2005) phytoliths were observed throughout most of the channel infill sediments, and indicate shallow surface water conditions in the vicinity of the channel during most of the post-abandonment period (Bremond, et al., 2005). However, the absence of bulliform phytoliths and reduced abundance of redoximorphic pedofeatures in thin section C018-2 demonstrates evidence that surface water conditions ceased or diminished after deposition of Unit 3 (Figure 5).

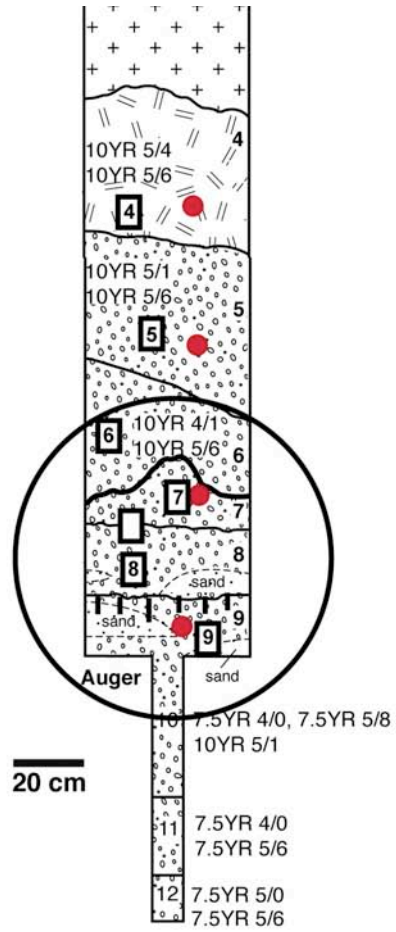
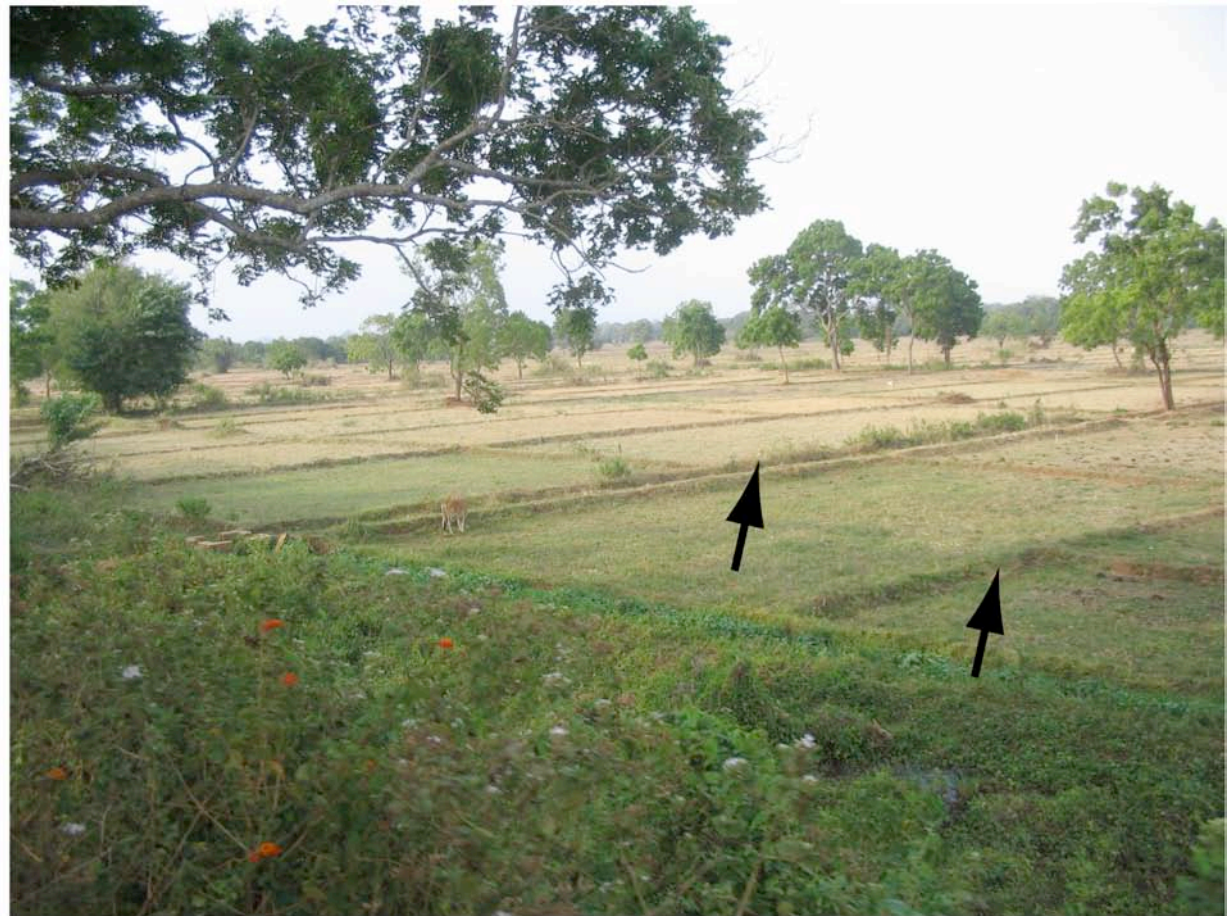
Figure 7. Modern *niyara* (arrows) and lower Z021 stratigraphy (circled).

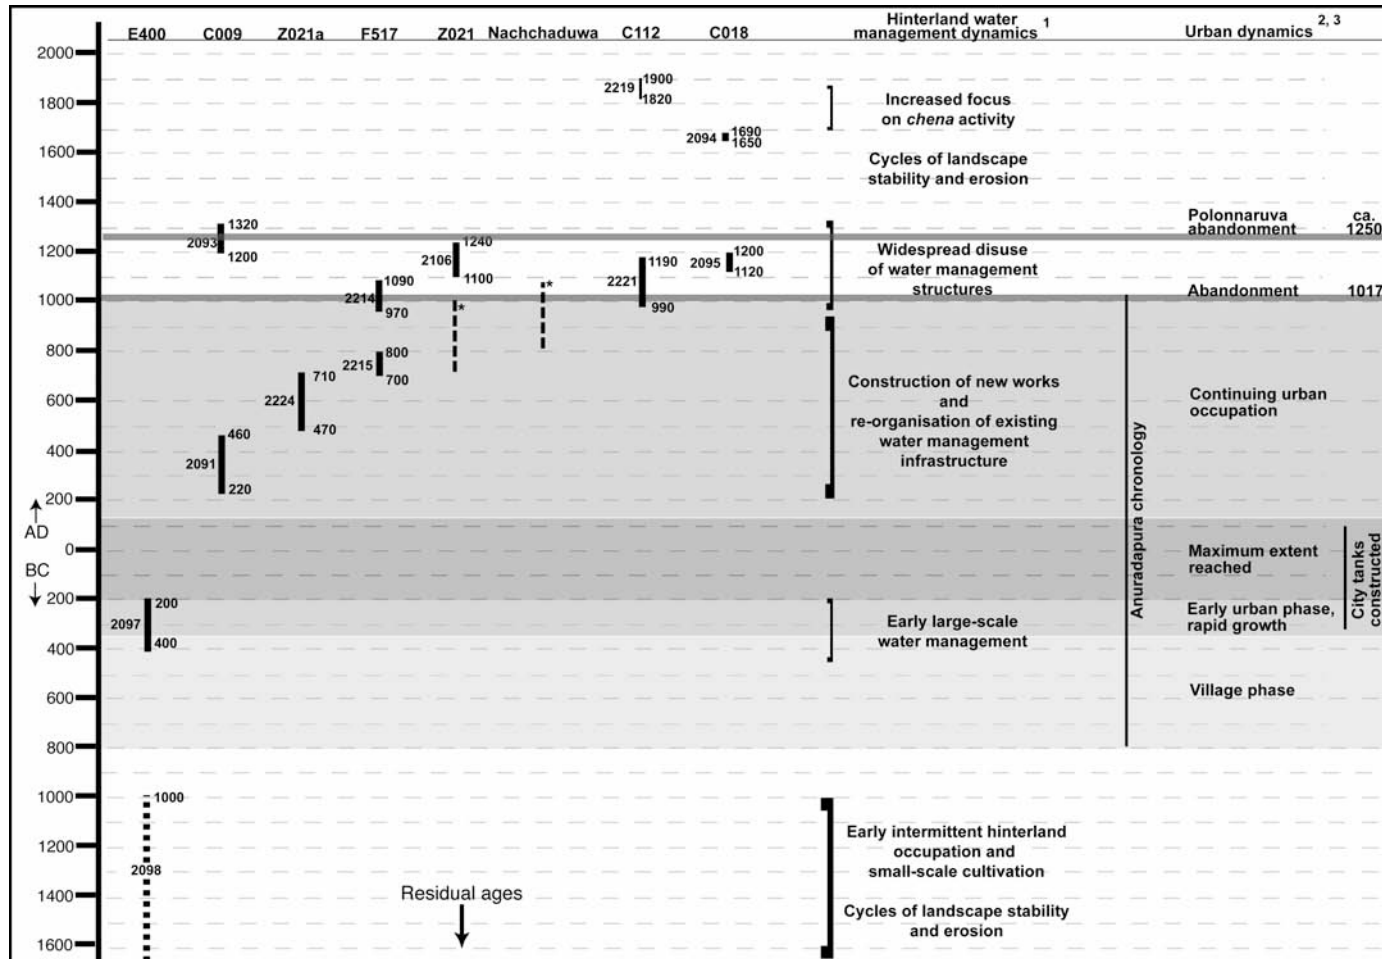
**Figure 9. Integration of early water management infrastructure dynamics in the Anuradhapura hinterland.**

1. This study. 2. Coningham (1999). 3. de Silva (2005). Dashed lines marked with an \* indicate that the dates for construction of these tanks are inferred using relative dating (see text). The dotted line for the date at E400 indicates that this date is earlier than expected and may represent a residual OSL signal.
