'Re-making the nation', uses and recycling of brick in medieval English buildings: insights from the application of luminescence dating and new avenues for further research.

Bailiff, I. K., Blain, S., Graves, C. P., Gurling, T. and Semple, S.

Department of Archaeology, Dawson Building, Durham University, South Road, Durham, DH1 3LE, UK.

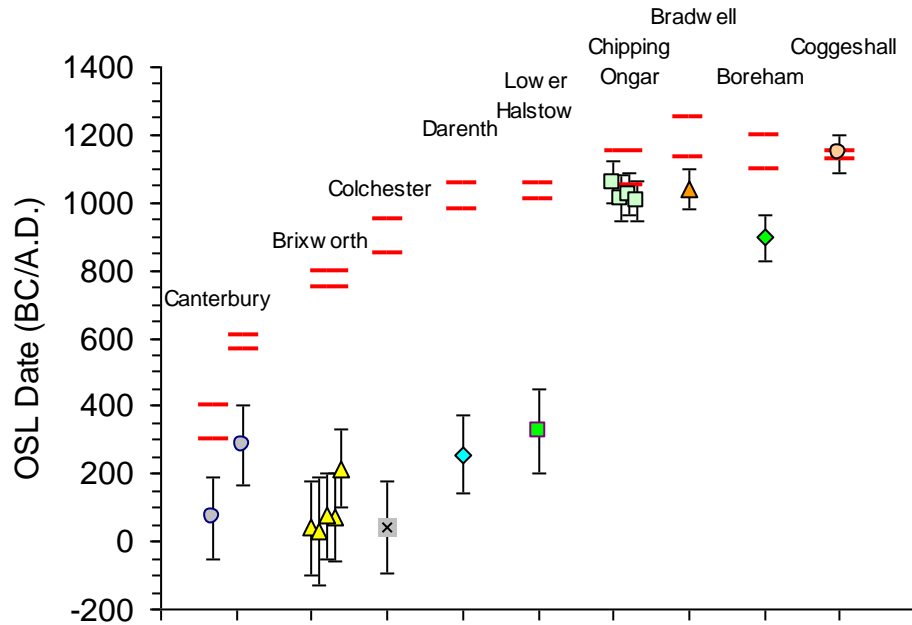
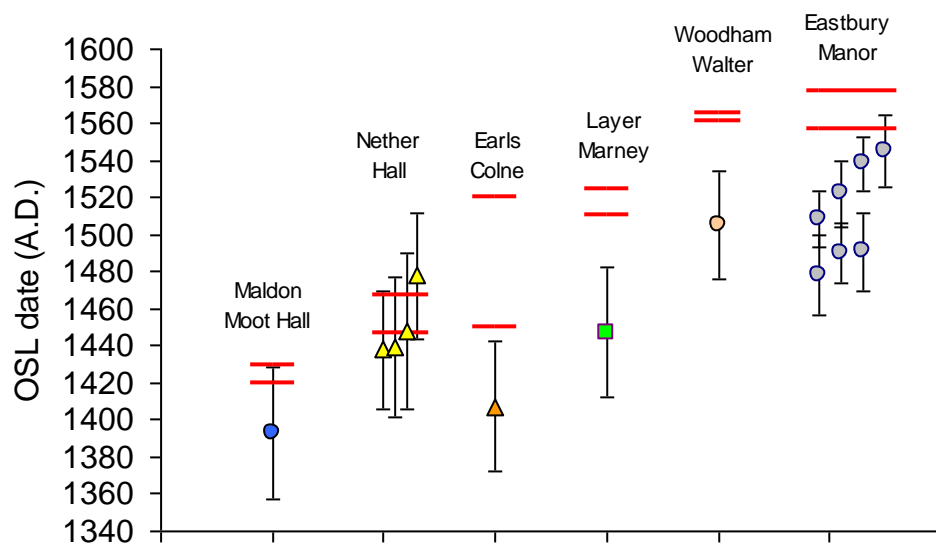
Figure 2.

Individual OSL dates grouped according to assigned date range: a) Sixth – thirteenth centuries AD and b) Fourteenth-sixteenth centuries AD, where the vertical bars correspond to the overall error ($\pm\sigma_B$). The horizontal bars indicate the upper and lower limits of the assigned date range (Table 2).

The luminescence dating results are summarised in Table 2, and key technical data associated with each date calculation are given in Table 3. The assigned building dates and luminescence dates are plotted in two groups (Figs 2a and 2b), shown in chronological order according to the archaeologically assigned date range for the sampled phase. The OSL date was initially calculated assuming the brick was in a primary context, and for those cases where archaeological evidence suggested reuse, the OSL date was recalculated by adjusting the average dose rate (see notes to Table 3) to make an allowance for the potentially different environment in which the brick had been located prior to construction of the wall, the estimated date of which was derived from the archaeological assessment of the fabric. Although for the cases considered here the adjustment to the dose rate is small (average increase of 1.6%) it is important that the effect is taken into account in the dose rate assessment procedure.
